## Notice of Intent to Remove Asbestos

## Roger Shea Project Report

Possible irrigation sprinkler burst. Basement flooded approximately 1000SF at 2 inches. EMS techs have been dispatched.  
Shut off valve and back flow valve failed.

| Sprinkler broke outside flooding the basement | Category 3 | |

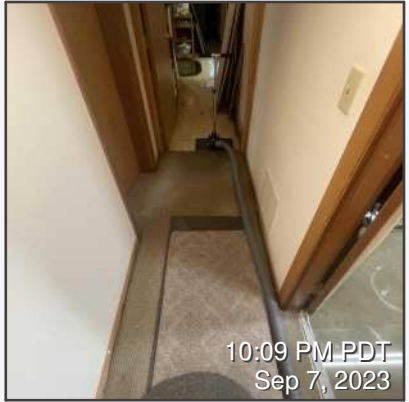
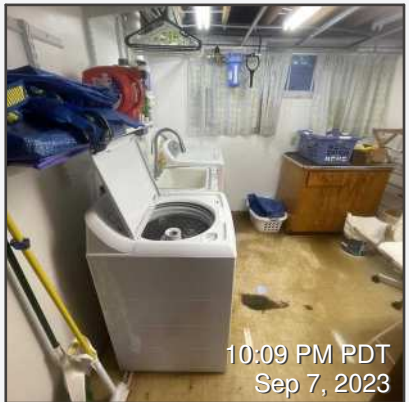
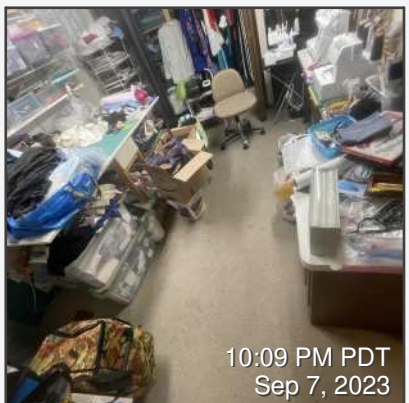
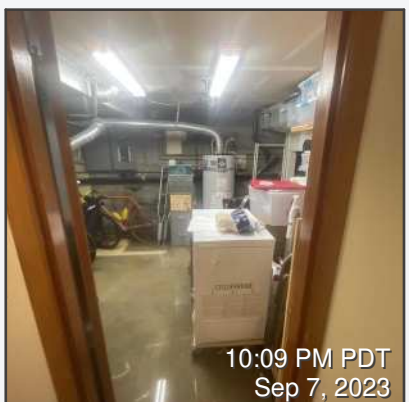
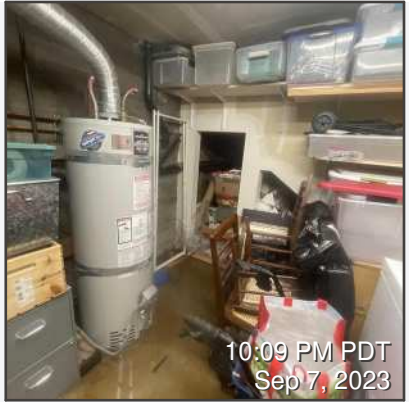
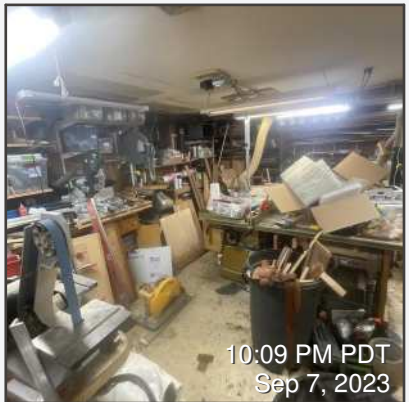
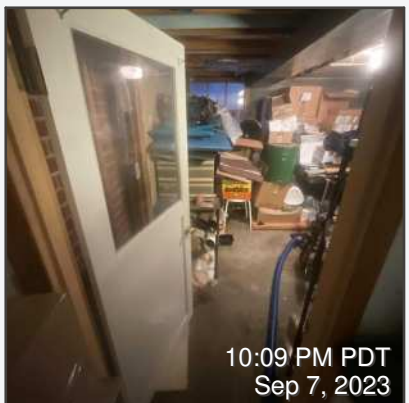
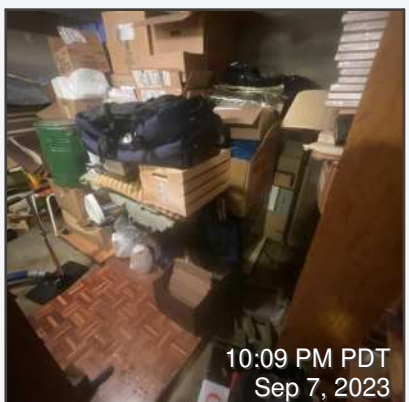
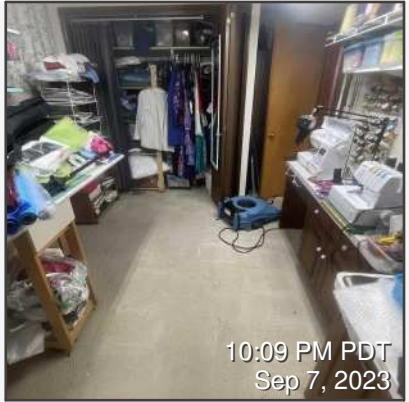
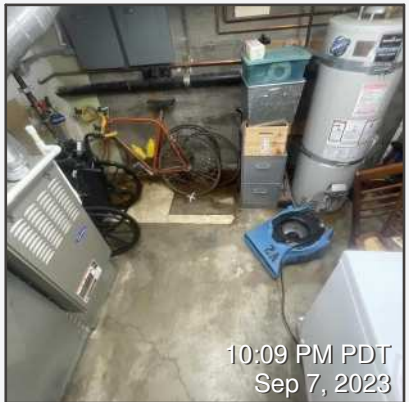
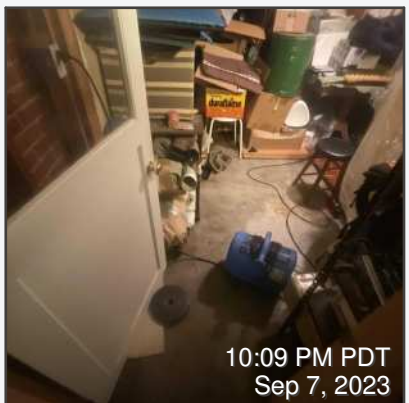
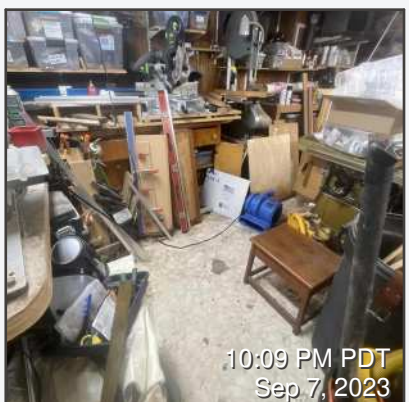
#### Emergency extraction 9/7/23

Chris called us because a sprinkler system had burst outside the laundry room window in basement causing water to flood entire floor. There are a lot of contents that will need to be moved and stored in garage or pod in order to evaluate and mitigate affected areas properly. We extracted 2" of standing water through out all rooms in basement (1275 SF). 13 air movers and 1 dehumidifier onsite.

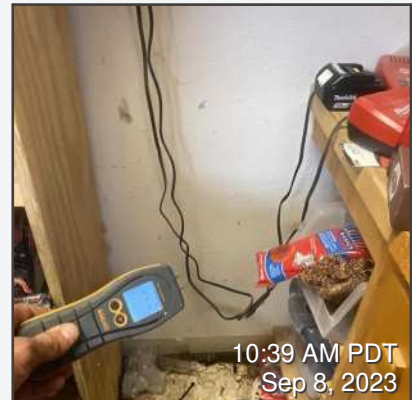
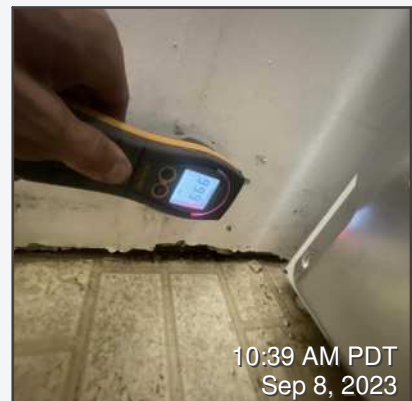
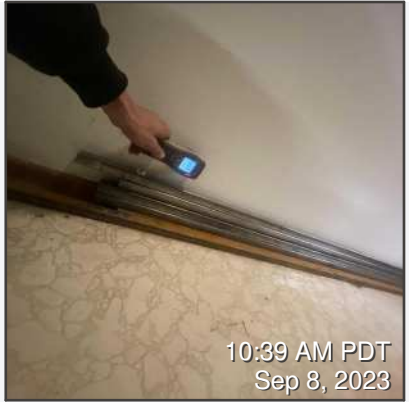
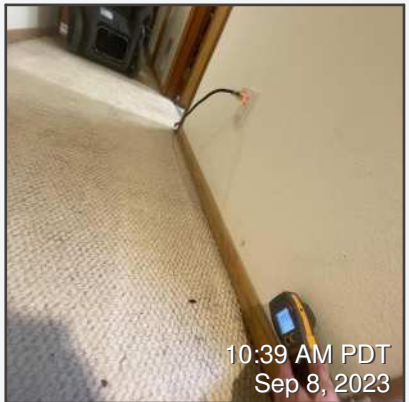
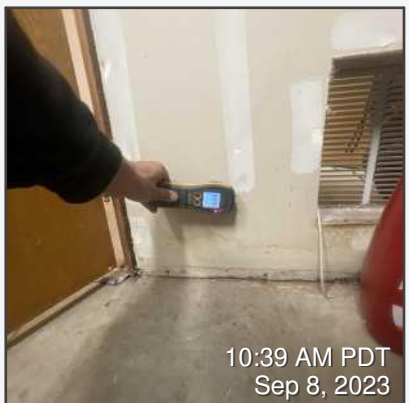
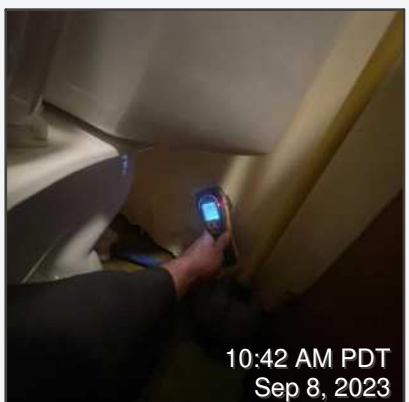
### Monitor / place equipment 9/8/23

Arrived onsite and began monitoring moisture points through out basement finding everything to still be fully saturated. Water has risen about 1' up each wall in basement. We installed 2 more dehumidifiers and 4 more air movers. We will want more equipment placed after contents have been moved out of all rooms. Had to plug our power distributor box in laundry room in order to run all equipment. 17 air movers and 3 dehumidifiers onsite. Will be back tomorrow to monitor material and equipment.

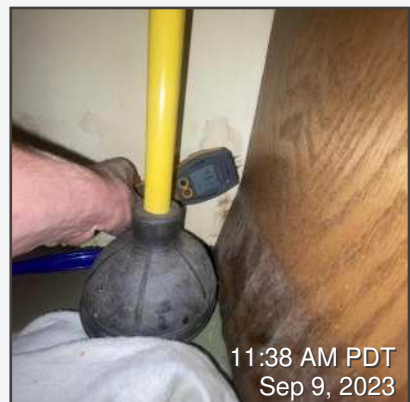
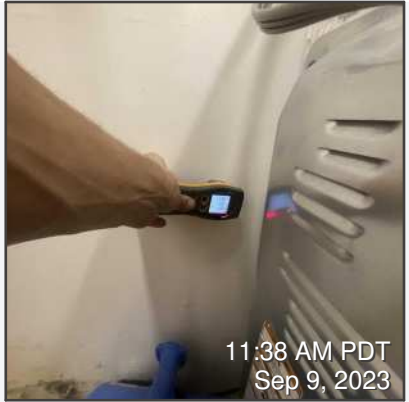
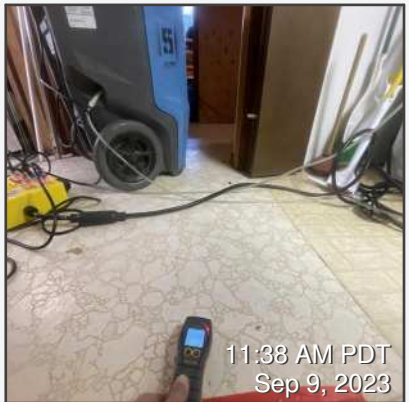
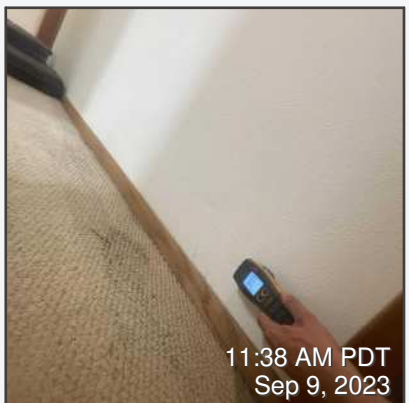
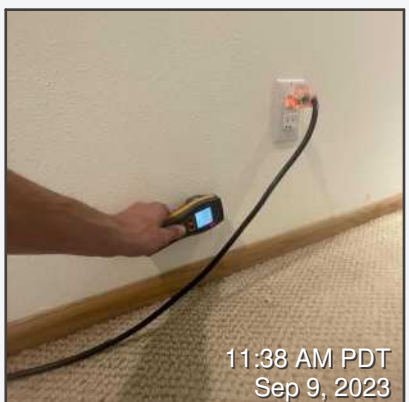
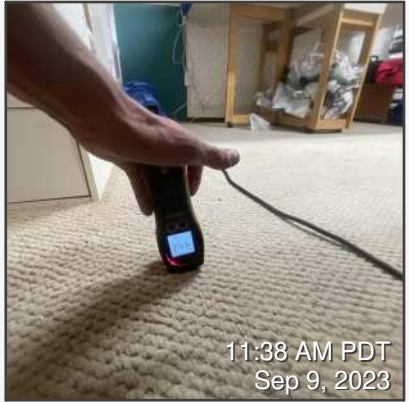
### Monitor visit 9/923

Arrived onsite and began monitoring moisture points through out affected areas finding everything to still be saturated. Will need to move all contents from rooms in order to remove necessary material and place equipment on said areas. All exterior walls will need to have flood cuts and remove any wet insulation that may be trapped inside.

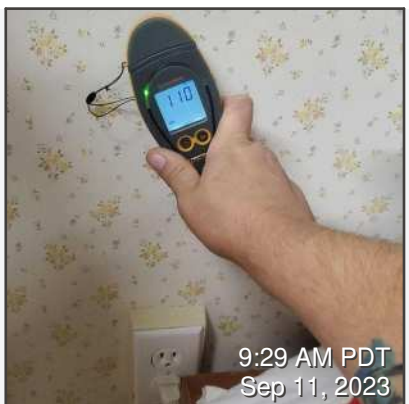
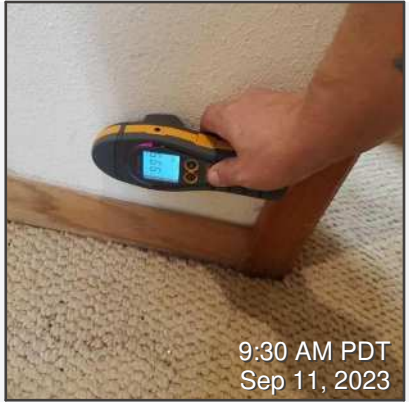
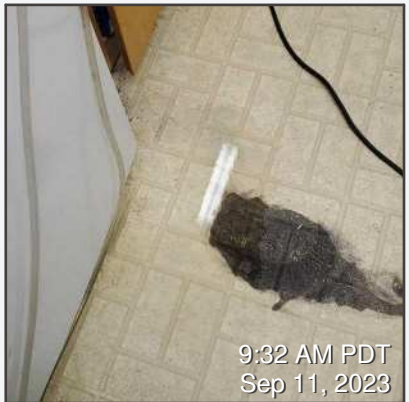
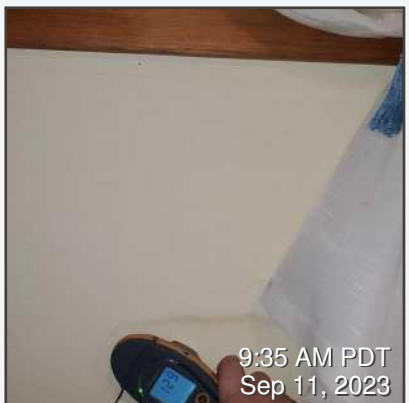
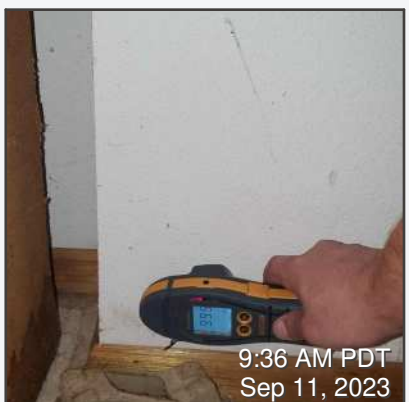
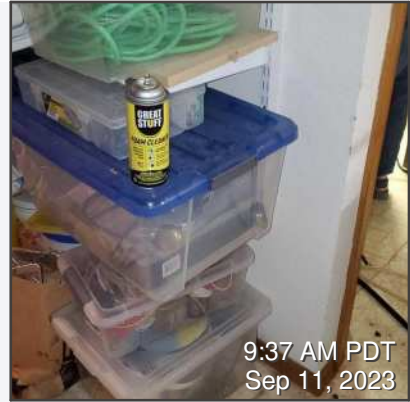
### Monitor 9/11/2023

Monitored moisture points and found all materials to still be highly saturated. Shannon with Restoration 1 will be by later today to walk the homeowners through the pack out process of moving their contents. PNW will be back tomorrow to monitor. 3 dehus 17 air movers 1 spider box onsite

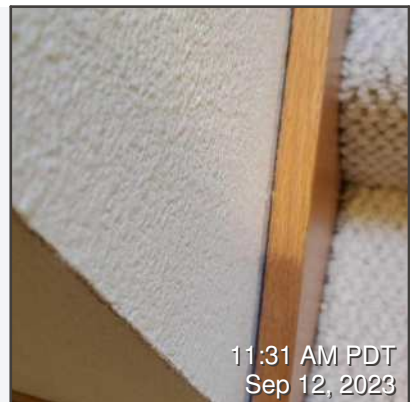
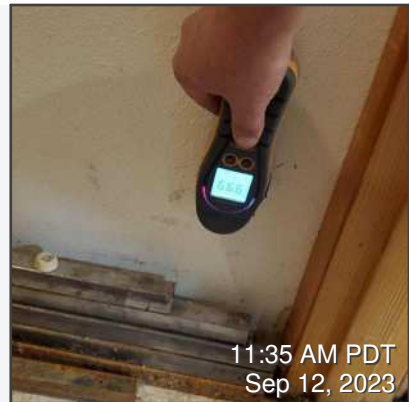
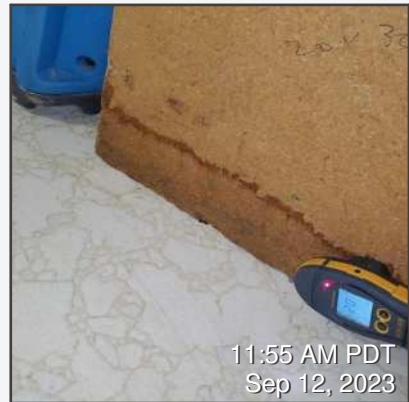
### Monitor 9/12/2023

Monitored moisture points Finding everything to still be highly saturated. A strong odor is now present. Sprayed decon 30 anitmicrobial on the carpeted areas. Rearranged the power to the breakers downstairs so that the home owner could use their laundry room. Still waiting on contents to be moved. Will return to continue monitoring.

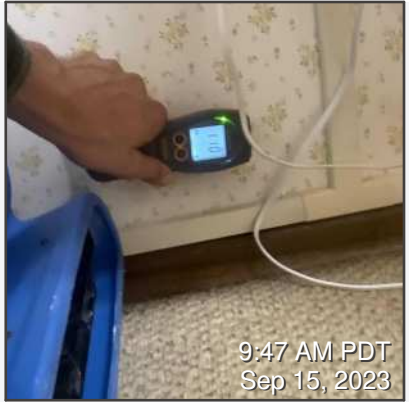
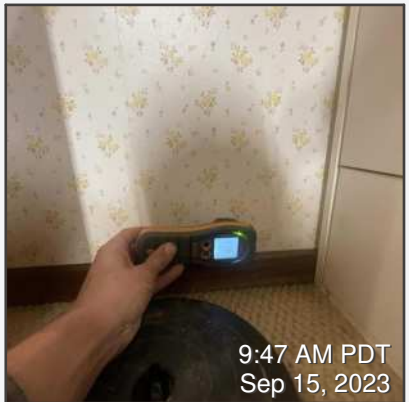
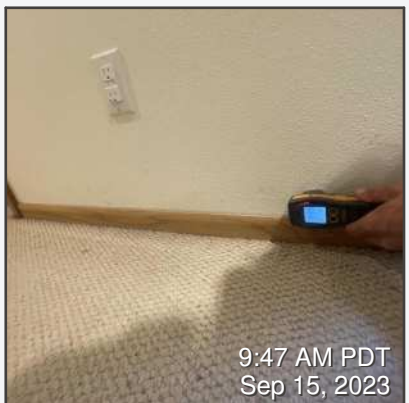
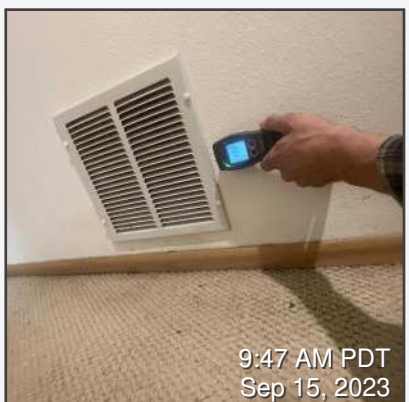
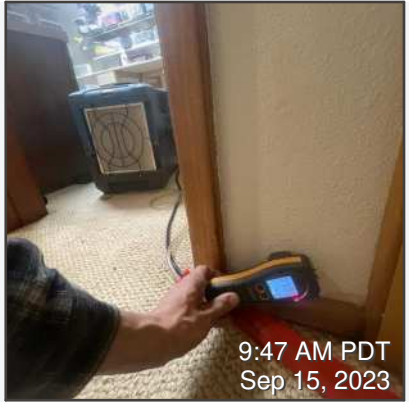
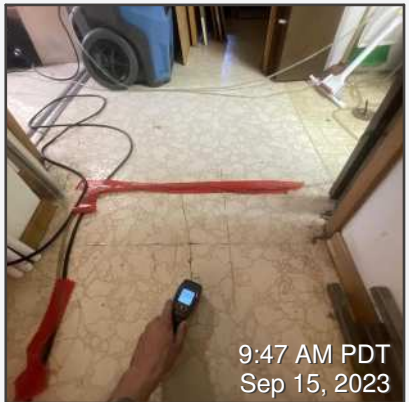
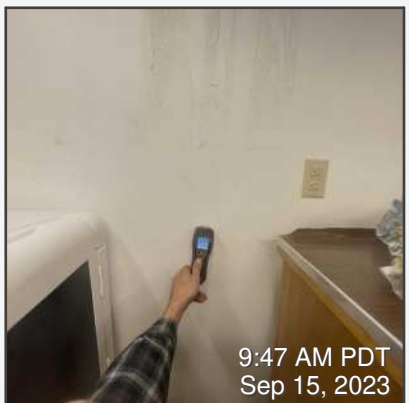
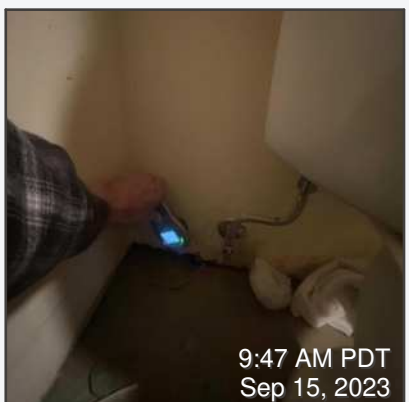
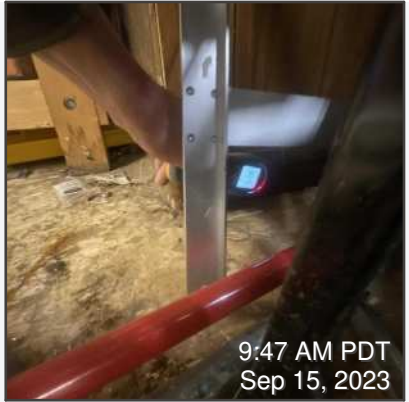
### Monitor visit 9/15/23

Arrived onsite and began monitoring moisture points through out affected areas. Most drywall through out is reading highly saturated however some areas have dried. Carpets are reading dry but will still want to move all contents and shelving off carpets to be sure it has dried out entirely. Still waiting for pack out crew to remove all contents away from affected material so we can begin demo on areas of concern.

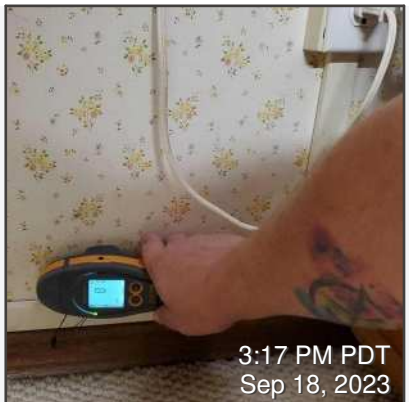
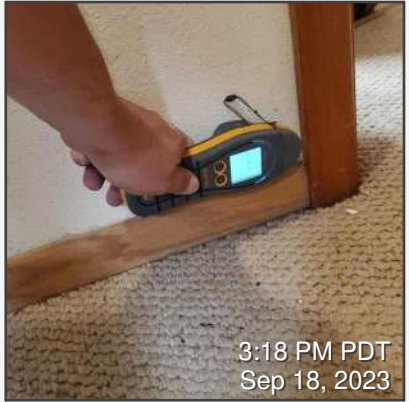
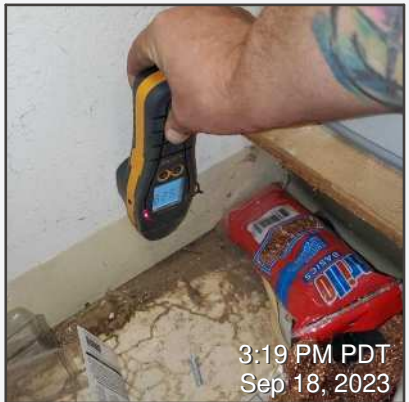
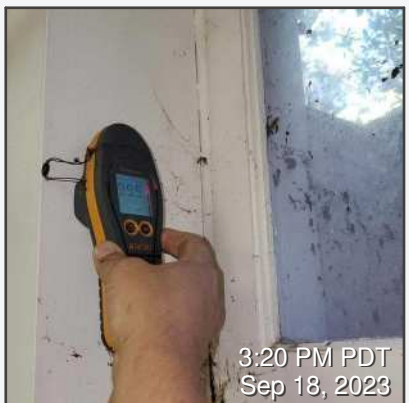
### Monitor 9/18/2023

Monitored moisture points finding materials to still be wet. Pack out of contents will begin tomorrow, once all contents are moved we will be able to begin demo. Will be back to continue monitoring.

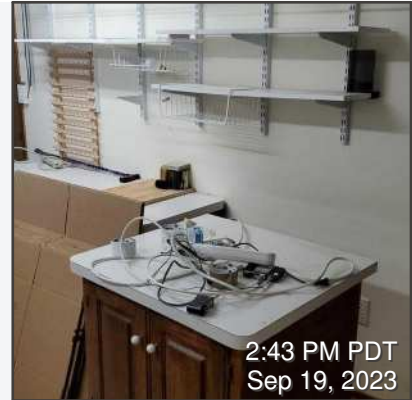
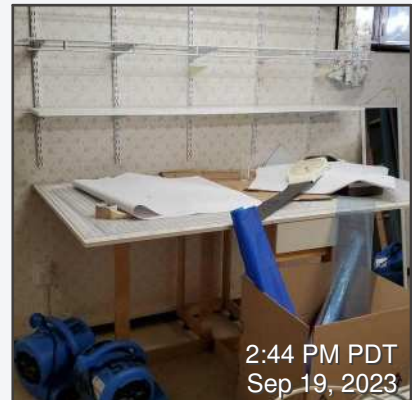
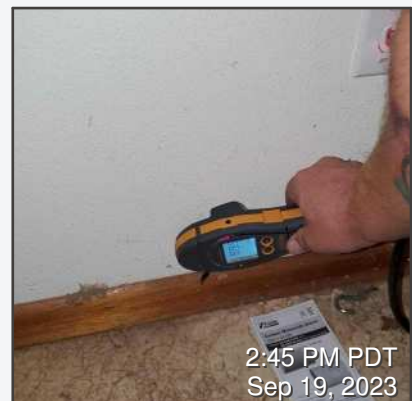
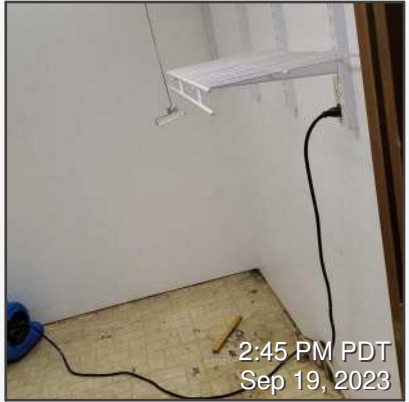
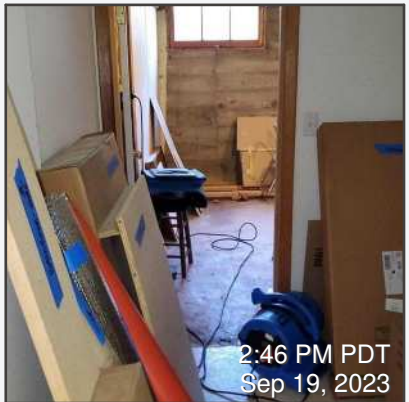
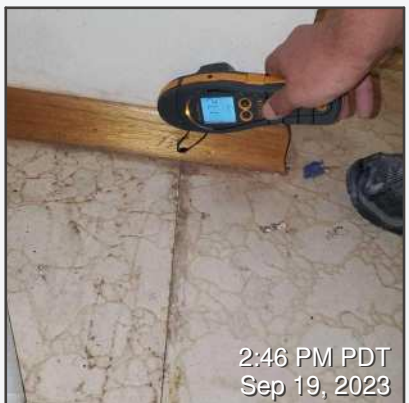
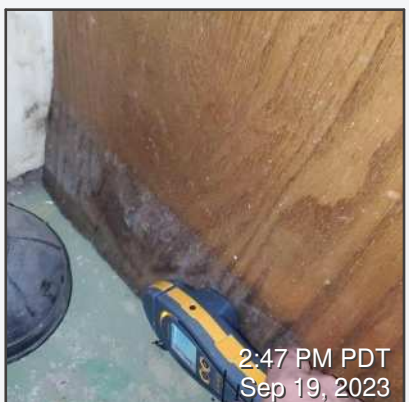
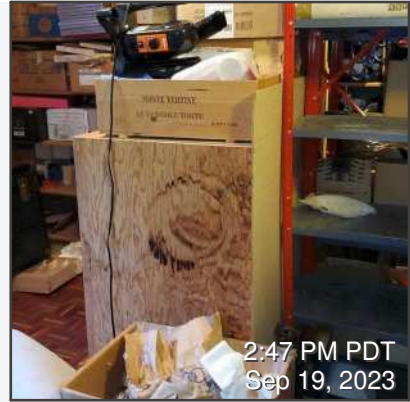
## Monitor 9/19/2023

Monitored moisture points finding materials to still be saturated. Pack out has begun. Pack out crew made good progress today. Will be back tomorrow to monitor. Could potentially start demo by the end of the week.

Still recommend 2 ft flood cuts along all walls as well as removing the carpet pad and vinyl flooring. Once all demo is complete we will perform a hepa clean, ensuring all surfaces are clean. 3 dehus and 17 air movers onsite

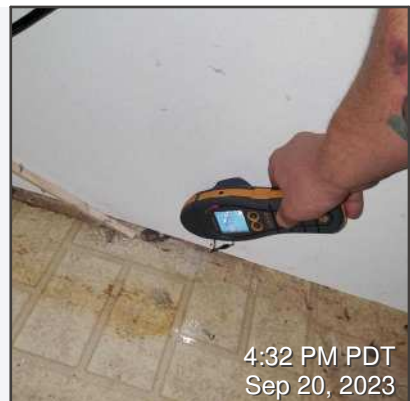
### Monitor 9/20/2023

Monitored moisture points finding materials to still be wet as well as some microbial growth once we moved some contents away from the wall. Contents crew is getting close to finishing moving contents out of the basement. Should be able to begin demo in the next day or two.

Recommend removing all carpet pad and vinyl flooring as well as making 2 ft flood cuts through out the entire basement and then performing a Hepa clean.

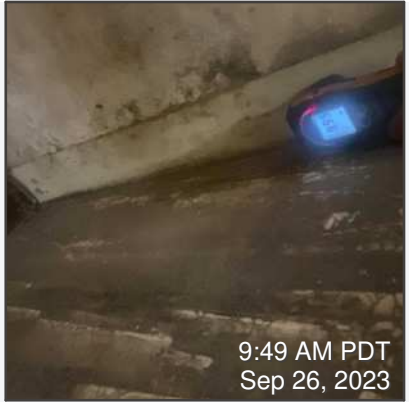
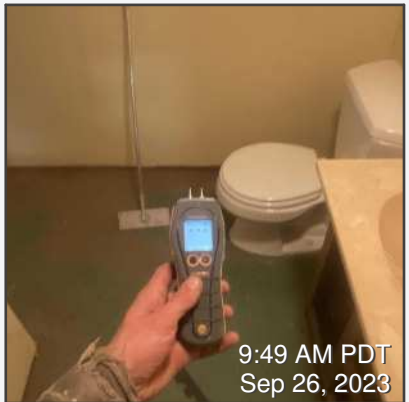
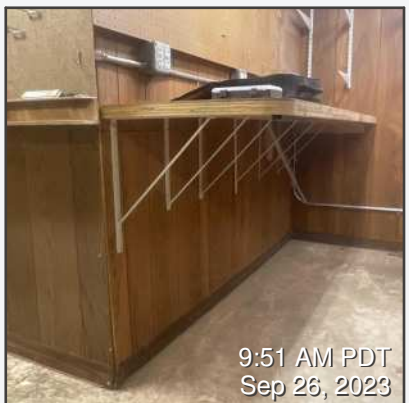
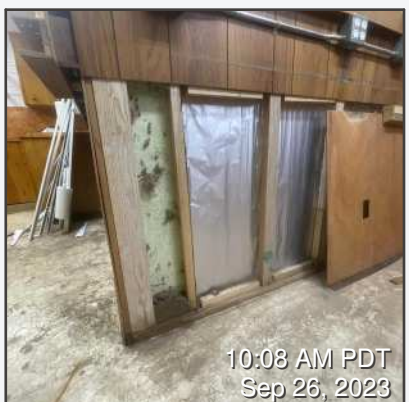
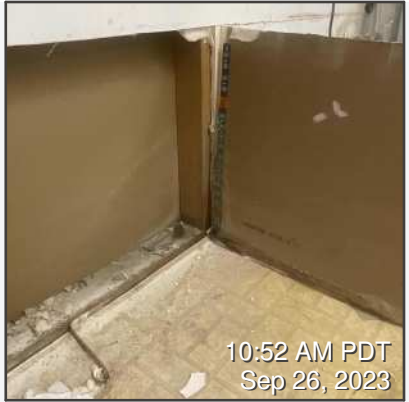
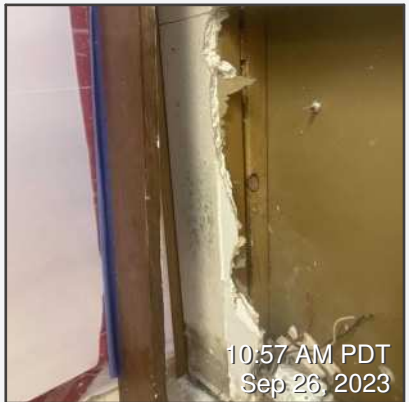
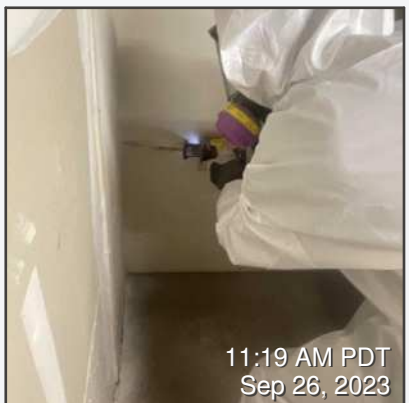
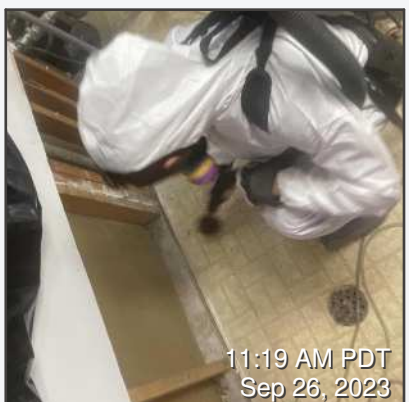
### Monitor / Demo visit 9/26/23

Arrived onsite and began monitoring moisture points through out affected areas. Finding moisture scattered through out basement. Mainly in shop, and interior hallway walls. Did 2' flood cuts through out all rooms. Tomorrow we will start on hallway and then begin our detail cleaning.
