# Notification of Demolition

Case #: 24-102

# Phase I Environmental Site Assessment

**RE: Asbestos Survey for Demolition at 1201 SE 192<sup>nd</sup> Avenue (South Cascade Terrace). Werner Home.**

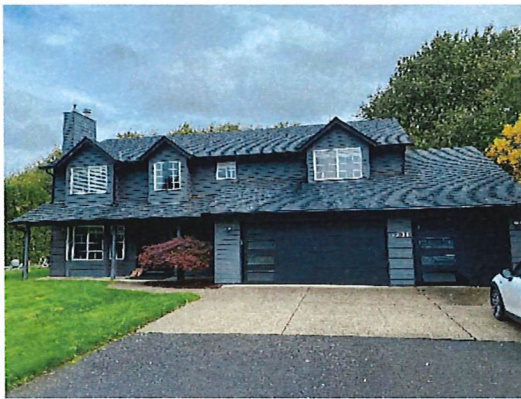
**Photo #1** Large residential house located in SE corner of 1201 parcel

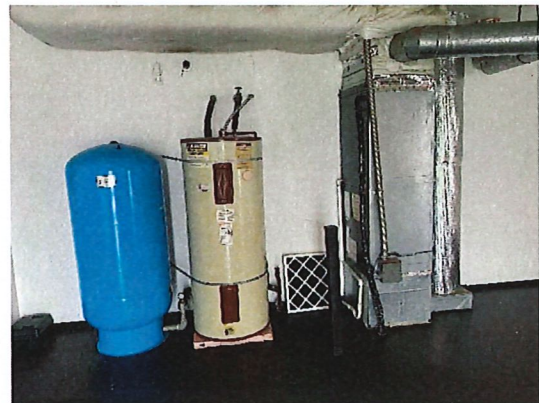
**Photo #2** View of water pressure tank, water heater, and furnace located in garage of 1201 parcel large house

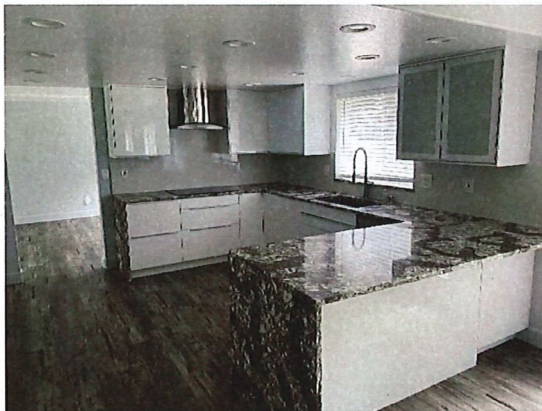
**Photo #3** Interior of large house on 1201 parcel

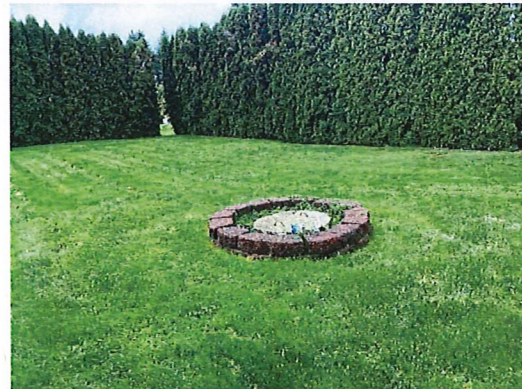
**Photo #4** Lid to septic system, located north adjacent to 1201 parcel large house

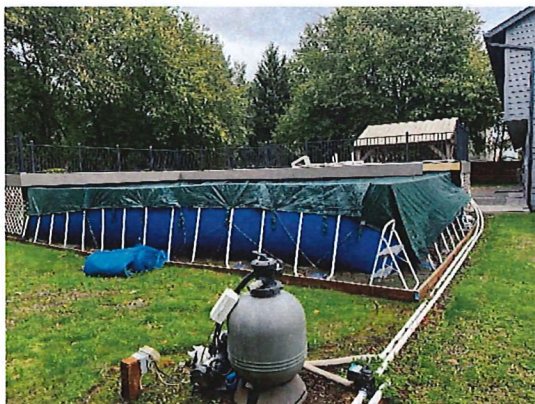
**Photo #5** View of above-ground pool in backyard of 1201 parcel

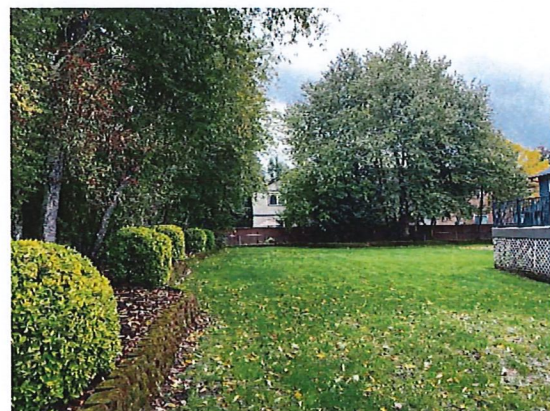
**Photo #6** View of east end of 1201 parcel, facing south

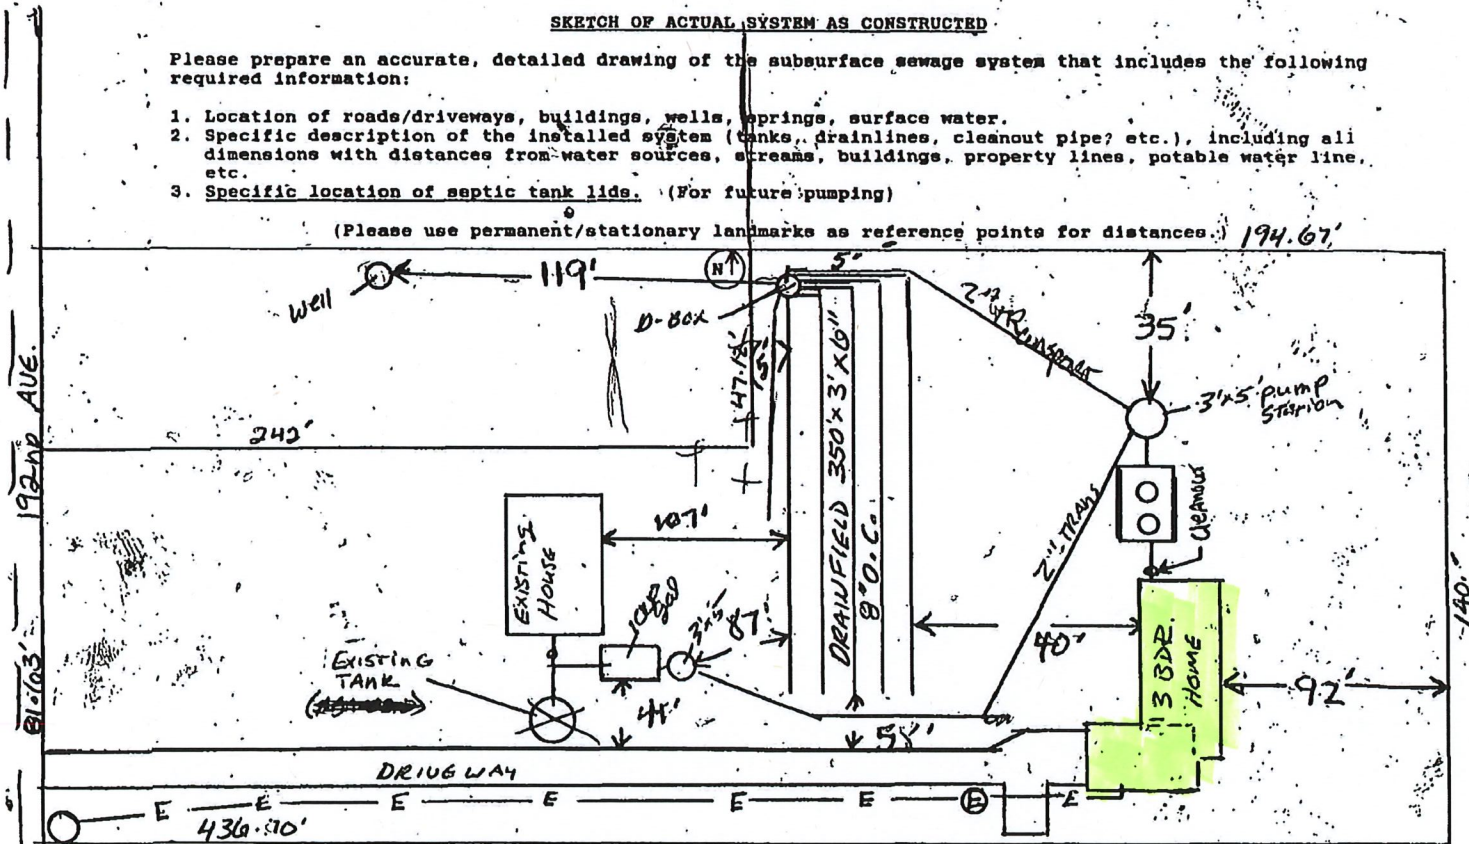
**SKETCH OF ACTUAL SYSTEM AS CONSTRUCTED**

COMMENTS: GUEST HOUSE HAS 1000 GAL TANK, MAIN HOUSE HAS 1250 TANK,

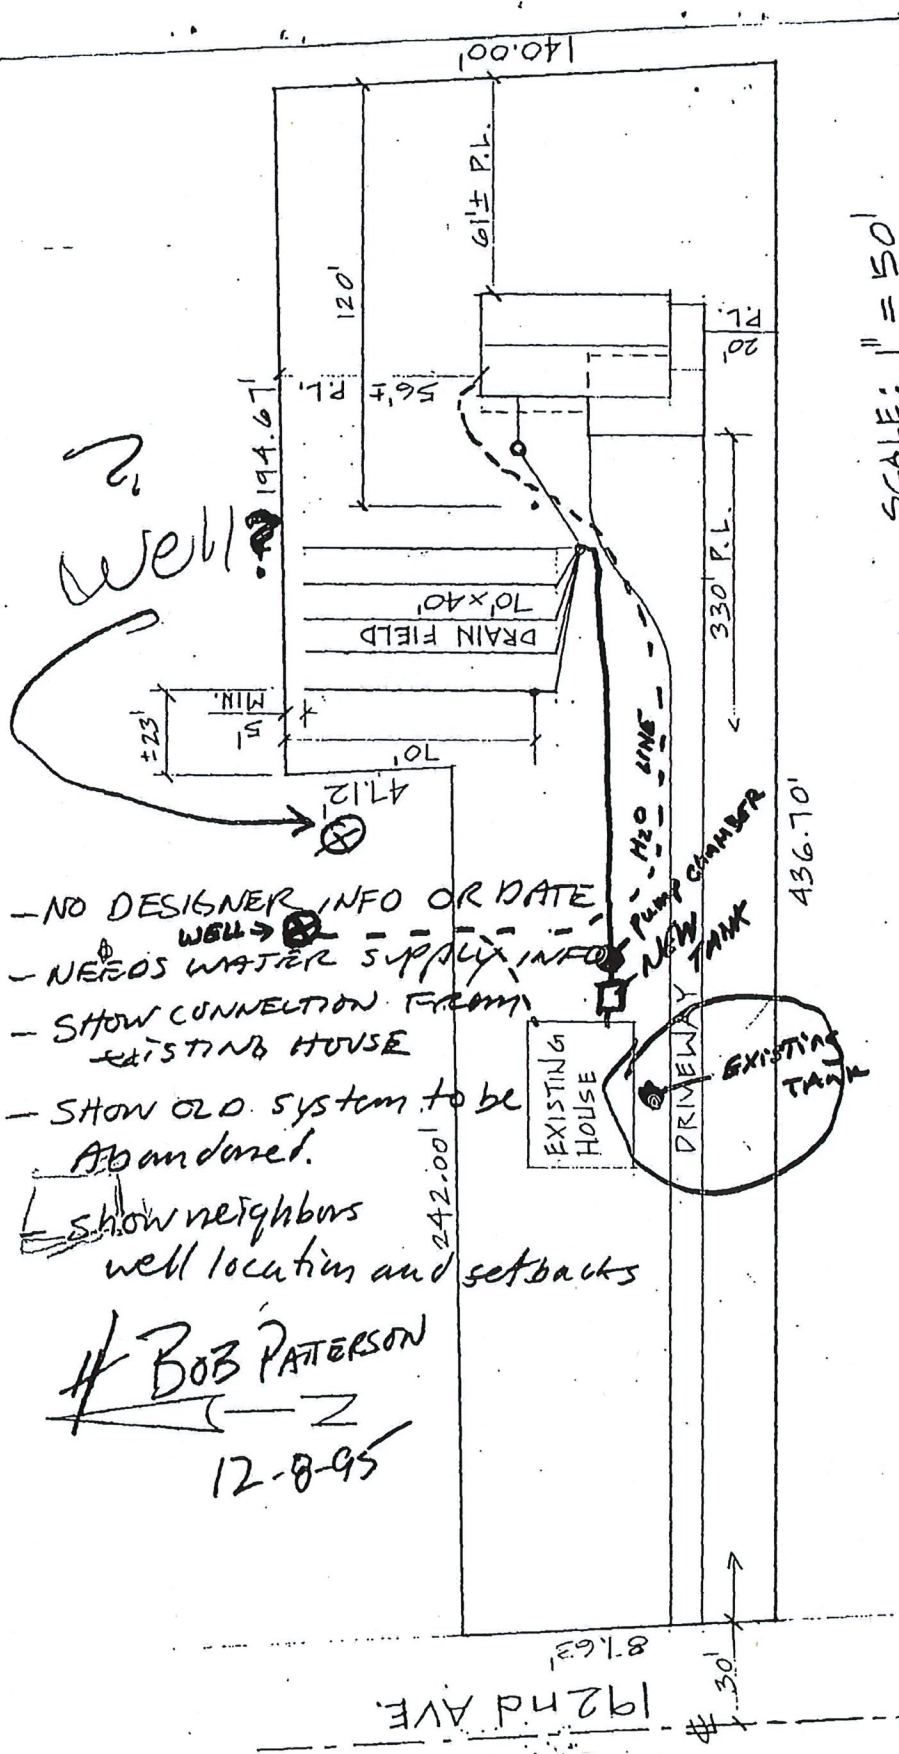
- NO DESIGNER INFO OR DATE
- NEEDS WATER SUPPLY INFO
- SHOW CONNECTION FROM EXISTING HOUSE
- SHOW OLD SYSTEM TO BE ABANDONED.
- SHOW neighbors well location and setbacks

APPROVED  
Signature  
NEED ASSURE  
100' to well  
13 Dec 95  
SOUTHWEST WASHINGTON HEALTH DIST
