Notice of Intent to Remove Asbestos

Site Name: CHOB Youth Shelter Training

February 6, 2024

RCP Environmental was retained by Bill Buchan of LP&H Mechanical Company to provide a limited pre-renovation hazardous building materials survey for the Longview Youth Shelter at the former Carriage House Restaurant space located at 1334 12th Avenue in Longview, Washington. The purpose of this inspection is to locate, identify and quantify asbestos-containing building materials and lead paint in the space prior to renovation.

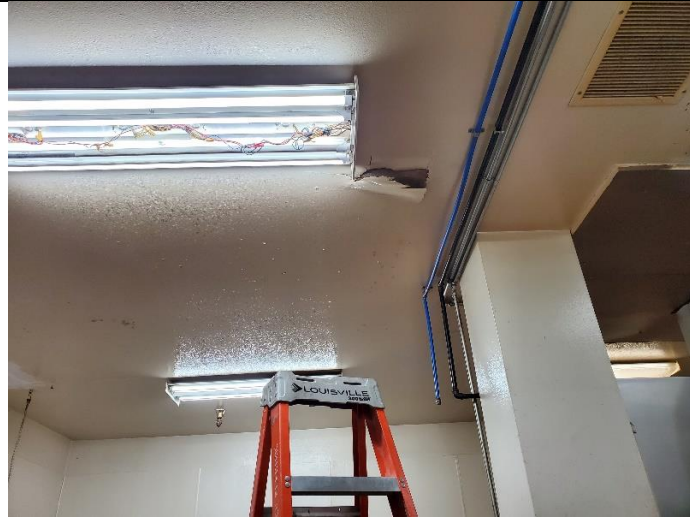
PHOTO 001 – Samples 106 and 107 Asbestos-Containing Texture Paint on Kitchen Ceiling

Asbestos containing materials must be removed by a Washington L&I licensed full scale asbestos abatement contractor utilizing L&I certified asbestos workers under the direct supervision of an L&I certified asbestos supervisor prior to any renovation or demolition activities that could disturb the materials. If additional suspect ACM is subsequently discovered during demolition, either stop work and have the suspect material tested, or presume it is asbestos and have it removed by a licensed asbestos abatement contractor.

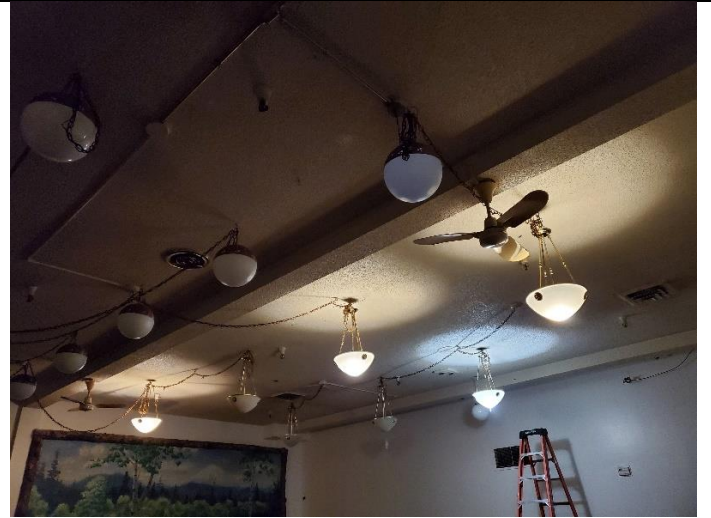
PHOTO 002 – Samples 108, 109, and 110 Asbestos-Containing Ceiling Texture in Banquet Room

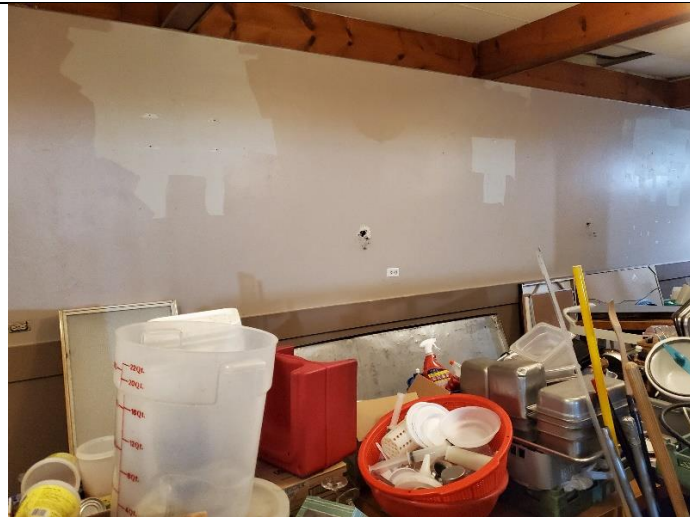
PHOTO 003 – Samples 119 and 120 Asbestos-Containing Joint Compound on Gypsum Wallboard

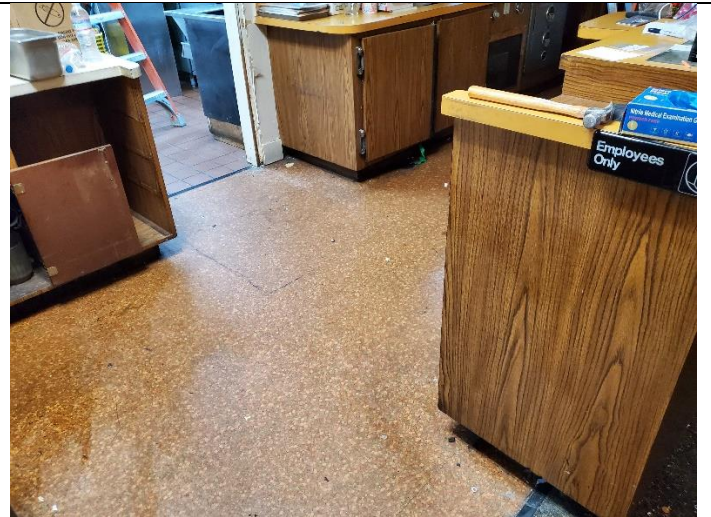
PHOTO 004 – Sample 121 Asbestos-Containing Sheet Vinyl Flooring in Serving Area

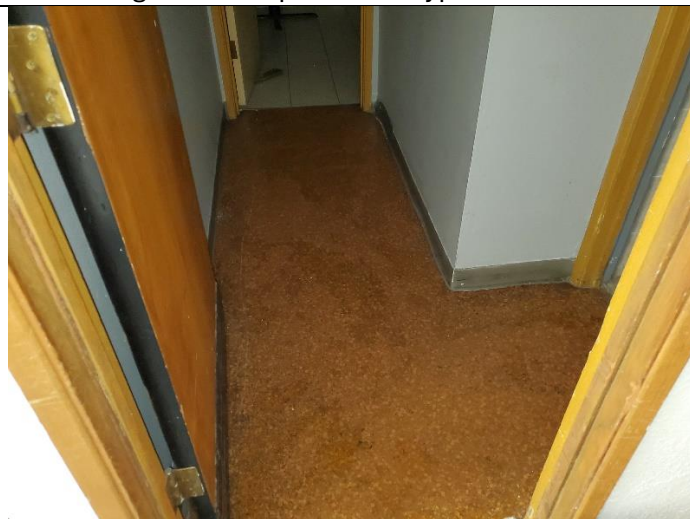
PHOTO 005 – Sample 123 Asbestos-Containing Sheet Vinyl Flooring in Rest Room Hallway

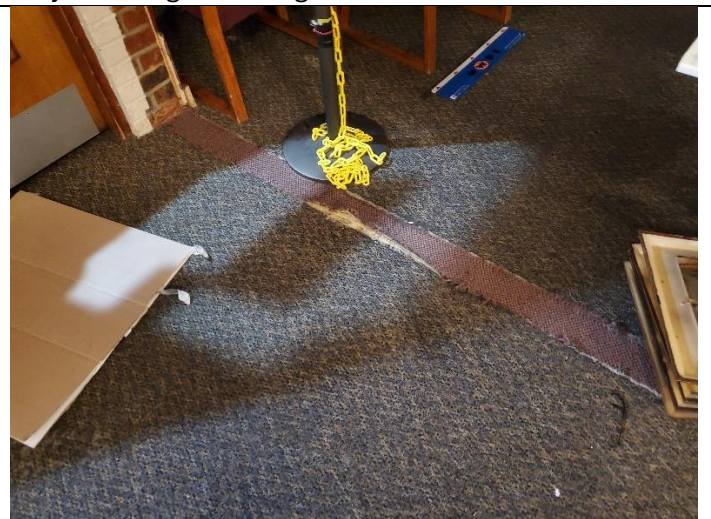
PHOTO 006 – Samples 129 and 130 Asbestos-Containing Black Mastic Under Dining Room Carpet
