# Notice of Intent to Remove Asbestos

# Asbestos Inspection

*At*  
12701 NE 119<sup>TH</sup> St  
*in*  
Vancouver, WA

## EPA/AHERA ASBESTOS INSPECTION

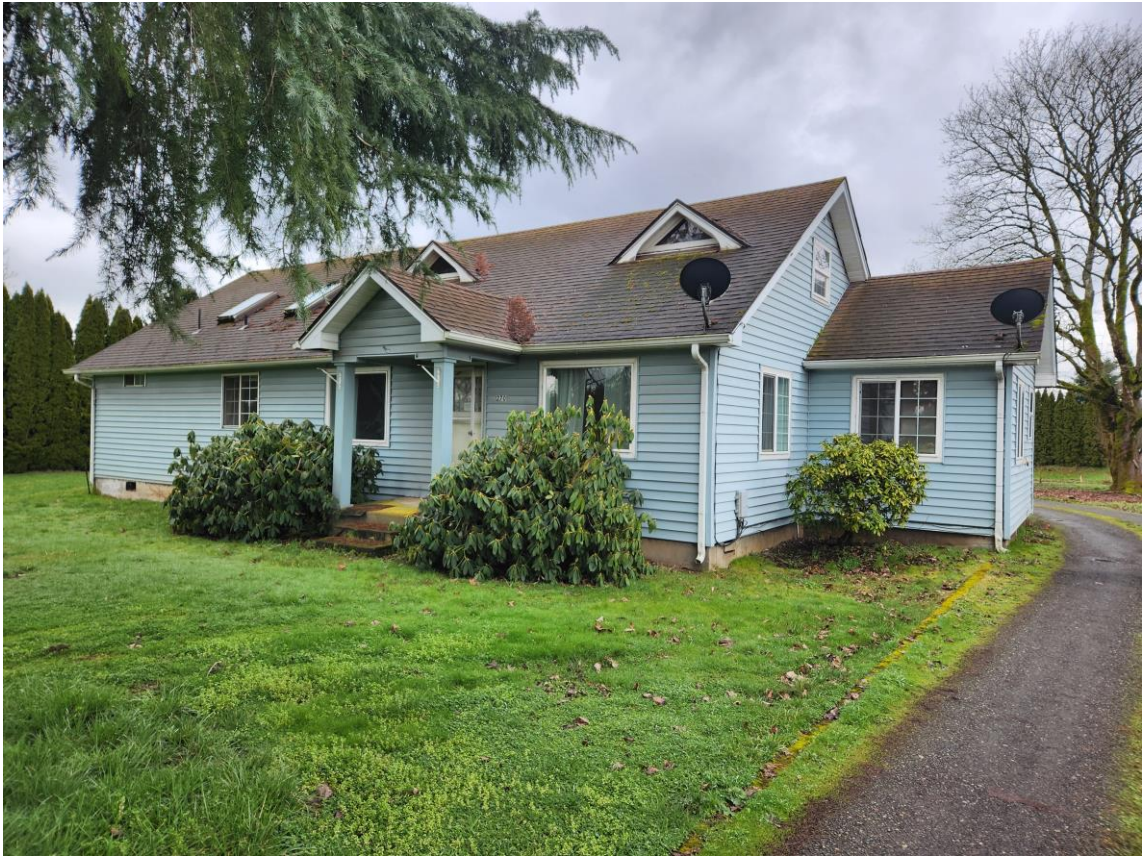
MAIN HOUSE @ 12701A NE 119<sup>TH</sup> ST VANCOUVER, WA

*\*(F-3) +/- 400 sq/ft 9X9 FLOOR TILE / STAIRS & 2<sup>ND</sup> FLOOR*

**F-3 - ASBESTOS FLOORING – 9X9 – UPSTAIRS AREA - +/- 400 sq/ft**

When demolition or renovation is to occur then all asbestos containing materials must be removed. The Occupational Safety and Health Administration (OSHA) & the Washington Industrial Safety and Health Administration (WISHA) classify the removal or disturbance of the above described asbestos containing materials as Class 1 asbestos abatement project. The removal or any disturbance of these materials must be undertaken by trained and qualified individuals. Furthermore, the Washington State Department of Labor and Industries (L&I) as well as the Southwest Washington Air Pollution Control Agency (SWAPCA) requires 10 days notification and the appropriate fees prior to the beginning of an asbestos abatement project of this nature.

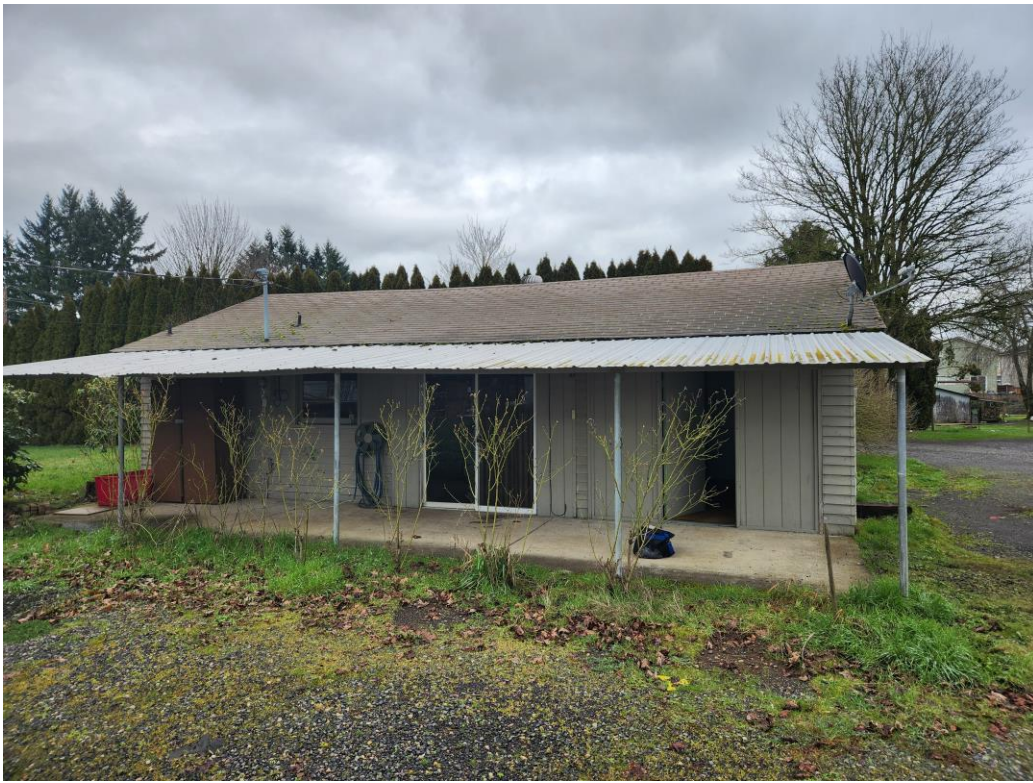
MIDDLE HOUSE @ 12701B NE 119<sup>TH</sup> ST VANCOUVER, WA

**\*(WP-1) +/- 2 WINDOWS EXTERIOR**

**WP-1 - ASBESTOS WINDOW PUTTY - +/- 2 WINDOWS**

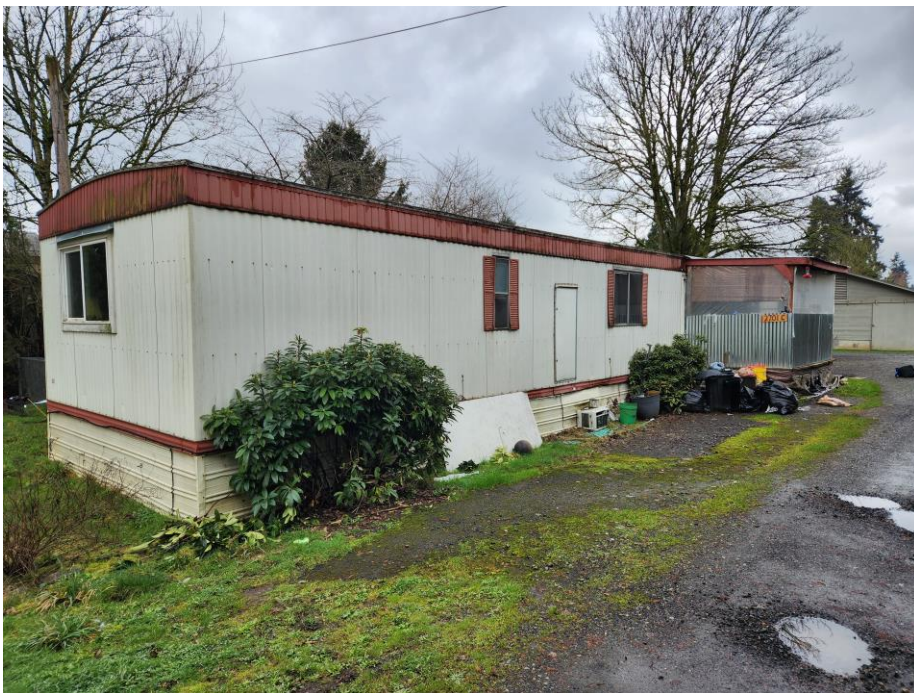
TRAILER @ 12701C NE 119<sup>TH</sup> ST VANCOUVER, WA

**R-1 ASBESTOS PAINT ON METAL ROOF +/- 700 SQ/FT**

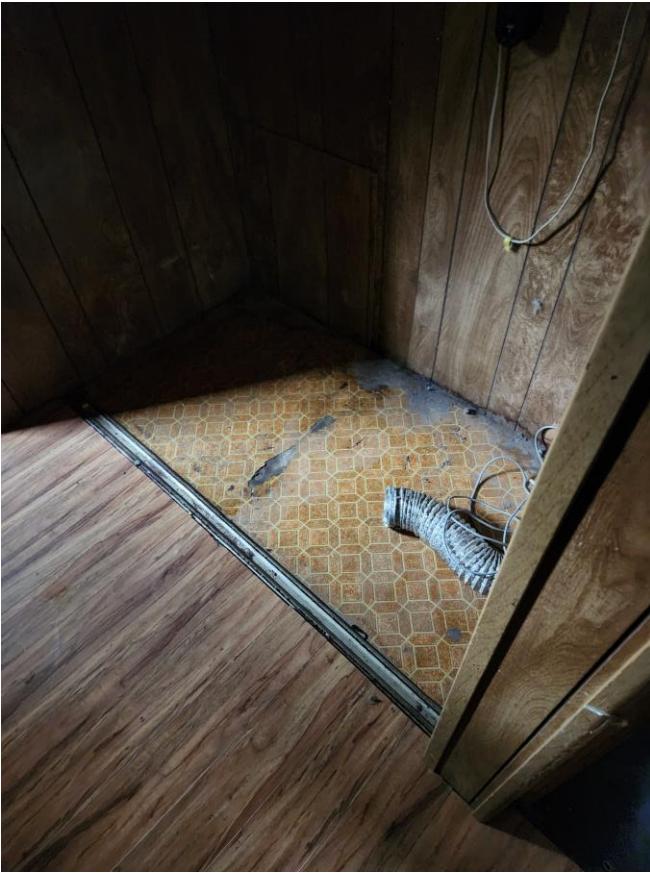
*\*(F-1) +/- 60 SQ/FT - POSSIBLY UNDER WOOD LAMINANT IN BEDROOM & HALL*

F-1- ASBESTOS FLOORING – HALL & BEDROOM CLOSET - +/- 60 sq/ft  
(POSSIBLY UNDER LAMINANT)

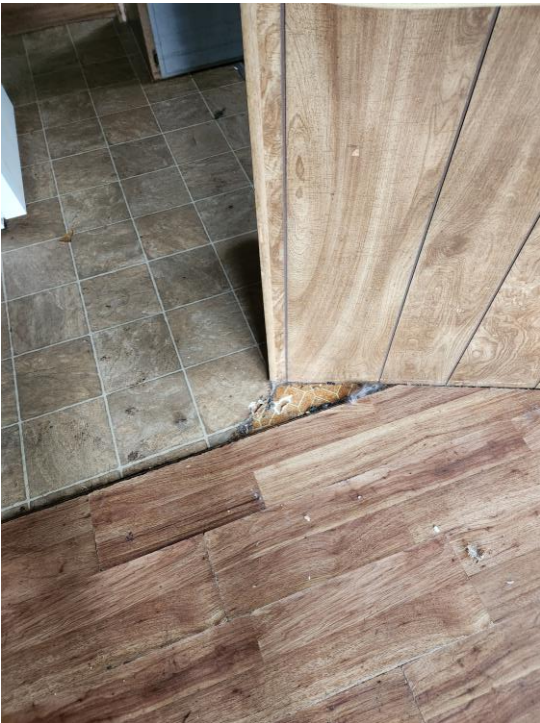
*\*(F-3&4) +/- 250 SQ/FT - ALL FLOORING IN THE KITCHEN AREA*

F-3 & 4 ASBESTOS FLOORING – KITCHEN AREA - +/- 250 sq/ft  
(UNDER LAMINANT)

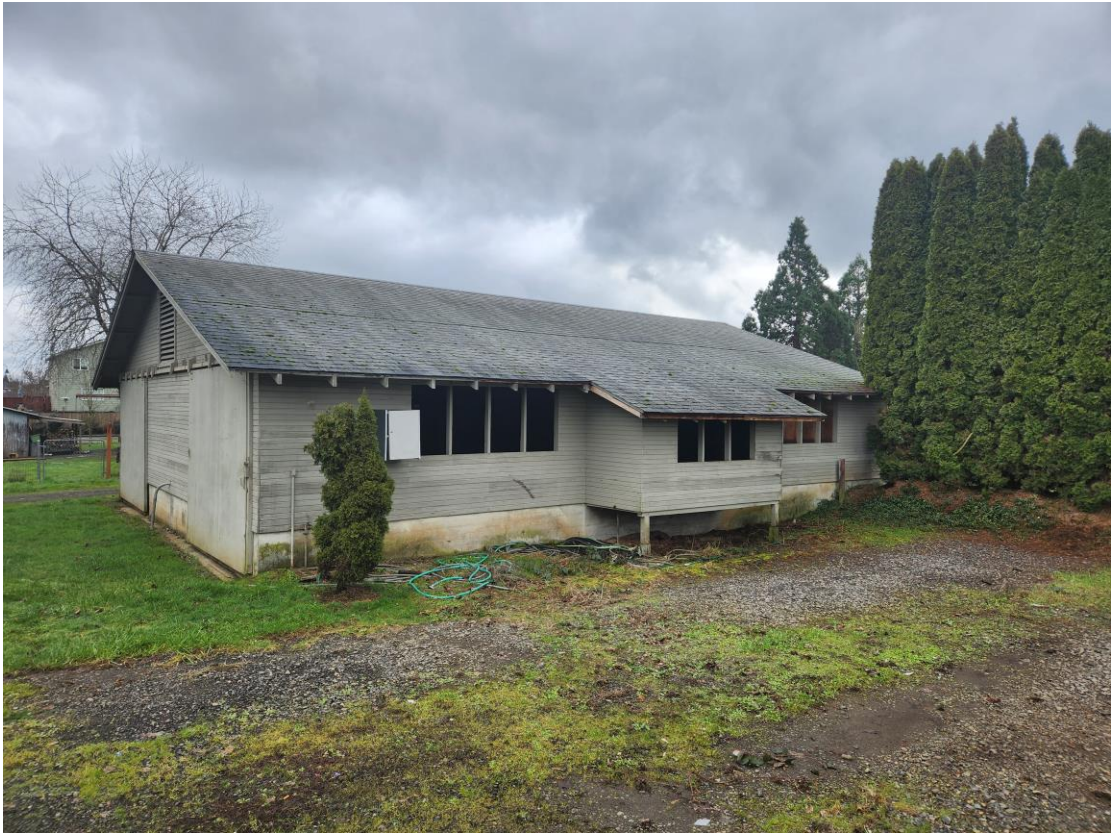
OUTBUILDING SOUTHEAST / NO ASBESTOS

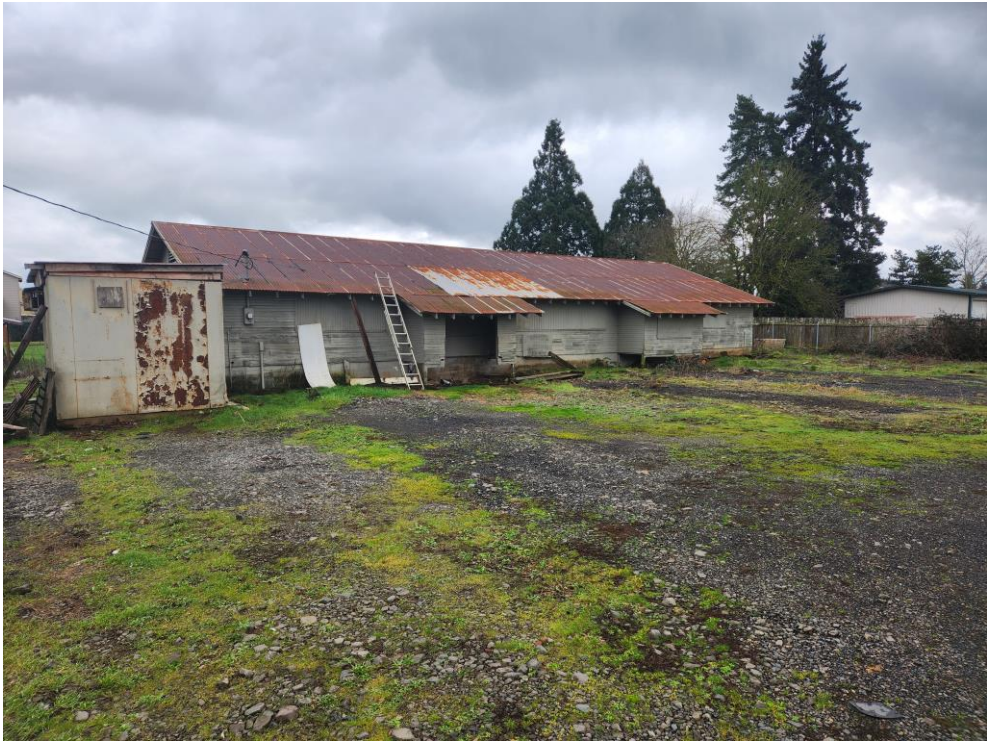
OUTBUILDING EAST / NO ASBESTOS
