Notification of Demolition

Report of Comprehensive Pre-Demolition Asbestos Survey

Project Name:
NW 304th Cir

Survey Address:
1402 NW 304th Cir, Ridgefield, WA 98642

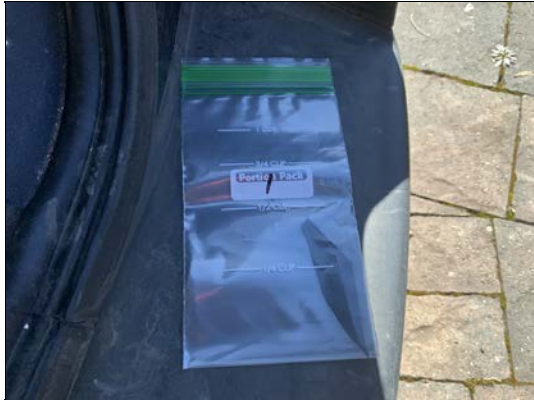
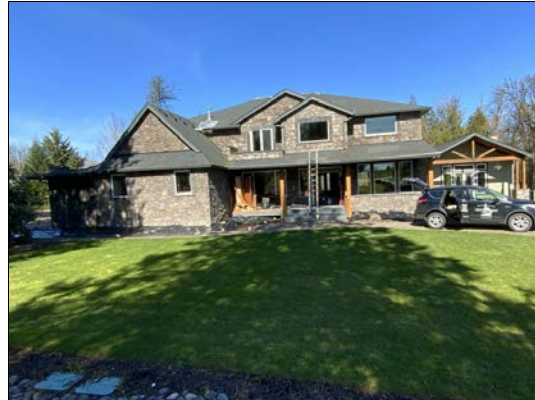
Sample #	Location	Description	Suspect ACM
1	Exterior	Vapor Barrier	Tar Paper

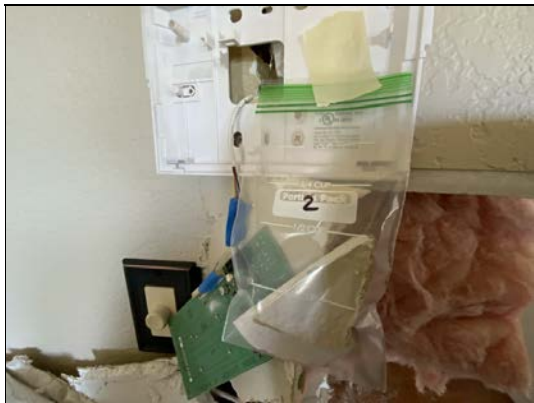
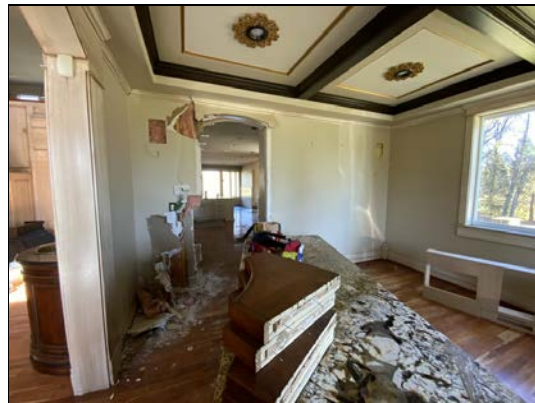
Sample #	Location	Description	Suspect ACM
2	Parlor off kitchen	Textured Drywall	Knock Down Texture

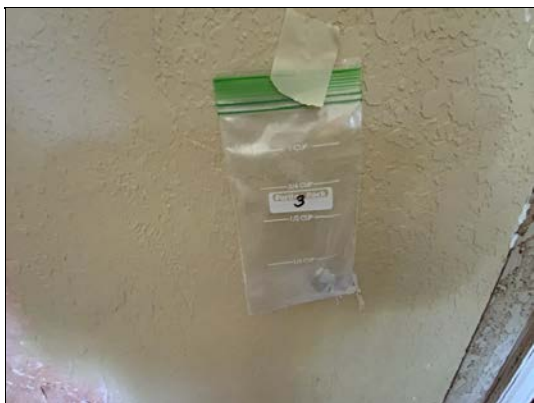
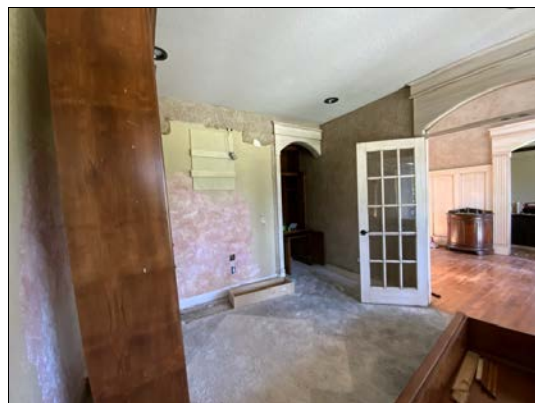
Sample #	Location	Description	Suspect ACM
3	Office off entry hall	Textured Drywall	Knock Down Texture

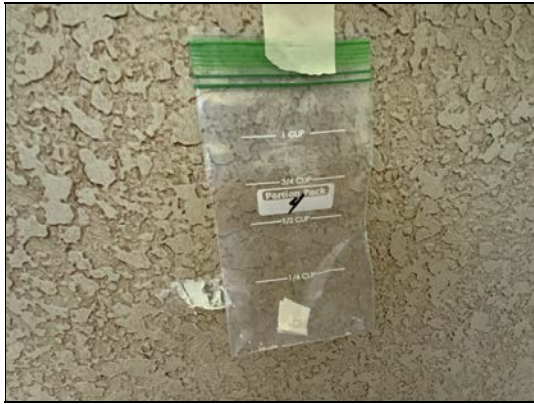
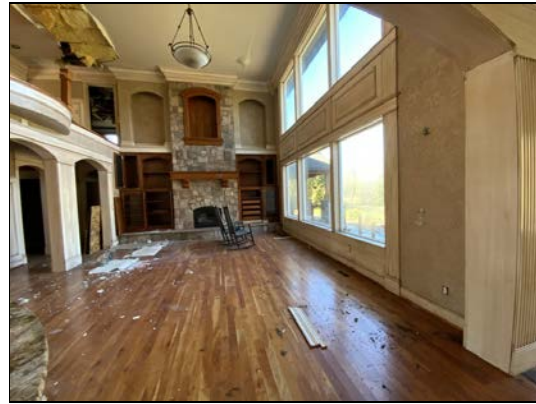
Sample #	Location	Description	Suspect ACM
4	Living Room	Textured Drywall	Knock Down Texture

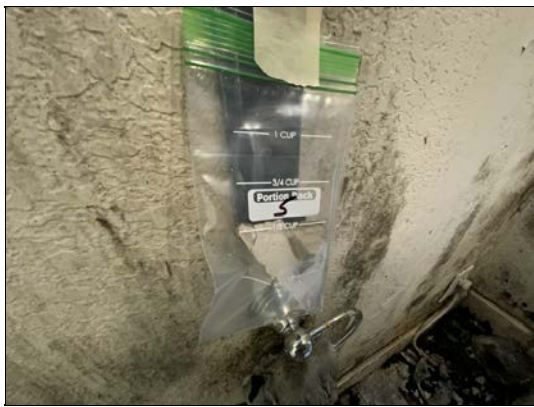
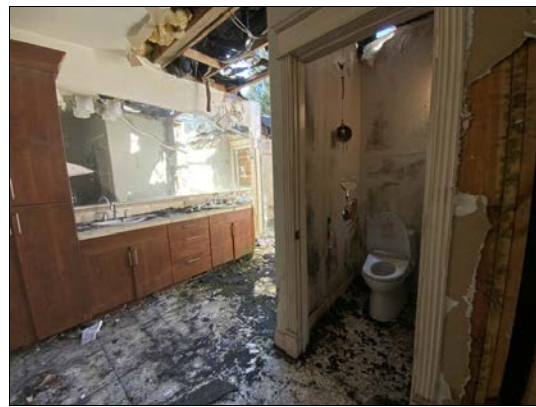
Sample #	Location	Description	Suspect ACM
5	Primary Bathroom	Textured Drywall	Knock Down Texture

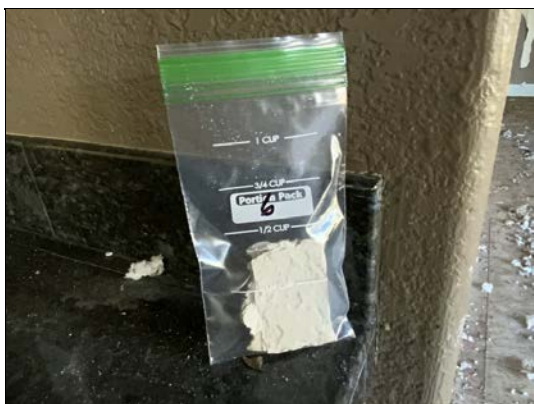
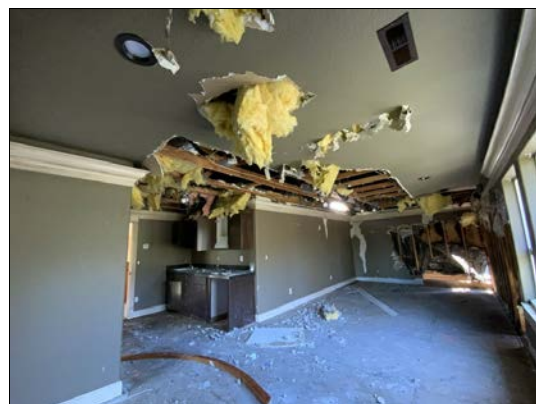
Sample #	Location	Description	Suspect ACM
6	Bonus Room	Textured Drywall	Knock Down Texture

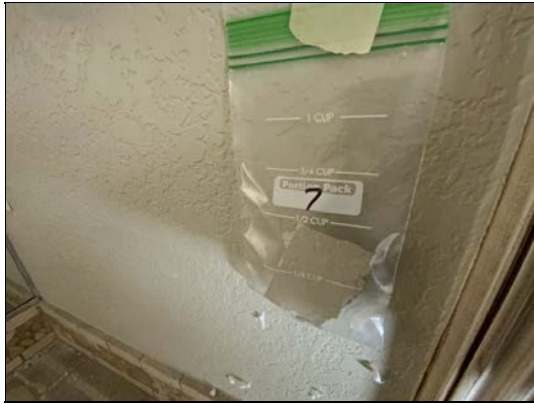
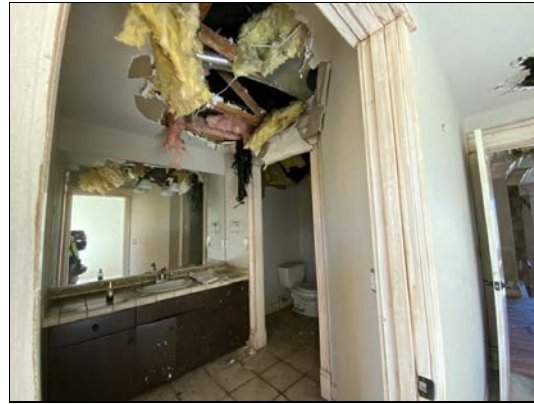
Sample #	Location	Description	Suspect ACM
7	Middle bedroom bathroom	Textured Drywall	Knock Down Texture

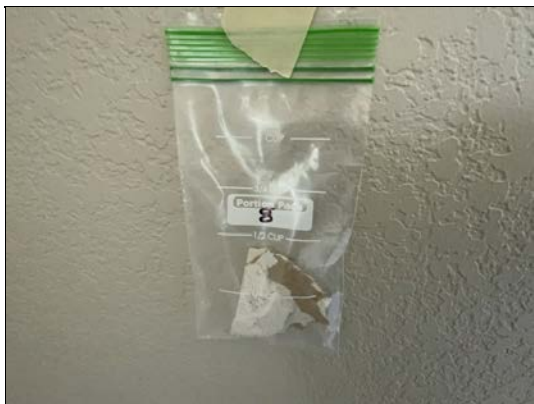
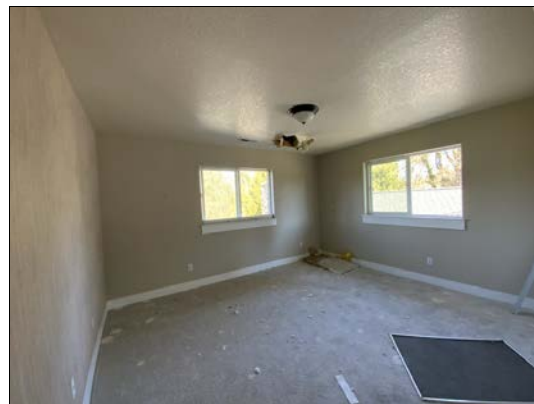
Sample #	Location	Description	Suspect ACM
8	Back corner bedroom	Textured Drywall	Knock Down Texture

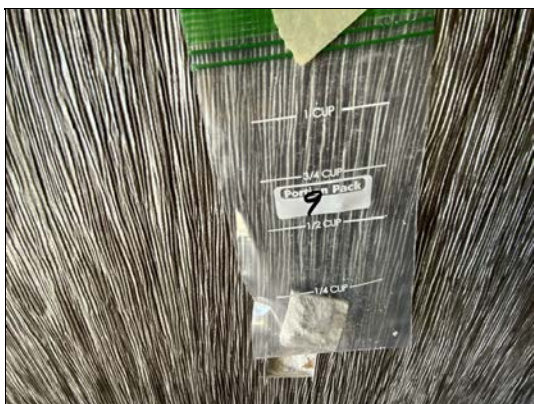
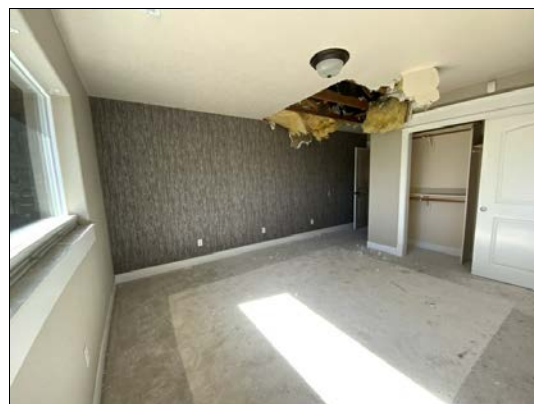
Sample #	Location	Description	Suspect ACM
9	Front Bedroom	Vinyl wall covering	Wall covering + drywall

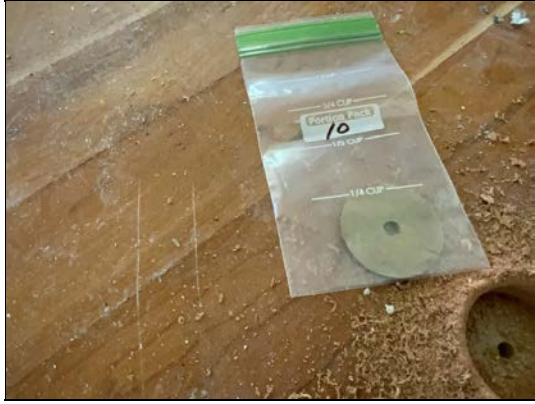
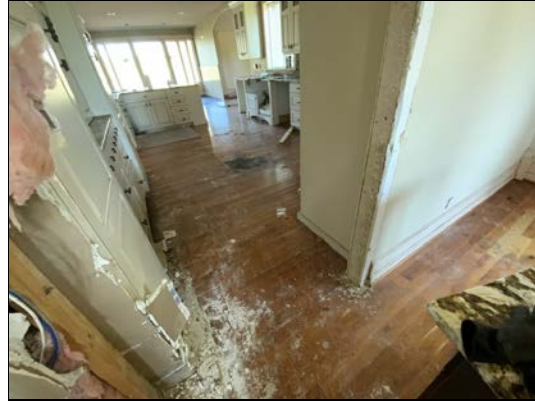
Sample #	Location	Description	Suspect ACM
10	Throughout	Vapor Barrier	Kraft Paper
