# Asbestos Containing Materials Inspection

Good Faith Inspection

Project: 5802 NE 6<sup>th</sup> Ave.  
Vancouver, WA 98665

RE: Good Faith Asbestos Survey

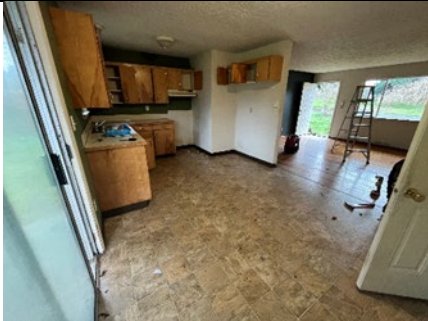
Sample #	Material Description	Sample Location	Friability / Condition / Category	Lab Result	Quantity
01 - 02	Multi-layer Sheet Vinyl Flooring and Backing with Mastic	Kitchen – Includes qty in kitchen and bathroom	NF / Good	15% Chrysotile-Sheet Vinyl Flooring	245 SF

01 – Sheet Vinyl Flooring in the kitchen in good condition. Material also located in the bathroom under laminate flooring.
--	--	--

3 Kings Environmental, Inc. recommends that any ACM or PACM to be impacted during the course of the renovation or demolition be removed by a licensed, bonded, and insured asbestos abatement firm. Removal and disposal of asbestos containing materials should only be performed by certified firms following all local, state, and federal guidelines. Should materials not noted in this report be discovered during the course of the work, stop all demolition and have the newly discovered materials tested for asbestos or treat the materials as an asbestos containing material. Be sure to notify the governing authorities and clean-air agencies prior to disturbing materials over the recordable limits.
