Asbestos Containing Materials Inspection

Good Faith Inspection

Project: 5813 NE 6th Ave.
Vancouver, WA 98665

RE: Good Faith Asbestos Survey

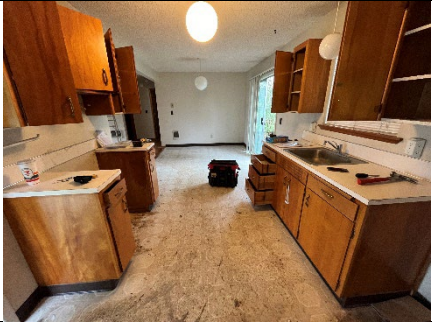
Sample #	Material Description	Sample Location	Friability / Condition / Category	Lab Result	Quantity
02	Octagon Pattern Sheet Vinyl Flooring and Mastic	Kitchen – Material Also Located in the Laundry Room	NF / Good	20% Chrysotile – Sheet Vinyl	250 SF

<p>02- Octagon Pattern Sheet Vinyl Flooring and Mastic in the Kitchen in good condition. Mastic associated with Sheet Vinyl Flooring is non detect for asbestos.</p>
--	--

3 Kings Environmental, Inc. recommends that any ACM or PACM to be impacted during the course of the renovation or demolition be removed by a licensed, bonded, and insured asbestos abatement firm. Removal and disposal of asbestos containing materials should only be performed by certified firms following all local, state, and federal guidelines. Should materials not noted in this report be discovered during the course of the work, stop all demolition and have the newly discovered materials tested for asbestos or treat the materials as an asbestos containing material. Be sure to notify the governing authorities and clean-air agencies prior to disturbing materials over the recordable limits.
