Notification of Demolition

Asbestos Containing Materials Inspection

Good Faith Inspection

Project: 5901 NE 6th Ave.
Vancouver, WA 98665

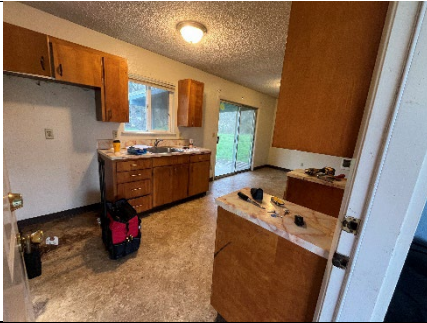
Sample #	Material Description	Sample Location	Friability / Condition / Category	Lab Result	Quantity
14	Popcorn Ceiling	Kitchen – Material also located in the living room, and bedrooms	F / Good	2% Chrysotile	768 SF

14-Popcorn Ceiling in the Kitchen of the home, in good condition. Condition extends to living room and all bedrooms.

3 Kings Environmental, Inc. recommends that any ACM or PACM to be impacted during the course of the renovation or demolition be removed by a licensed, bonded, and insured asbestos abatement firm. Removal and disposal of asbestos containing materials should only be performed by certified firms following all local, state, and federal guidelines. Should materials not noted in this report be discovered during the course of the work, stop all demolition and have the newly discovered materials tested for asbestos or treat the materials as an asbestos containing material. Be sure to notify the governing authorities and clean-air agencies prior to disturbing materials over the recordable limits.
