Asbestos Containing Materials Inspection

Good Faith Inspection

Project: 5907 NE 6th Ave.
Vancouver, WA 98665

RE: Good Faith Asbestos Survey

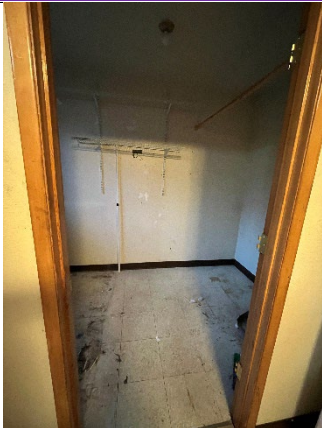
<p>01-Laundry Room - 12x12 Vinyl Floor Tile, Sheet Vinyl Flooring, Mastic and Backing in good condition with multiple layers analyzed.</p>
-------------------------------------------------------------------------------------	--------------------------------------------------------------------------------------------------------------------------------------------

<p>03- Sheet Vinyl Flooring with Backing paper in the kitchen in good condition.</p>
 	<p>14-Popcorn ceiling in the kitchen in good condition. This homogenous material is also present in the living room and all bedrooms.</p>

3 Kings Environmental, Inc. recommends that any ACM or PACM to be impacted during the course of the renovation or demolition be removed by a licensed, bonded, and insured asbestos abatement firm. Removal and disposal of asbestos containing materials should only be performed by certified firms following all local, state, and federal guidelines. Should materials not noted in this report be discovered during the course of the work, stop all demolition and have the newly discovered materials tested for asbestos or treat the materials as an asbestos containing material. Be sure to notify the governing authorities and clean-air agencies prior to disturbing materials over the recordable limits.
