## **Notice of Intent to Remove Asbestos**

# **Pre-Renovation Limited Hazardous Building Materials Survey Report**

PeaceHealth Southwest Medical Center Wound Healing Center 8716 E Mill Plain Boulevard Vancouver, Washington 98664

October 2023 PBS Project 23867.078

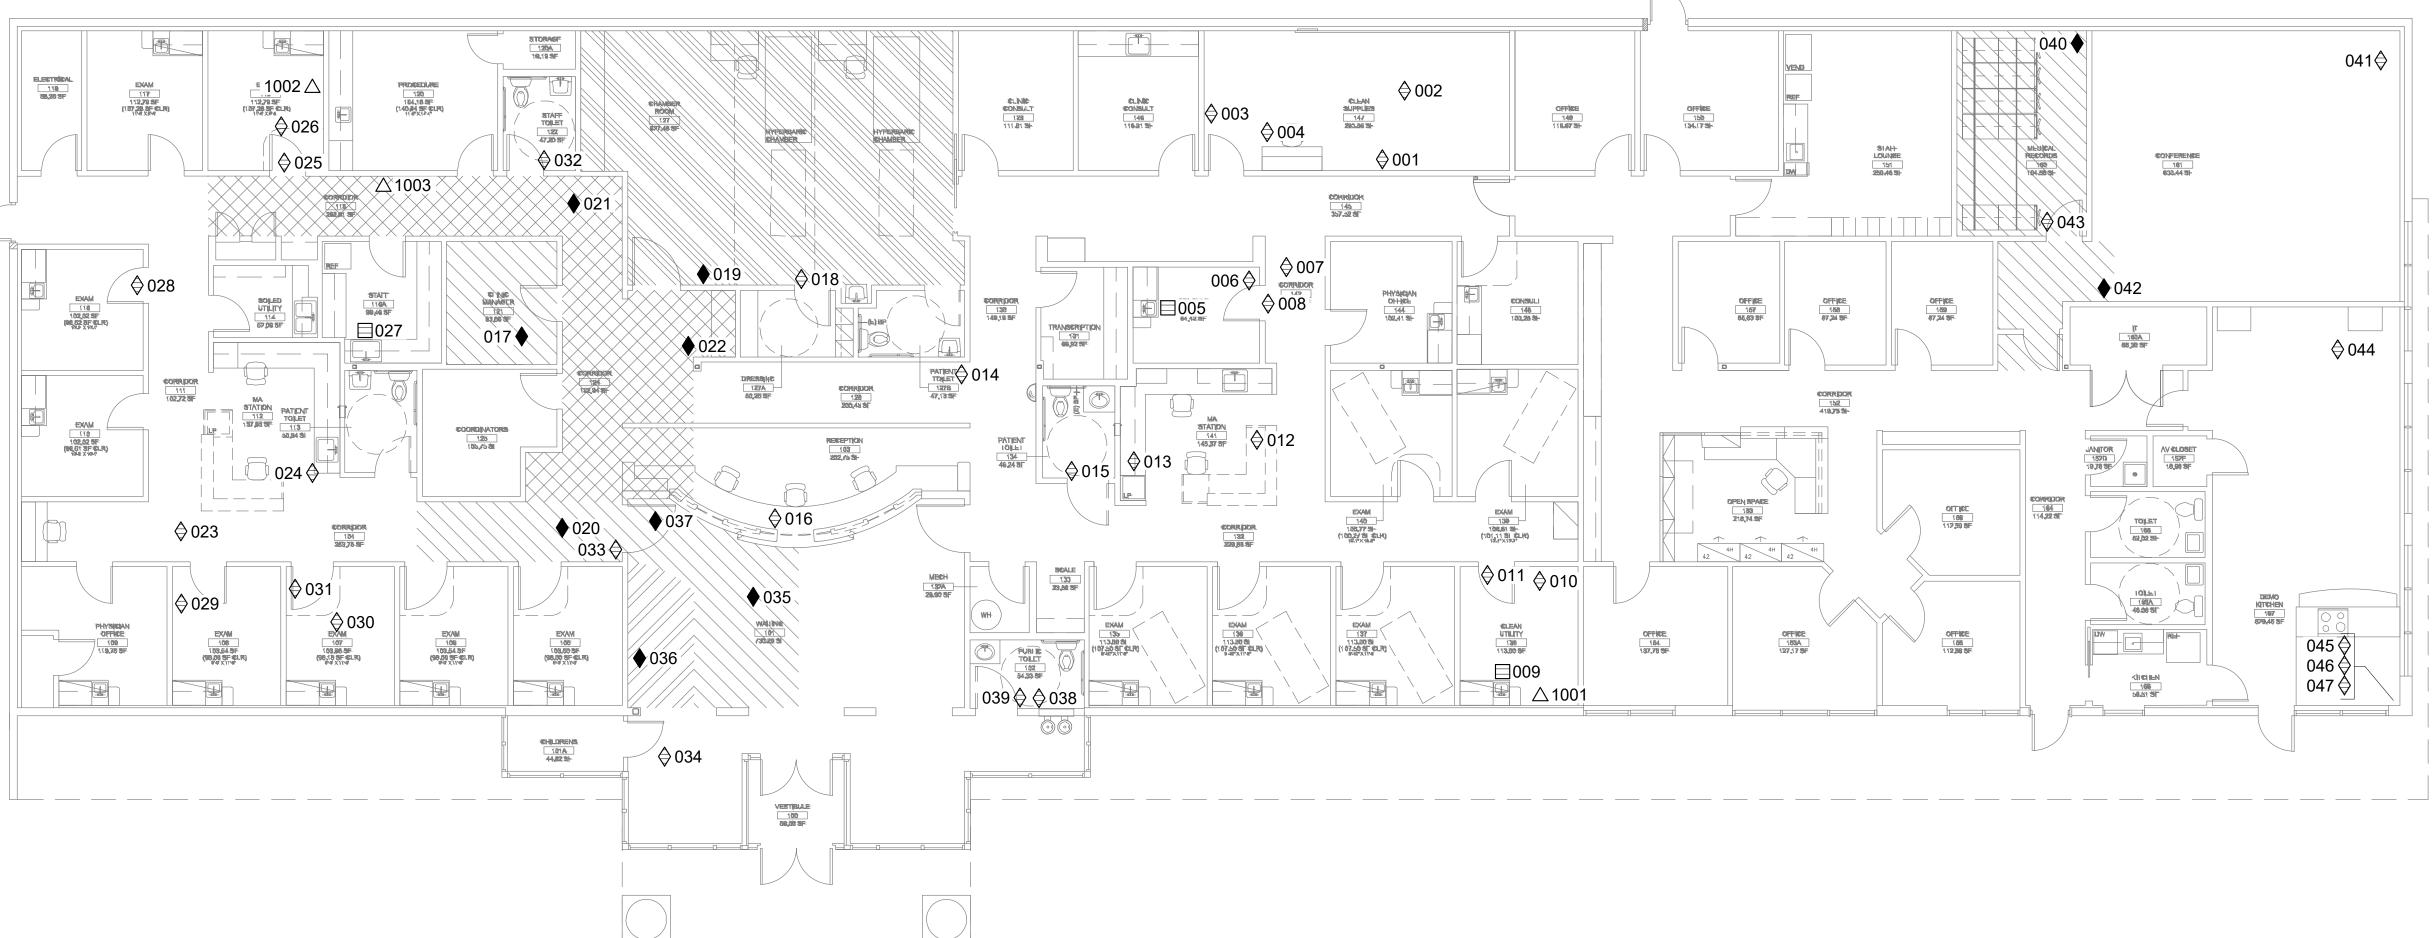
HS1

- Asbestos-containing black mastic was discovered in various locations throughout the Building. The
  material was observed under carpeting and wood grain vinyl sheet flooring. See survey drawings for
  approximate locations.
- Asbestos-containing off-white vinyl floor tile was observed under carpet in the North end of the building in Corridors 124 and 115. See survey drawings for approximate locations.
- Asbestos-containing yellow patterned vinyl sheet flooring was found under carpet in the North side of the waiting room. See survey drawing for approximate location.

ASBESTOS-CONTAINING RESIDUAL BLACK MASTIC UNDER CARPET

ASBESTOS-CONTAINING VINYL FLOOR TILE WITH ASBESTOS-CONTAINING BLACK MASTIC UNDER CARPET

ASBESTOS-CONTAINING VINYL SHEET FLOOR COVERING WITH BLACK MASTIC ON CONCRETE UNDER CARPET

ASBESTOS-CONTAINING BLACK MASTIC UNDER NON-ASBESTOS WOOD GRAINED VINYL SHEET FLOORING

PBS recommends that all ACM to be impacted by the project be removed prior to renovation activities. A qualified Washington State licensed asbestos abatement contractor should be employed to remove all such ACM according to applicable local, state, and federal regulations.
