Notification of Demolition

HAZARDOUS MATERIALS INVESTIGATION SURVEY

PERFORMED FOR:
CENTRALIA COLLEGE

PROPERTY KNOWN AS:
415 S KING ST.
CENTRALIA, WA 98531

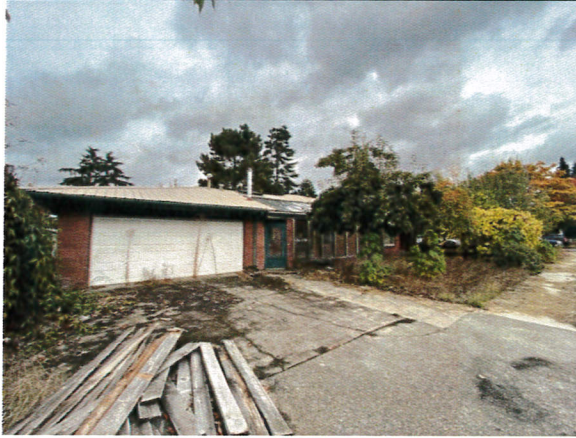
Exterior front view of 415 S King St. Centralia, WA 98531.

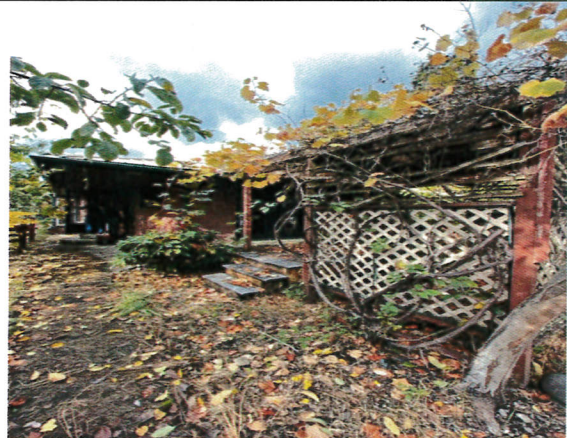
Additional side view of 415 S King St. Centralia, WA 98531.

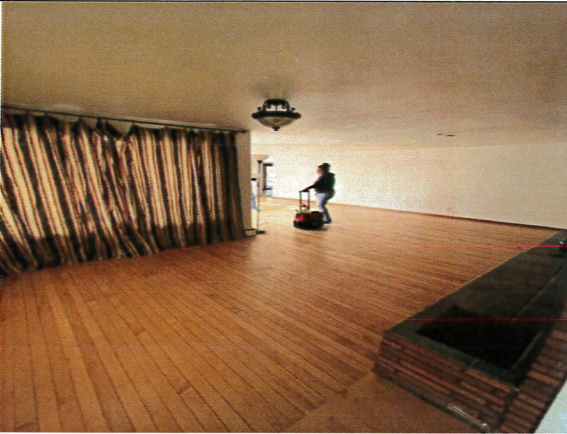
Living room with original wood floor and sheetrock with orange peel texture walls and ceiling.

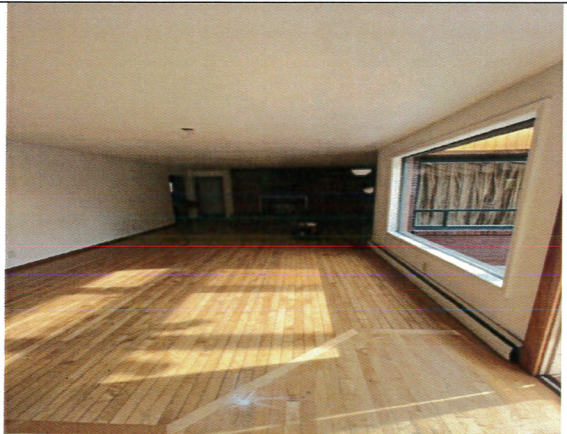
Additional living room picture.

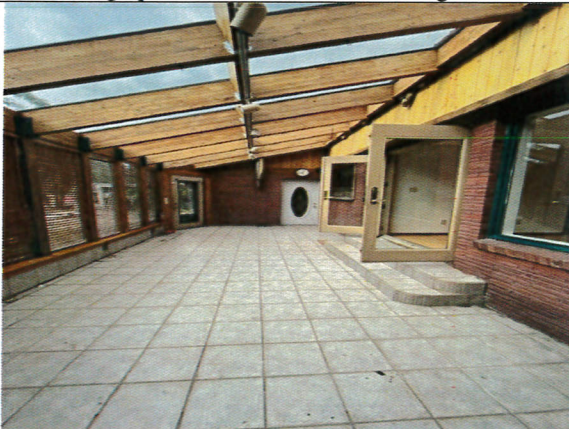
Sunroom with tile floor, brick walls and open beam ceiling with windows.

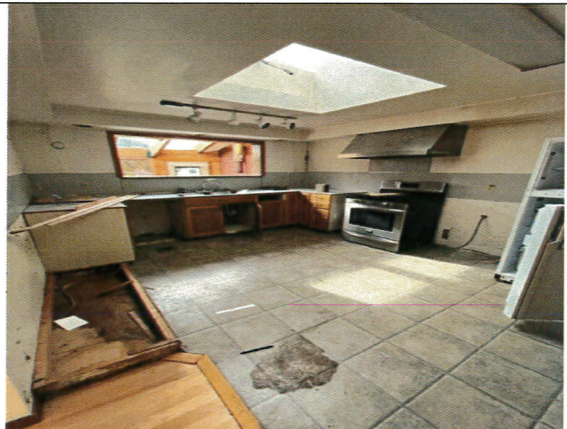
Kitchen with 2 layers of vinyl sheeting floor and sheetrock with orange peel texture walls and ceiling.

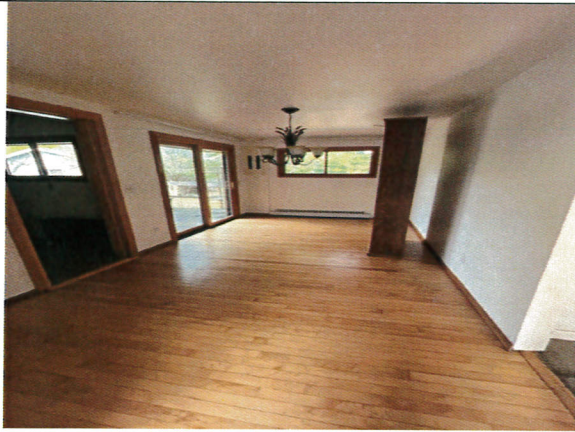
Dining room with original hardwood floor, and sheetrock with orange peel texture walls and ceiling.

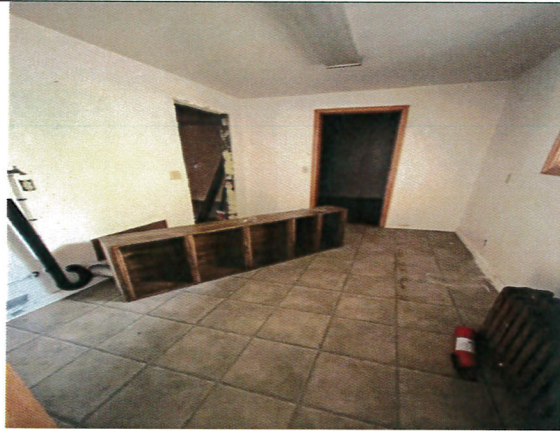
Utility with 2 layers of vinyl sheeting floor and sheetrock with orange peel texture walls and ceiling.

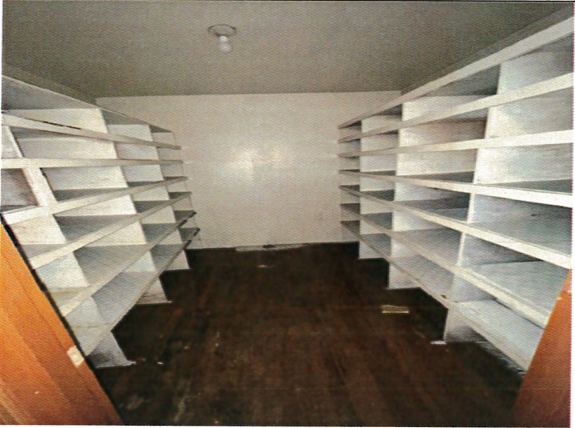
Pantry with original hardwood floor, and smooth sheetrock walls and ceiling.

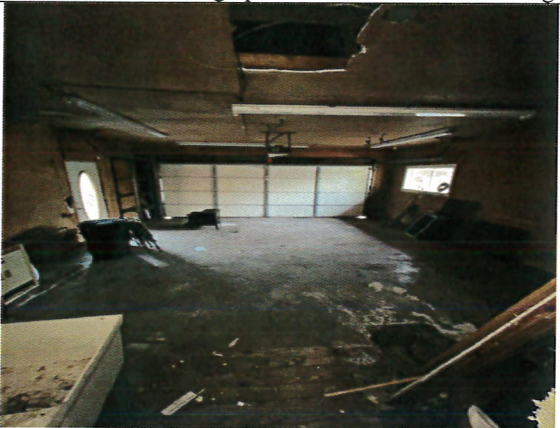
Garage with concrete floor, and 2 layers of sheetrock walls and ceiling.

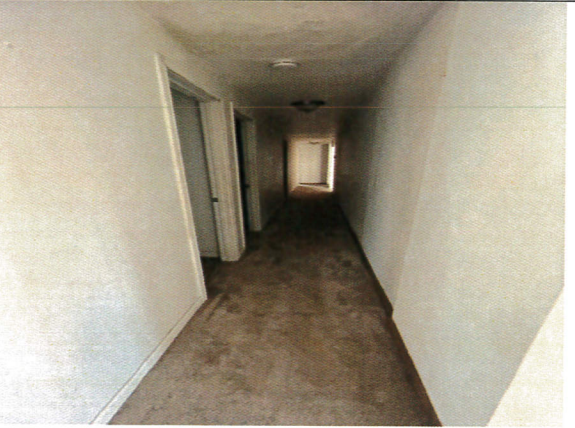
Hallway with carpet floor and sheetrock with orange peel texture walls and ceiling.

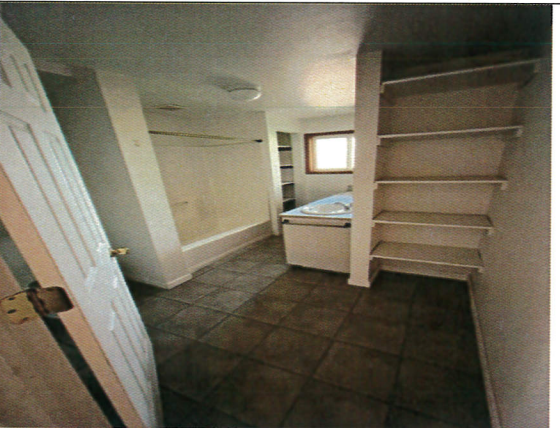
Bathroom with vinyl sheeting floor, and sheetrock with orange peel texture walls and ceiling.

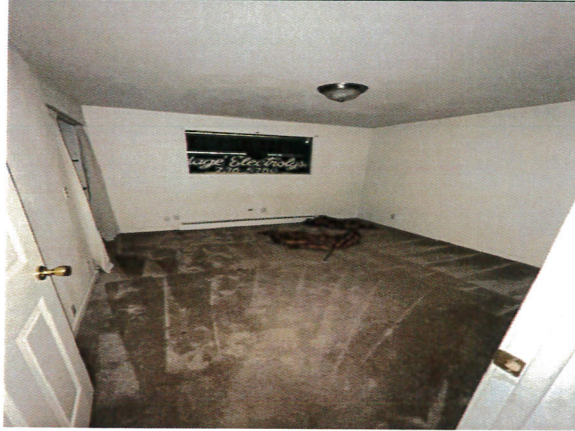
Bedroom 4 with carpet floor and sheetrock with orange peel texture walls and ceiling.

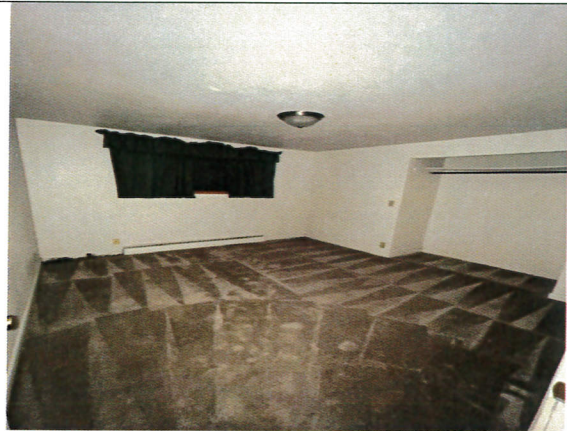
Bedroom 3 with carpet floor and sheetrock with orange peel texture walls and ceiling.

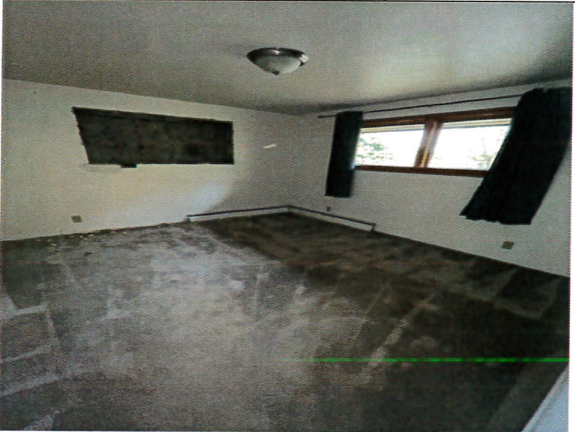
Bedroom 2 with carpet floor and sheetrock with orange peel texture walls and ceiling.

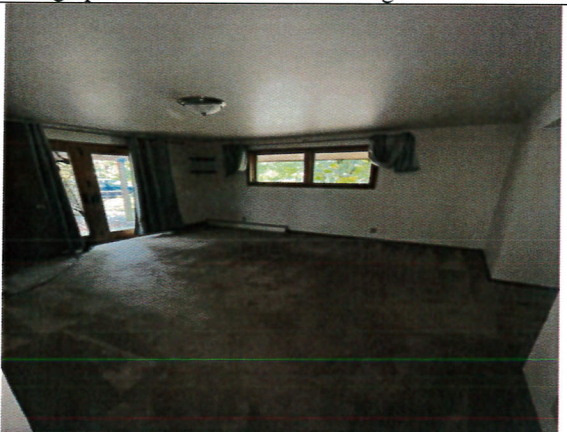
Master bedroom with carpet floor and sheetrock with orange peel texture walls and ceiling.

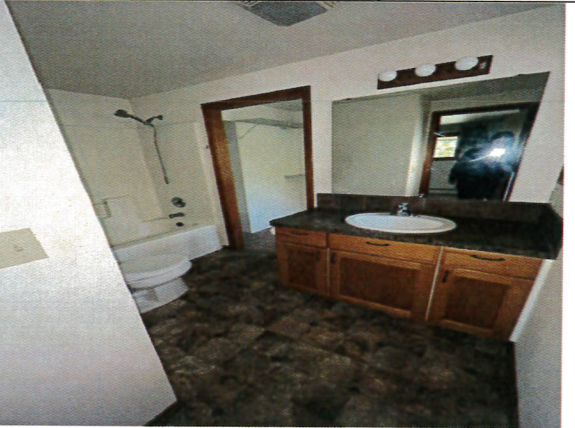
Master bathroom with vinyl sheeting floor, and sheetrock with orange peel texture walls and ceiling.

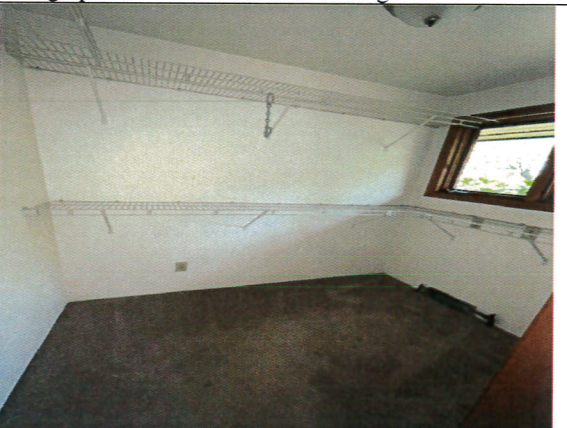
Closet with carpet floor and sheetrock with orange peel texture walls and ceiling.
