Asbestos Containing Materials Inspection

Good Faith Inspection

Project: 3203 O Street
Vancouver, WA 98663

RE: Pre-Demolition Good Faith Asbestos Survey

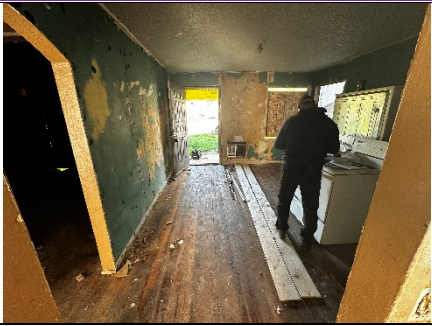
<p>04 – In the living room area contained Black Mastic Glue Dots which contained 5% Chrysotile. The Glue Dots were seen in good condition.</p>

3 Kings Environmental, Inc. recommends that any ACM or PACM to be impacted during the course of the renovation or demolition be removed by a licensed, bonded, and insured asbestos abatement firm. Removal and disposal of asbestos containing materials should only be performed by certified firms following all local, state, and federal guidelines. Should materials not noted in this report be discovered during the course of the work, stop all demolition and have the newly discovered materials tested for asbestos or treat the materials as an asbestos containing material. Be sure to notify the governing authorities and clean-air agencies prior to disturbing materials over the recordable limits.

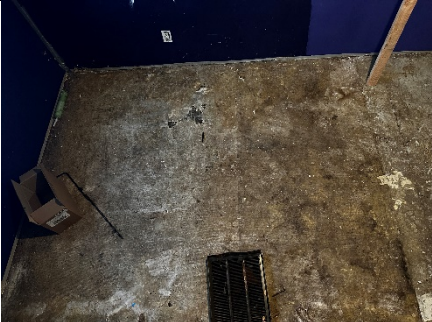
<p>24 – Brown Sheet Vinyl Flooring at the center of the floor in the lower bonus room contained 15% Chrysotile. The condition of this flooring was fair.</p>
