**Environmental & Hazardous Material Report
Transportation Department Main Building
Evergreen School District**

Project Location: Transportation Department
13909 NE 28th Street
Vancouver, WA 98682

Now Project Number: N22-0255

Report Deliverable Date: May 24, 2022

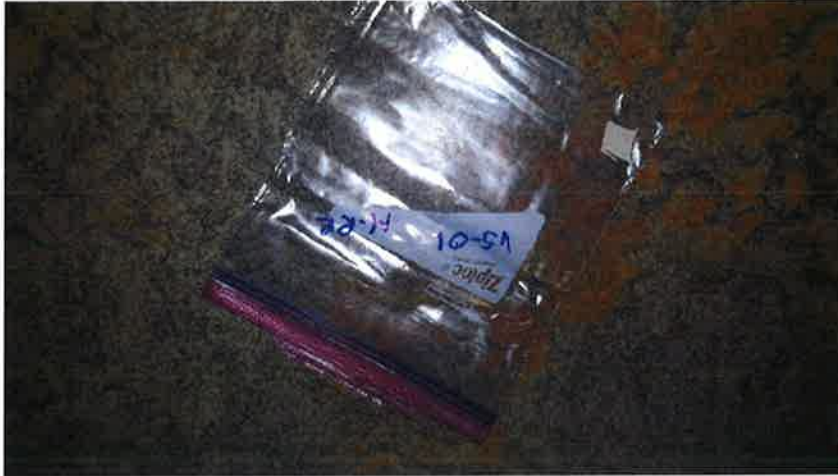
VS-01

Description: Vinyl Sheetting
w/gray felt backing. Non-
Separable Mastic

Material Location: Men's
Restroom

Asbestos Content: 30%
Chrysotile

Estimated Quantity: 600 Square
Feet

Non-Friable

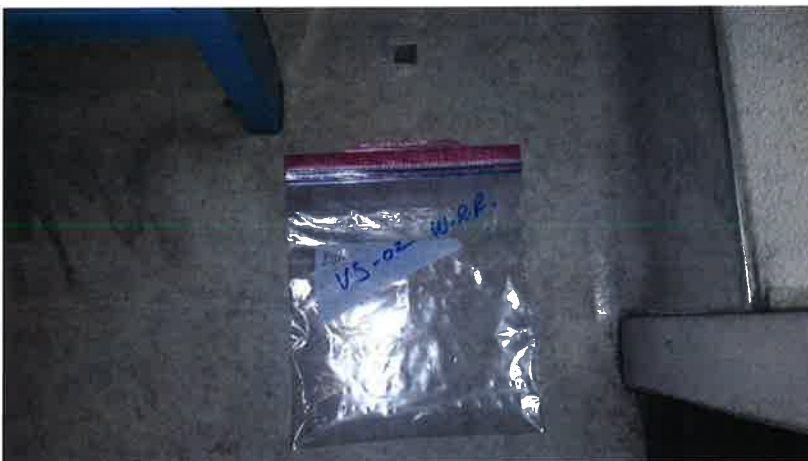
VS-02

Description: Sheetting w/gray felt |
Backing. Non-Separable Mastic

Material Location: Women's
Restroom

Asbestos Content: 30%
Chrysotile

Estimated Quantity: 1,200
Square Feet

Non-Friable

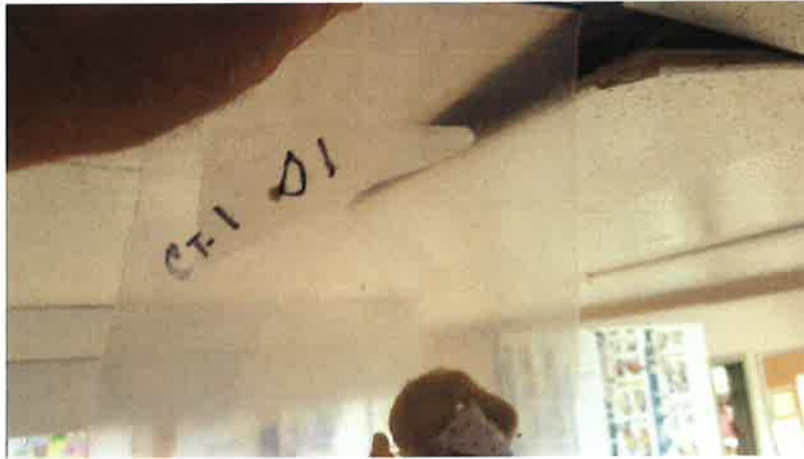
CT-01

Description: 2x4 Ceiling Tiles
w/Glue Dots

Material Location: Offices

Asbestos Content: None Detected

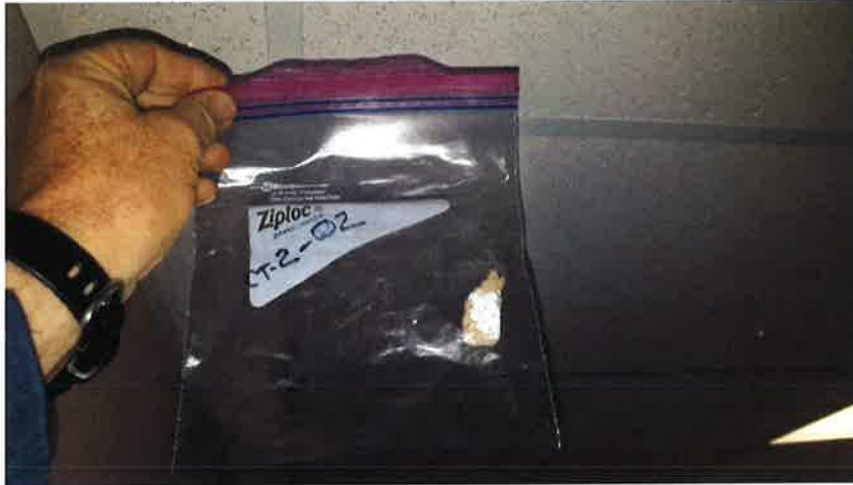
CT-02

Description: 2x4 Ceiling Tile

Material Location: Offices

Asbestos Content: None Detected

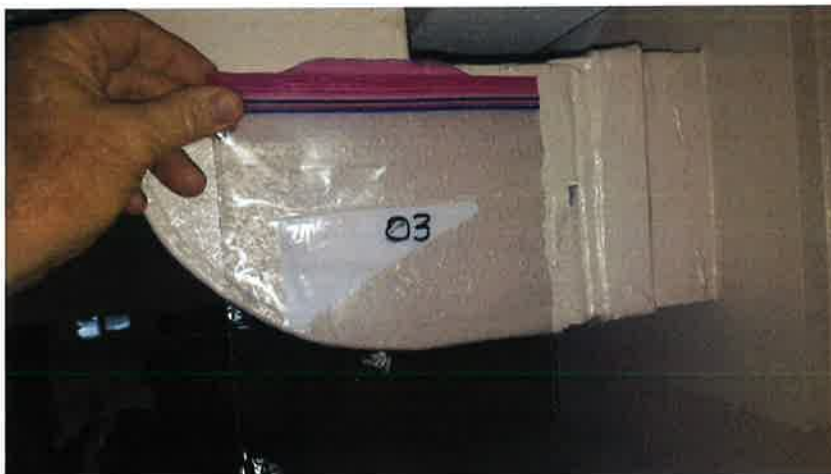
MISC-01

Description: HVAC Caulking

Material Location: Offices

Asbestos Content: None Detected

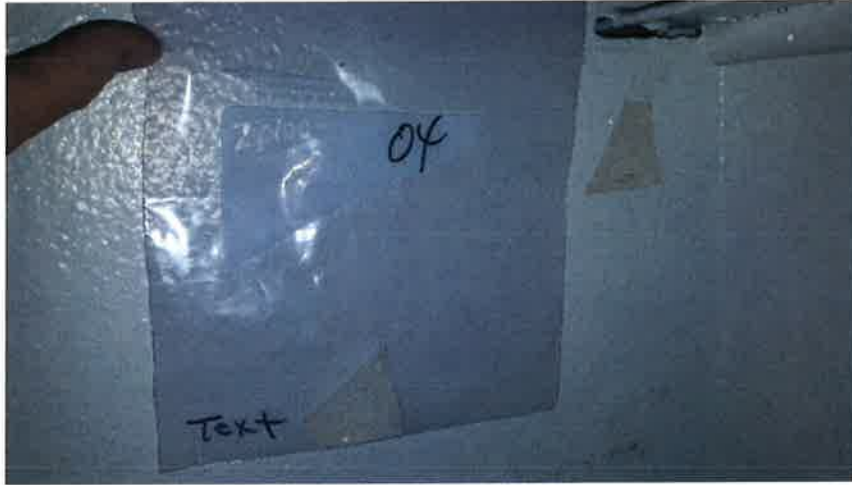
SM-01

Description: Wall Texture

Material Location: Throughout

Asbestos Content: None Detected

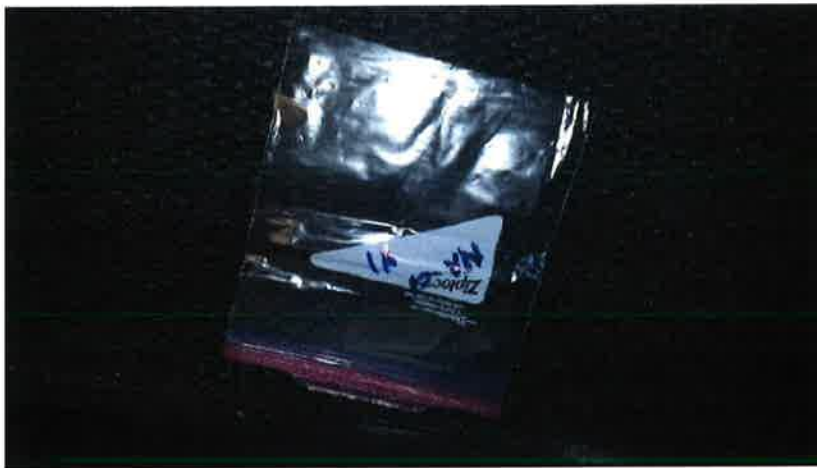
MA-01

Description: Carpet Mastic

Material Location: Office Space

Asbestos Content: None Detected

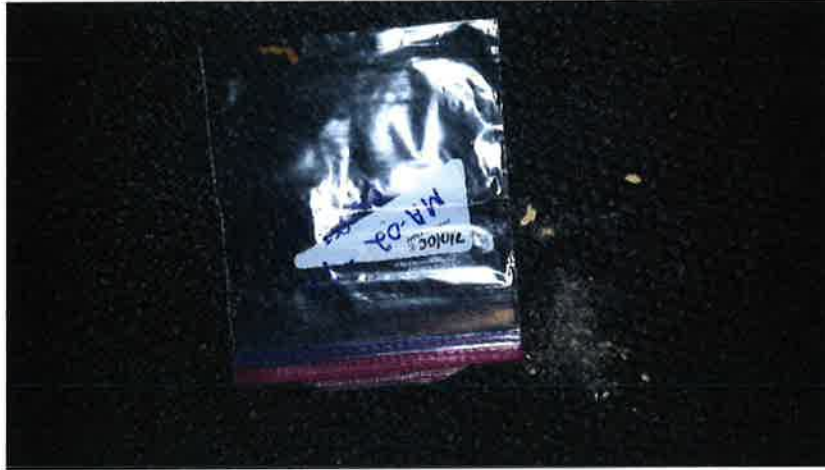
MA-02

Description: Tan Carpet Mastic

Material Location: Bus Drivers
Lunch Room

Asbestos Content: None Detected

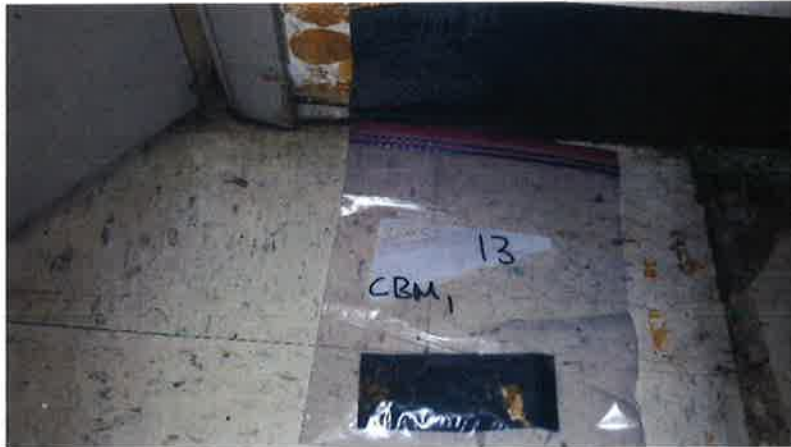
CBM-01

Description: Tan Cove Baase
Mastic

Material Location: Throughout

Asbestos Content: None Detected

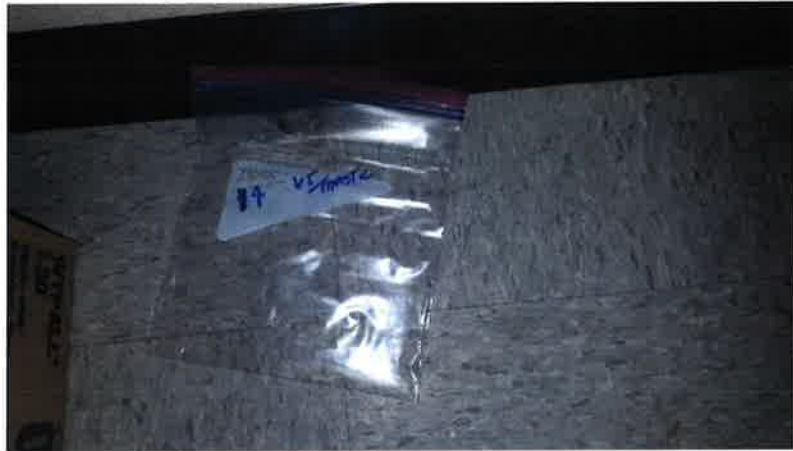
VT-01

Description: 12x12 Vinyl Tile Tan Mastic

Material Location: Office/Lunch Room

Asbestos Content: None Detected

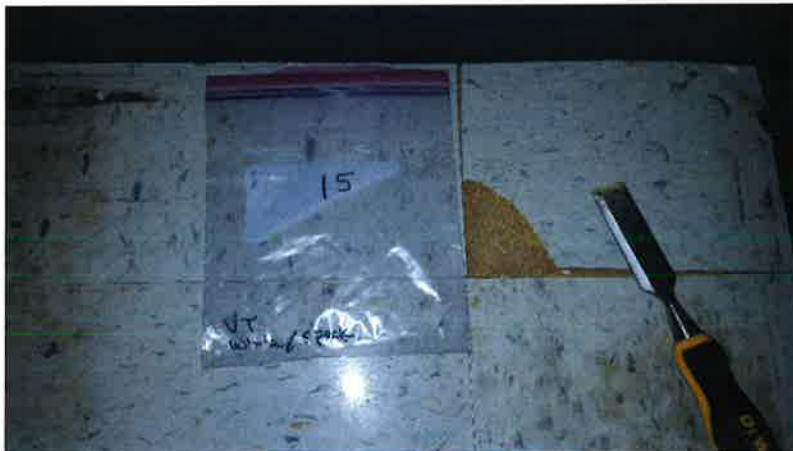
VT-02

Description: 12x12 Vinyl Tile/Mastic

Material Location: 2nd Floor Break Room

Asbestos Content: None Detected

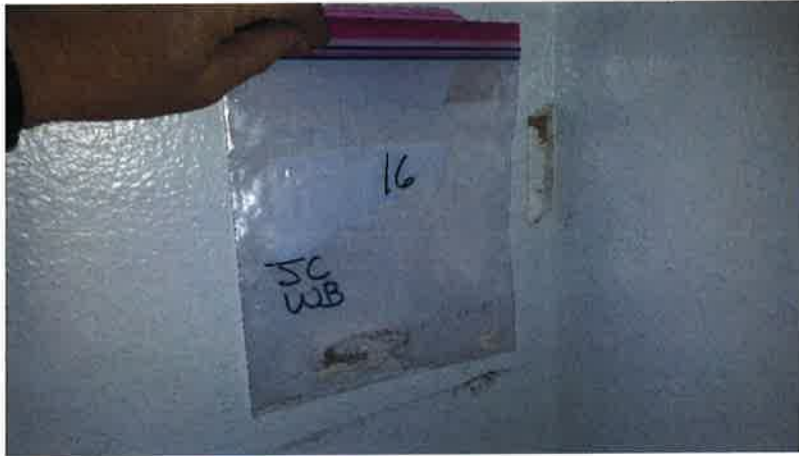
WS-01

Description: Joint Compound associated w/Wallboard

Material Location: Throughout

Asbestos Content: None Detected

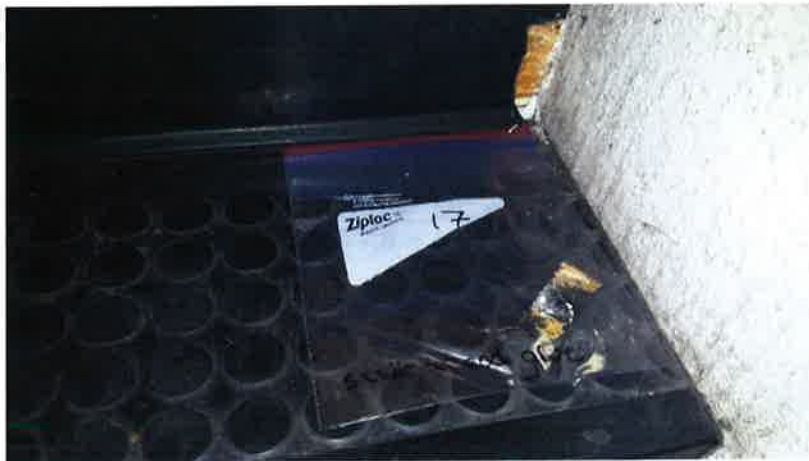
MA-03

Description: Stair Tread Mastic

Material Location: 2nd Floor Stairwell

Asbestos Content: None Detected

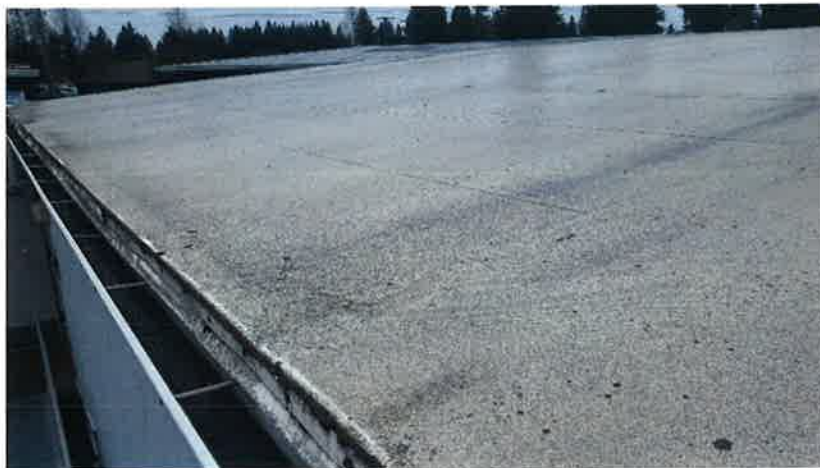
RM-01

Description: Roofing Sealant

Material Location: Metal Roof

Asbestos Content: None
Detected
