Notice of Intent to Remove Asbestos

Asbestos Containing Materials Inspection

Project: Former OYO Hotel
602 E Frontage Rd.
Kalama, WA 98625

RE: Pre-Demolition Good Faith Asbestos Survey

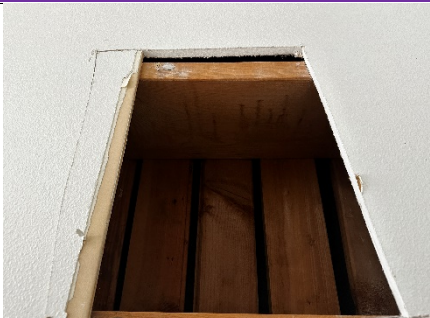
01 - Drywall with Joint Compound and Orange Peel Texture located in Unit 101 on the Ceiling in good condition.

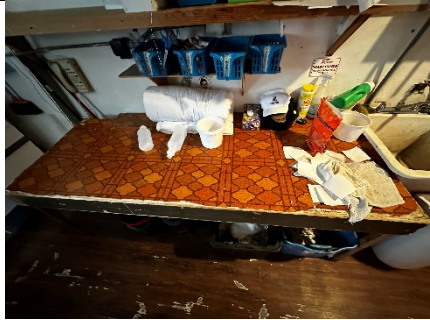
24, 25 – Orange Sheet Vinyl located in the housekeeping area in good condition.

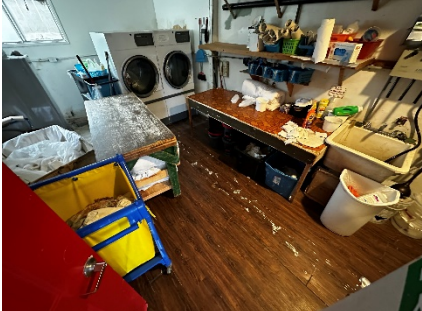
<p>26, 27 – Beige Tile with Black Mastic located in the Housekeeping area in good condition.</p>

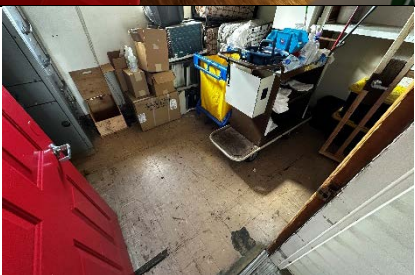
<p>34, 35 – Beige 9x9 Tile with Black Mastic located in the 2nd Floor Housekeeping area in good condition.</p>

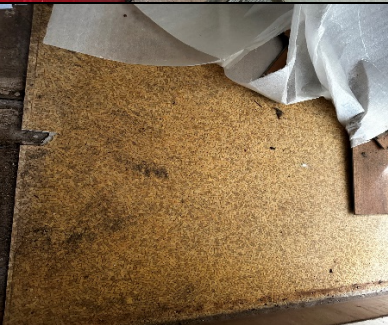
<p>36 – Sheet Vinyl Backing with Brown Mastic located in Unit 218 Bathroom in good condition.</p> <p>**Picture is of single bed unit and may not be of the actual room stated.</p>

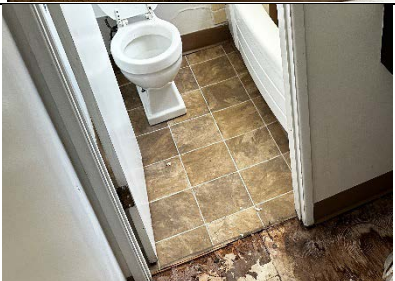
<p>38, 39 – Tan Sheet Vinyl with Small Square Pattern located in Unit 217 Bathroom Sink area in good condition.</p> <p>**Picture is of single bed unit and may not be of the actual room stated.</p>

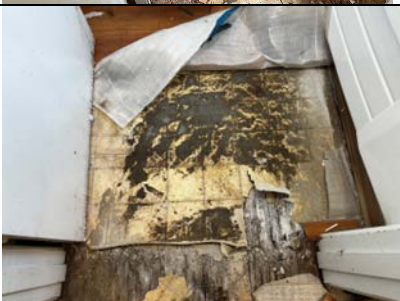
<p>40, 41 – Cream Sheet Vinyl 4" Square Pattern located in Unit 216 Bathroom in good condition.</p> <p>**Picture is of single bed unit and may not be of the actual room stated.</p>

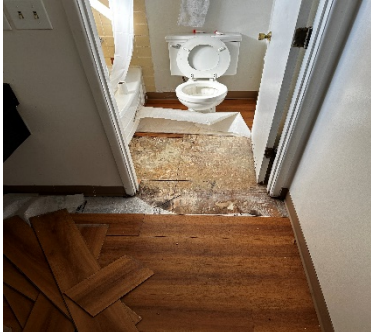
<p>47 – Sheet Vinyl Backing located in Unit 209 Bathroom Floor in good condition.</p> <p>**Picture is of single bed unit and may not be of the actual room stated.</p>

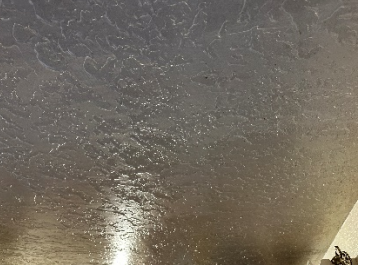
<p>MO – 01, 02 - Drywall with Joint Compound and Heavy Knockdown Ceiling Texture located in the Managers Office in good condition.</p>

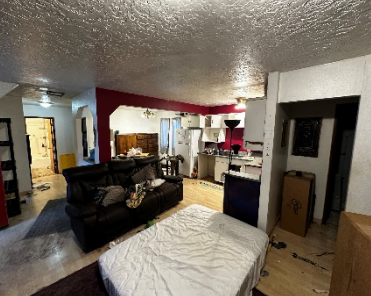
<p>MO – 04, 05 - Drywall with Joint Compound and Orange Peel Texture located in the Managers Office in good condition.</p>

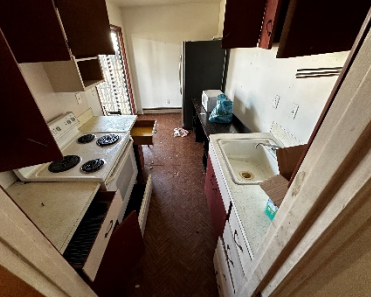
<p>201 – 01, 02 - Wood Pattern Sheet Vinyl over Pebble Pattern Sheet Vinyl located in the Kitchen in good condition.</p>

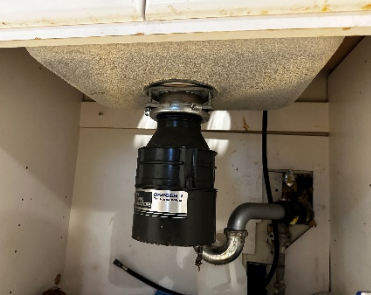
<p>PACM – Kitchen sinks in the managers unit and unit 201</p>
