## Notice of Intent to Remove Asbestos

Site Name: Hidden RV and Mobile Home Park

## Limited Asbestos Building Material Survey

Conducted for:  
Deer Point Meadows  
7607 NE 26<sup>th</sup> Ave  
Vancouver, WA 98665

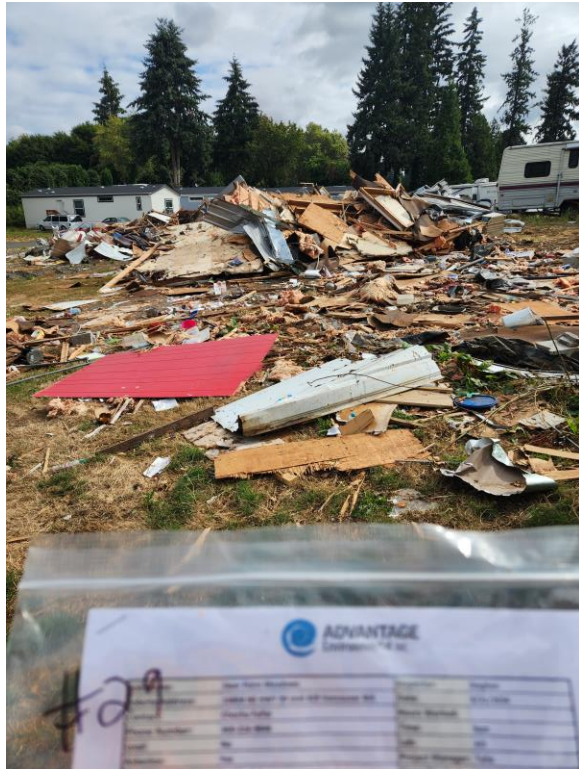
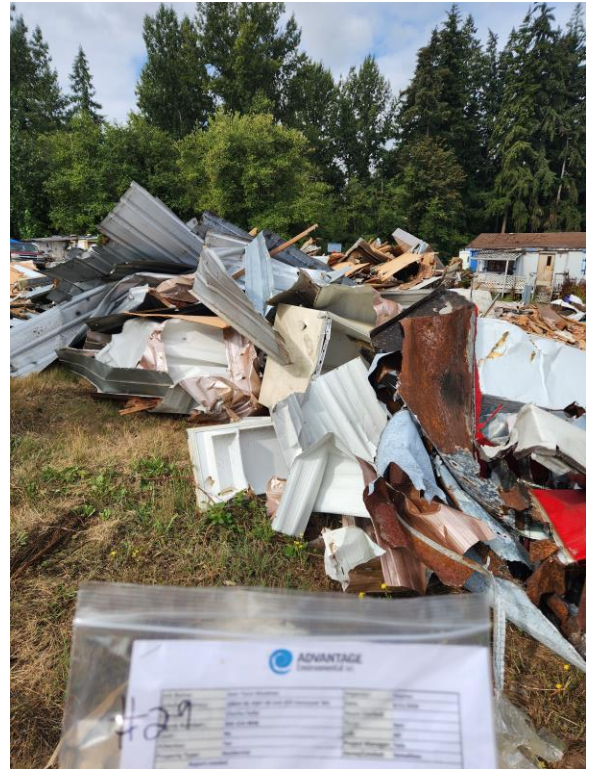
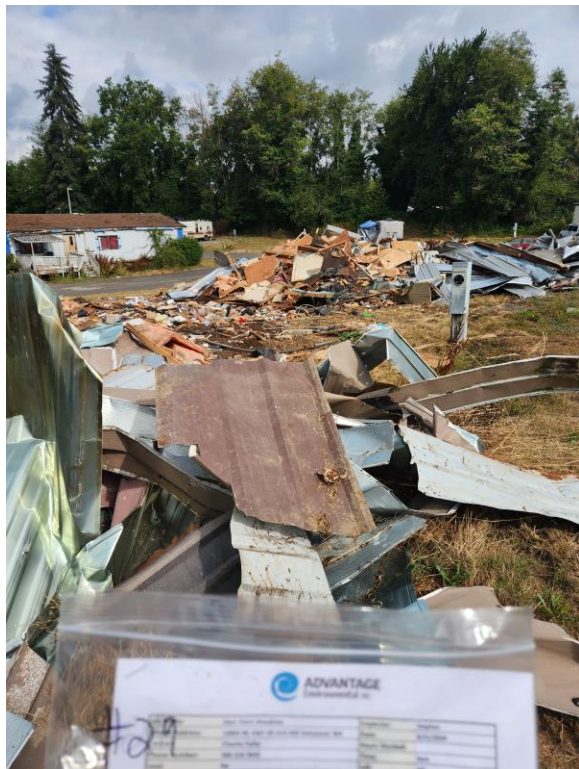
Greater Than 1% Asbestos Containing Materials						
Sample Group Number	Material Type	Material Location	Condition	Quantity	Friable Or Non-Friable	Asbestos Concentration
3	Brown/light yellow floor tile	Mixed throughout the debris pile on site. <i>Additional material may be present in other areas as the debris pile was sorted through by unknown persons presumably with mechanized equipment.</i>	Poor	Debris covers approximately a 50' X 20' area	Friable	2% Chrysotile
7	Black caulking	Mixed throughout the debris pile on site. <i>Additional material may be present in other areas as the debris pile was sorted through by unknown persons presumably with mechanized equipment.</i>	Poor	Debris covers approximately a 50' X 20' area	Non-Friable	4% Chrysotile

<b>7</b>	Black caulking	Yard debris	Poor	See Page 4	No	4% Chrysotile

Asbestos-containing material must be removed by a licensed asbestos abatement contractor prior to any renovation, demolition, or repair work that will impact those materials.

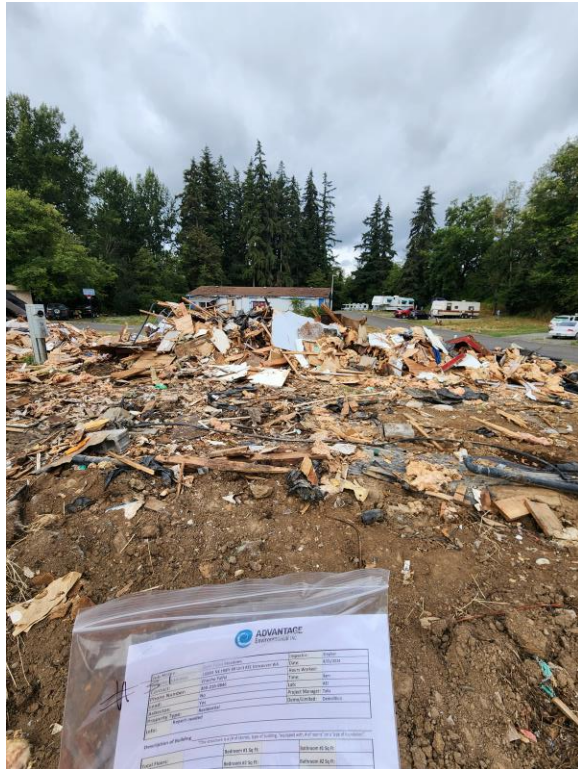
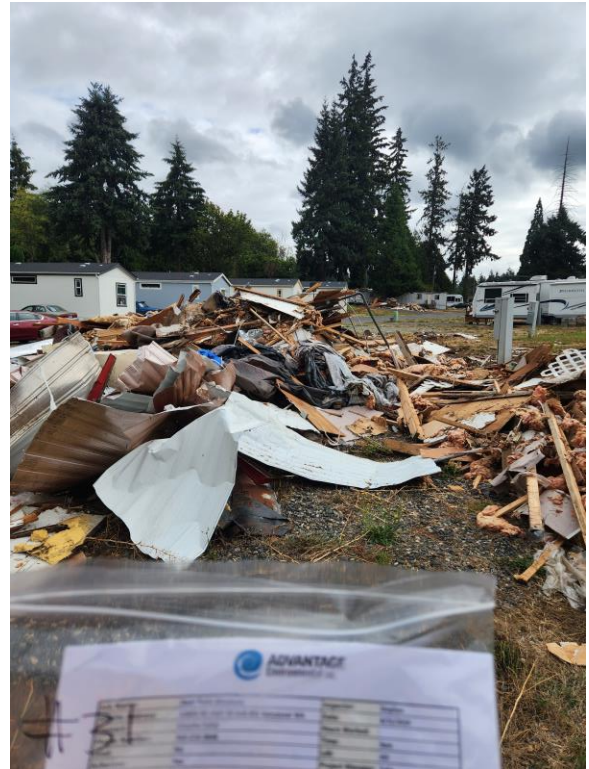
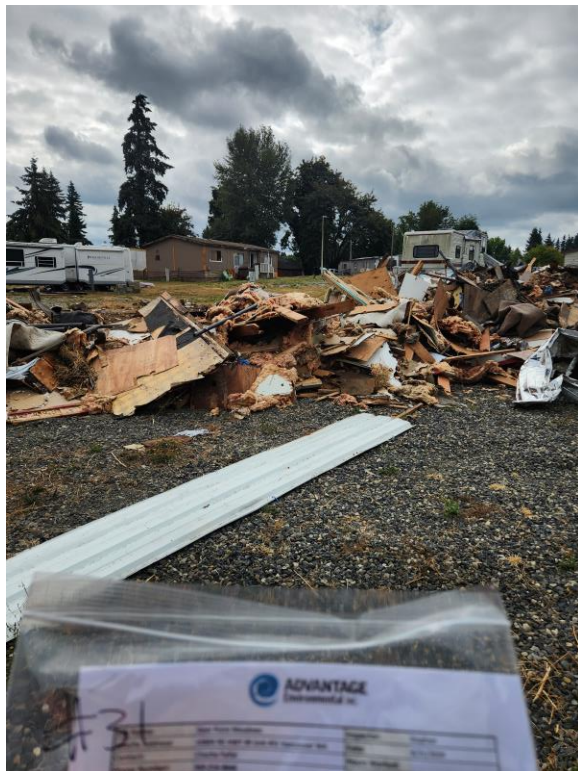
Greater Than 1% Asbestos Containing Materials						
Sample Group Number	Material Type	Material Location	Condition	Quantity	Friable Or Non-Friable	Asbestos Concentration
3	Yellow sheet flooring	Mixed throughout the debris pile on site. <i>Additional material may be present in other areas as the debris pile was sorted through by unknown persons presumably with mechanized equipment.</i>	Poor	Debris covers approximately a 50' X 20' area	Friable	15% Chrysotile
4	Off-white/tan sheet flooring	Mixed throughout the debris pile on site. <i>Additional material may be present in other areas as the debris pile was sorted through by unknown persons presumably with mechanized equipment.</i>	Poor	Debris covers approximately a 50' X 20' area	Friable	15% Chrysotile

Asbestos-containing material must be removed by a licensed asbestos abatement contractor prior to any renovation, demolition, or repair work that will impact those materials.

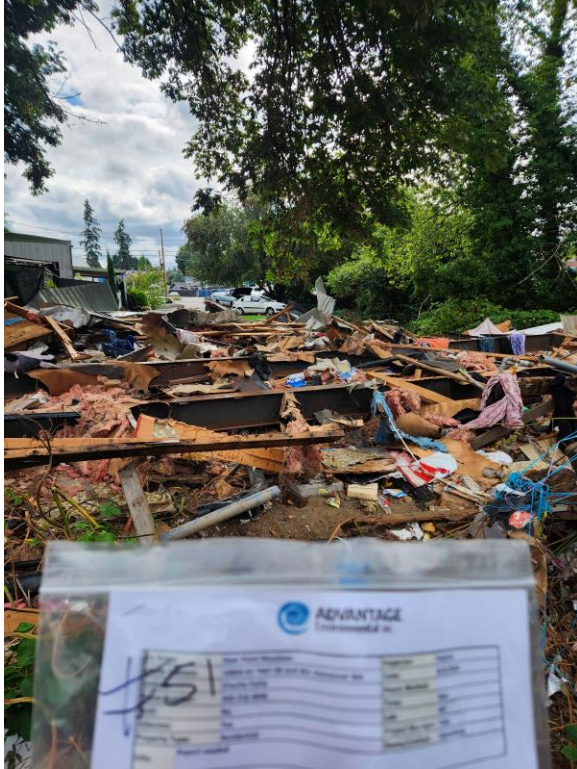
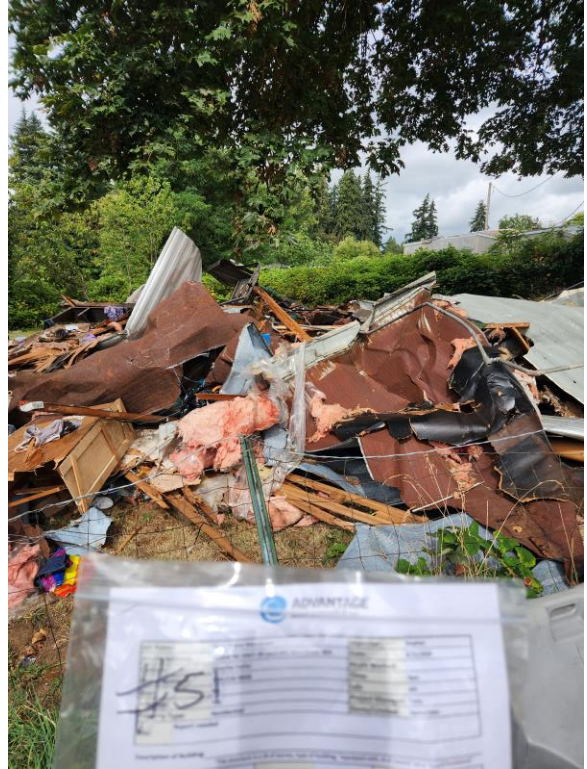
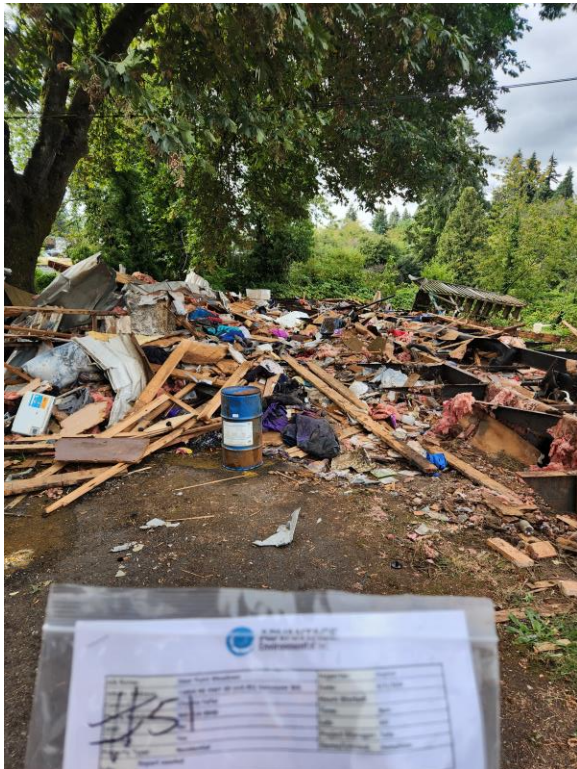
<b>6</b>	Gray caulking	Yard debris				Asbestos Not Present
<b>7</b>	Pink insulation Brown paper backing	Yard debris Yard debris				Asbestos Not Present Asbestos Not Present
<b>8A</b>	Silver roof coating	Yard debris	Poor	See Page 4	No	4% Chrysotile
<b>8B</b>	Silver roof coating	Yard debris	Poor	See Page 4	No	4% Chrysotile
<b>8C</b>	Silver roof coating	Yard debris	Poor	See Page 4	No	4% Chrysotile

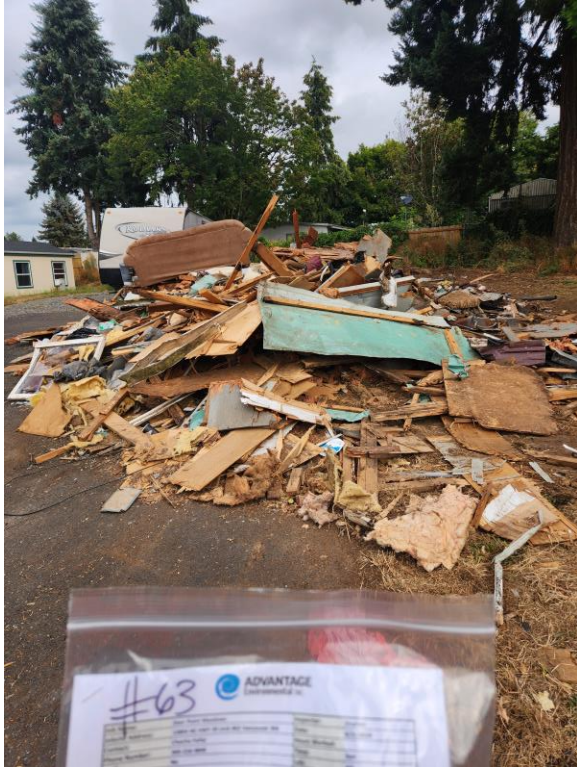
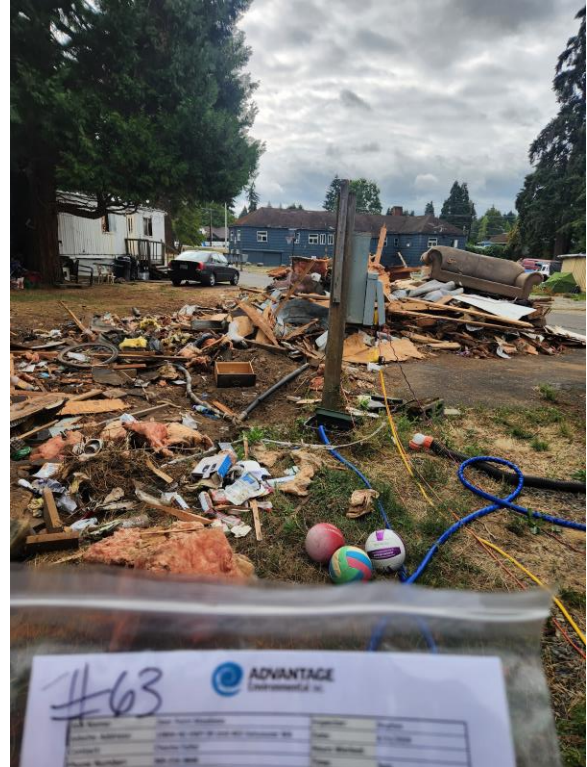
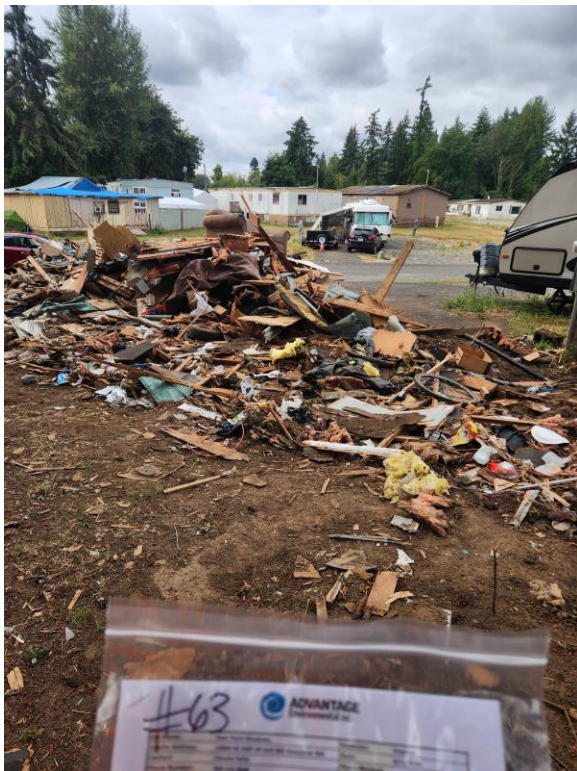
7	Beige caulking	Yard debris				Asbestos Not Present
8A	Silver roof coating	Yard debris	Poor	See Page 4	No	2% Chrysotile
8B	Silver roof coating	Yard debris	Poor	See Page 4	No	2% Chrysotile
8C	Silver roof coating	Yard debris	Poor	See Page 4	No	2% Chrysotile
