Notification of Demolition

HAZARDOUS MATERIALS INVESTIGATION SURVEY

PROPERTY KNOWN AS:
**407 S KING ST.
CENTRALIA, WA 98531**

October 27, 2022

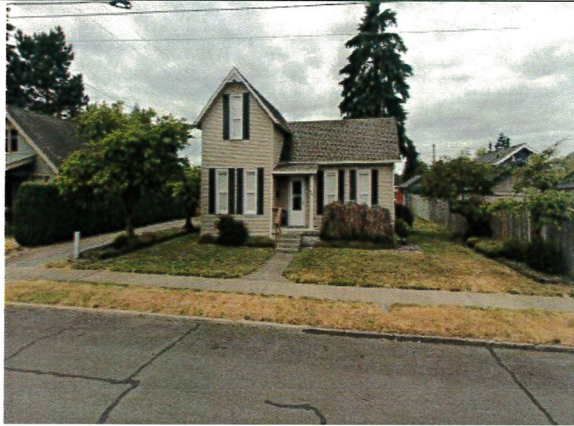
Exterior front view of 407 S King St. Centralia, WA 98531.

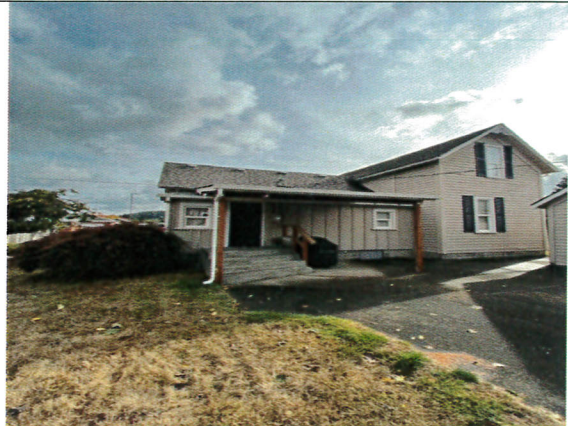
Additional rear view of 407 S King St. Centralia, WA 98531.

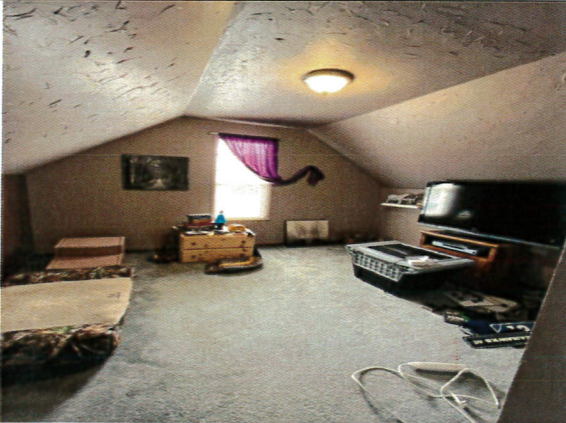
Bedroom 2 with carpet on original hardwood floor, and textured sheetrock and ceiling with skimcoat.

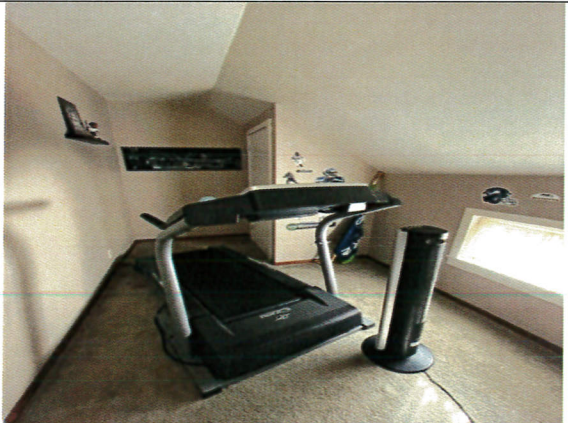
Bedroom 3 with carpet on original hardwood, and sheetrock walls and ceiling with brocade texture.

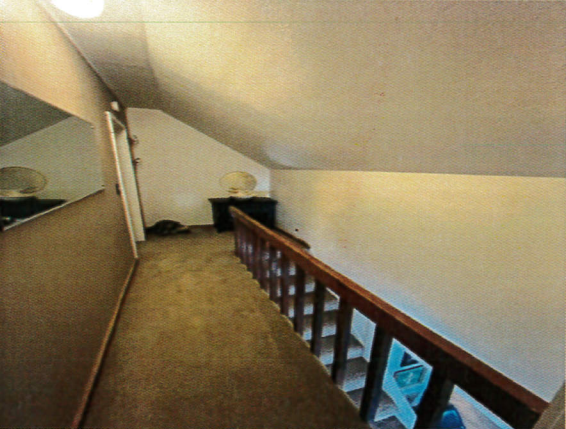
Upstairs hallway with carpet on original hardwood, one wood panel wall and three sheetrock walls and ceiling with brocade texture.

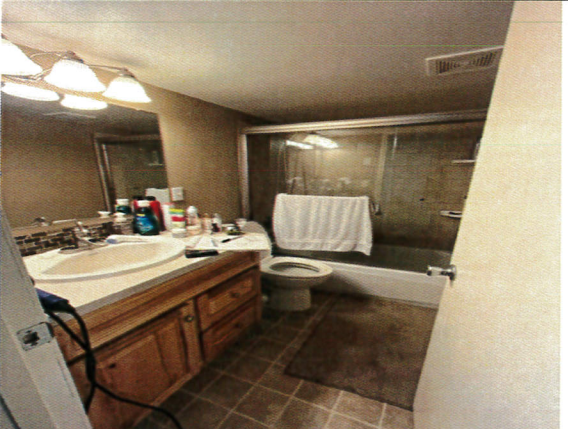
Bathroom with 2 layers of vinyl sheeting floor, and sheetrock walls and ceiling with brocade texture.

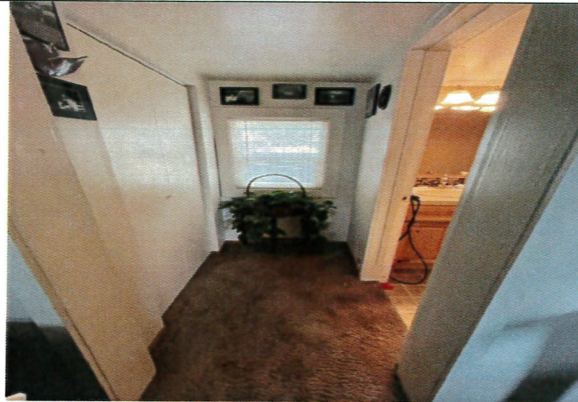
Hallway with carpet floor, and sheetrock walls and ceiling with brocade texture.

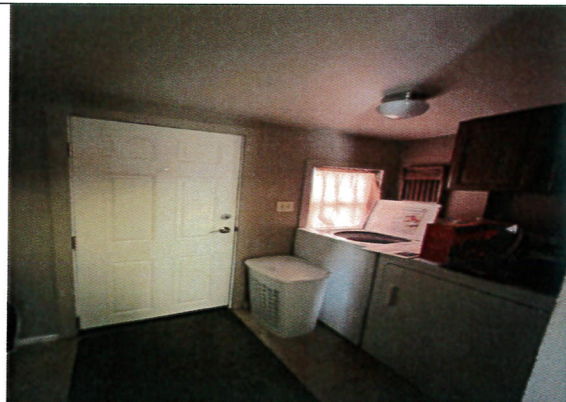
Utility with 2 layers of vinyl sheeting floor, and sheetrock walls and ceiling with brocade texture.

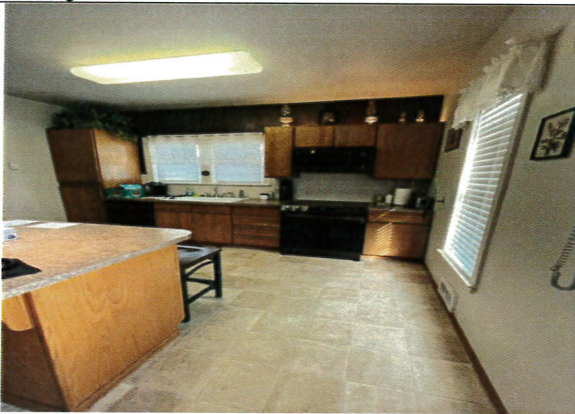
Kitchen with 2 layers of vinyl sheeting floor, and sheetrock walls and ceiling with brocade texture.

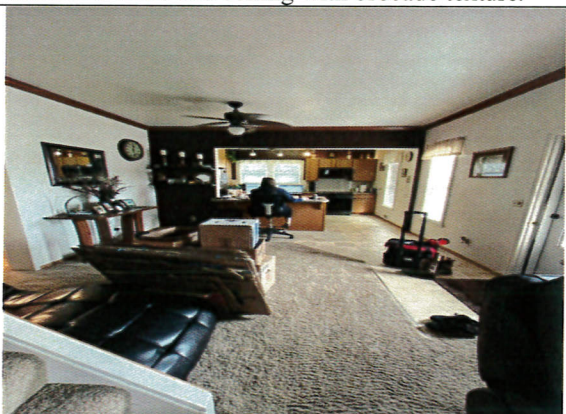
Dining room with carpet floor, and sheetrock walls and ceiling with brocade texture.

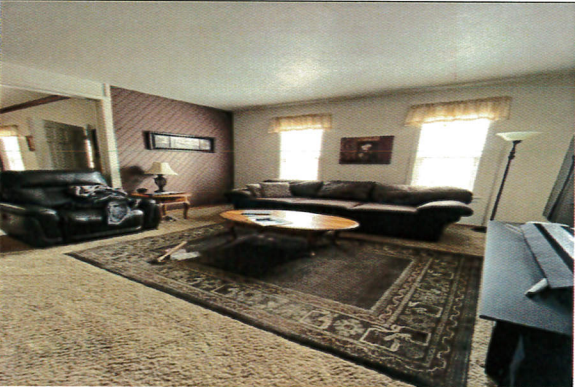
Living room with 2 layers of carpet on vinyl sheeting floor, and sheetrock walls and ceiling with brocade texture.

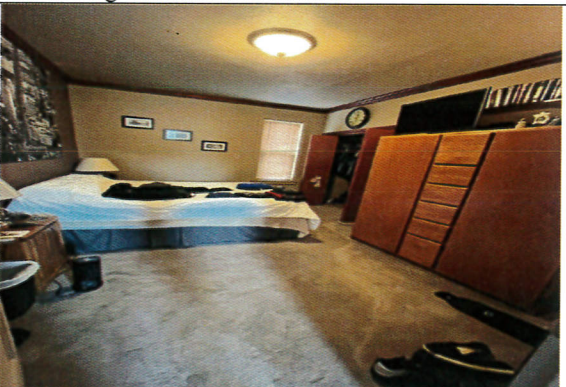
Master bedroom with carpet on wood floor, and sheetrock walls and ceiling with brocade texture.
