Notice of Intent to Remove Asbestos

Site Name: Deer Point Meadows

Limited Asbestos Building Material Survey

Conducted for:
Deer Point Meadows
7607 NE 26th Ave
Vancouver, WA 98665

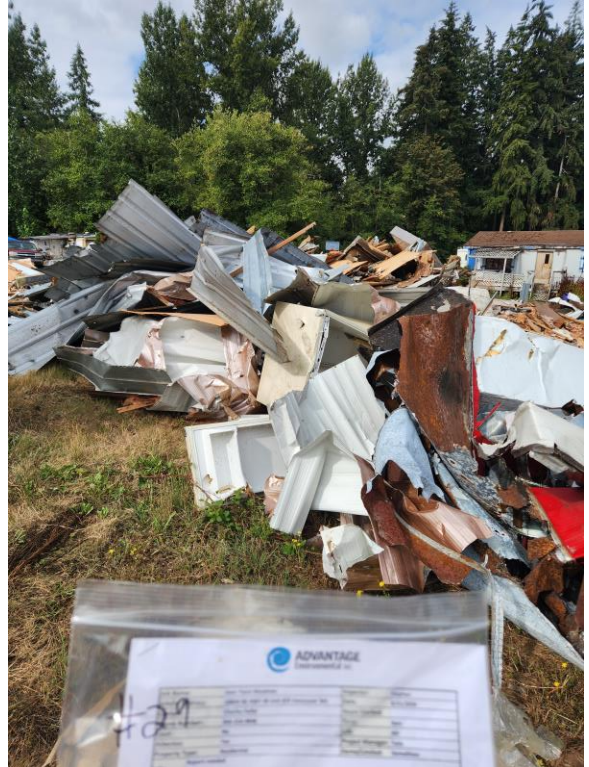
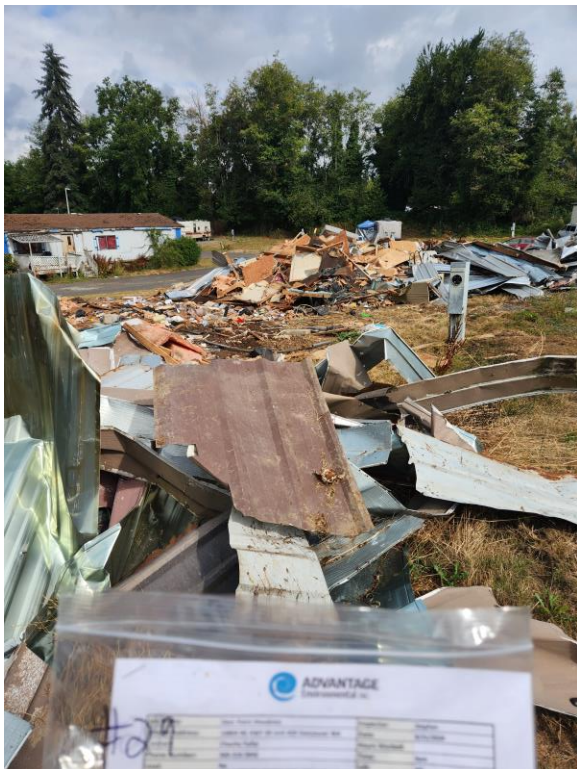
Inspection Photos

Greater Than 1% Asbestos Containing Materials						
Sample Group Number	Material Type	Material Location	Condition	Quantity	Friable Or Non-Friable	Asbestos Concentration
3	Brown/light yellow floor tile	Mixed throughout the debris pile on site. <i>Additional material may be present in other areas as the debris pile was sorted through by unknown persons presumably with mechanized equipment.</i>	Poor	Debris covers approximately a 50' X 20' area	Friable	2% Chrysotile
7	Black caulking	Mixed throughout the debris pile on site. <i>Additional material may be present in other areas as the debris pile was sorted through by unknown persons presumably with mechanized equipment.</i>	Poor	Debris covers approximately a 50' X 20' area	Non-Friable	4% Chrysotile

If marked "No" above, please explain or notes relating to other concerns: Buildings were
demolished and sifted through by thieves. Metal and frames
partly missing. Debris is throughout most the yard, street &
neighbors property.

Asbestos-containing material must be removed by a licensed asbestos abatement contractor prior to any renovation, demolition, or repair work that will impact those materials.

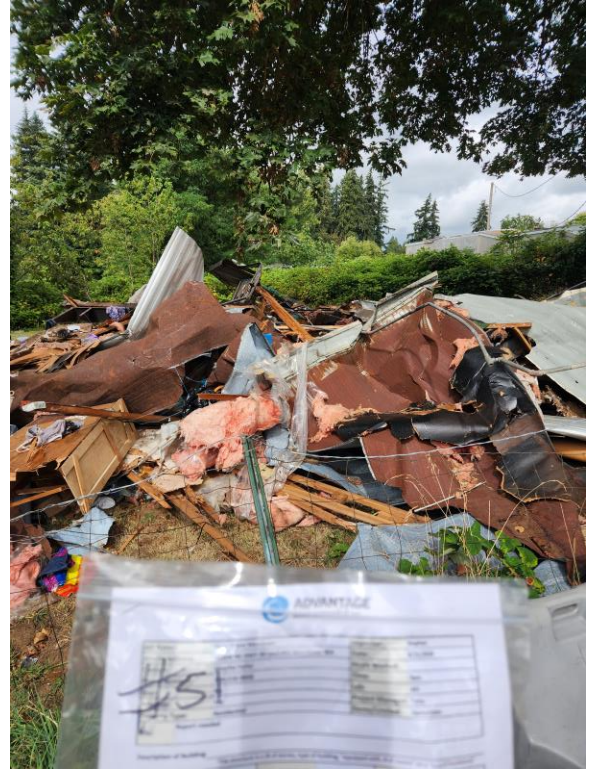
Inspection Photos

7	Pink insulation Brown paper backing	Yard debris Yard debris				Asbestos Not Present Asbestos Not Present
8A	Silver roof coating	Yard debris	Poor	See Page 4	No	4% Chrysotile
8B	Silver roof coating	Yard debris	Poor	See Page 4	No	4% Chrysotile
8C	Silver roof coating	Yard debris	Poor	See Page 4	No	4% Chrysotile

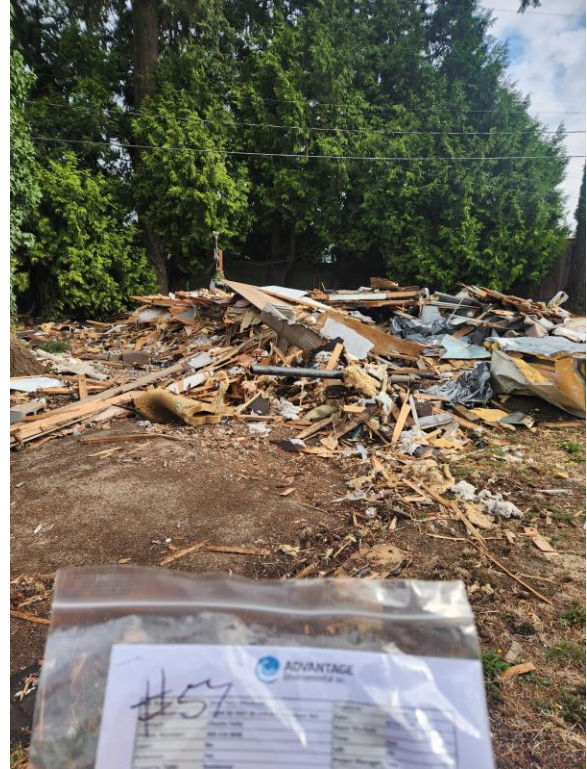
Inspection Photos

7B	Silver roof coating	Yard debris	Poor	See Page 4	No	2% Chrysotile
	Black tar	Yard debris	Poor	See Page 4	No	3% Chrysotile
7C	Silver roof coating	Yard debris	Poor	See Page 4	No	2% Chrysotile
	Black tar	Yard debris	Poor	See Page 4	No	3% Chrysotile
8	Brown carpet	Yard debris				Asbestos Not Present

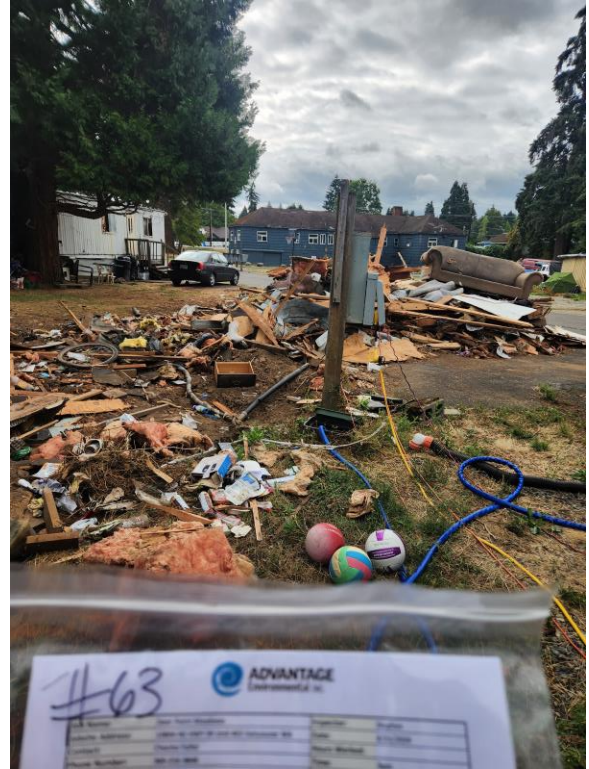
Inspection Photos

7	Beige caulking	Yard debris				Asbestos Not Present
8A	Silver roof coating	Yard debris	Poor	See Page 4	No	2% Chrysotile
8B	Silver roof coating	Yard debris	Poor	See Page 4	No	2% Chrysotile
8C	Silver roof coating	Yard debris	Poor	See Page 4	No	2% Chrysotile
