# Notification of Demolition

Case #: 24-862

## Limited Asbestos Building Material Survey

Conducted for:  
Deer Point Meadows  
7607 NE 26<sup>th</sup> Ave  
Vancouver, WA 98665

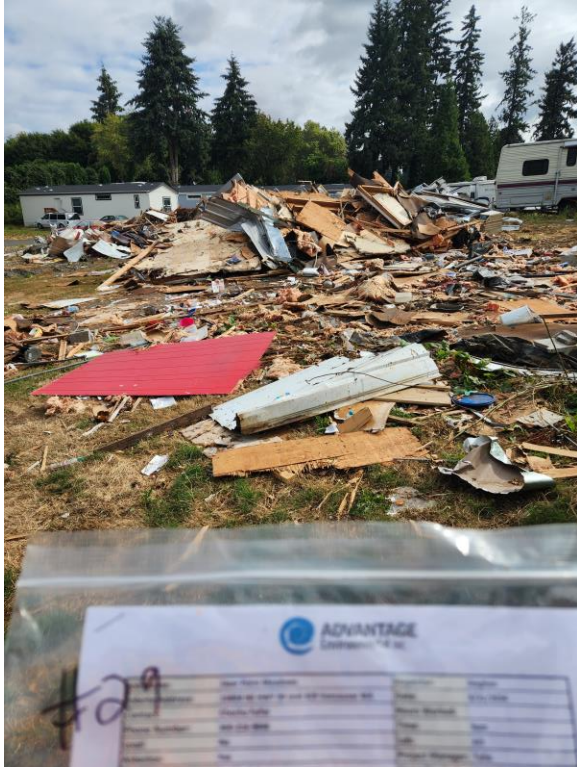
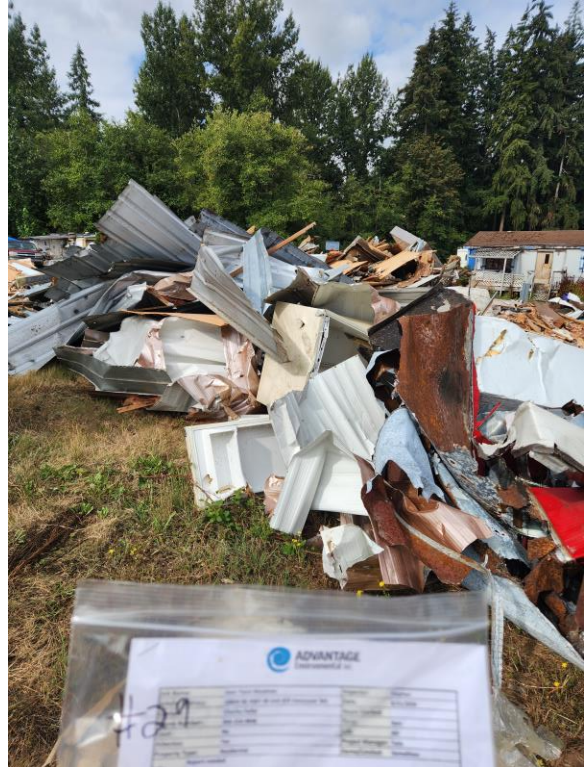
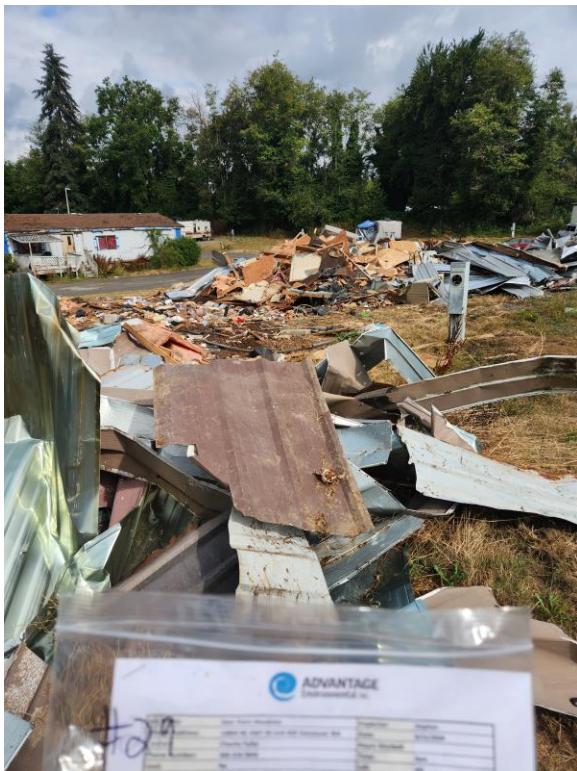
## Inspection Photos

Greater Than 1% Asbestos Containing Materials						
Sample Group Number	Material Type	Material Location	Condition	Quantity	Friable Or Non-Friable	Asbestos Concentration
3	Brown/light yellow floor tile	Mixed throughout the debris pile on site. <i>Additional material may be present in other areas as the debris pile was sorted through by unknown persons presumably with mechanized equipment.</i>	Poor	Debris covers approximately a 50' X 20' area	Friable	2% Chrysotile
7	Black caulking	Mixed throughout the debris pile on site. <i>Additional material may be present in other areas as the debris pile was sorted through by unknown persons presumably with mechanized equipment.</i>	Poor	Debris covers approximately a 50' X 20' area	Non-Friable	4% Chrysotile

<b>7</b>	Black caulking	Yard debris	Poor	See Page 4	No	4% Chrysotile

Asbestos-containing material must be removed by a licensed asbestos abatement contractor prior to any renovation, demolition, or repair work that will impact those materials.

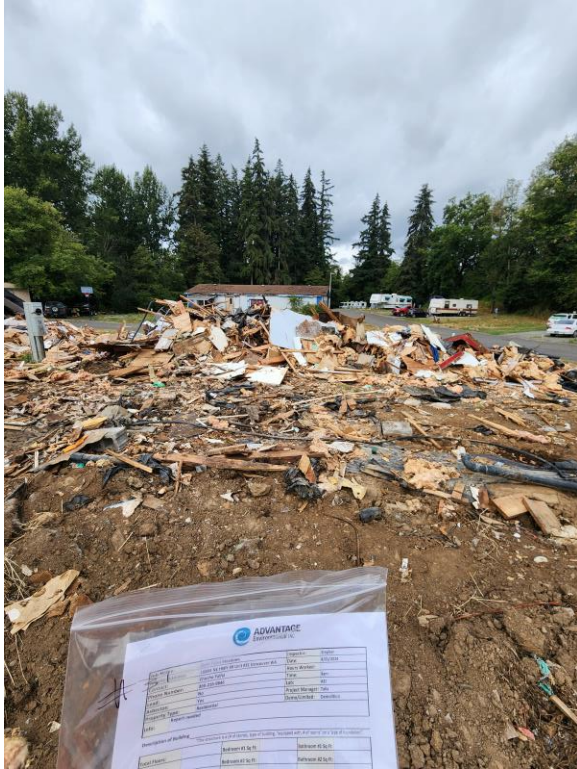
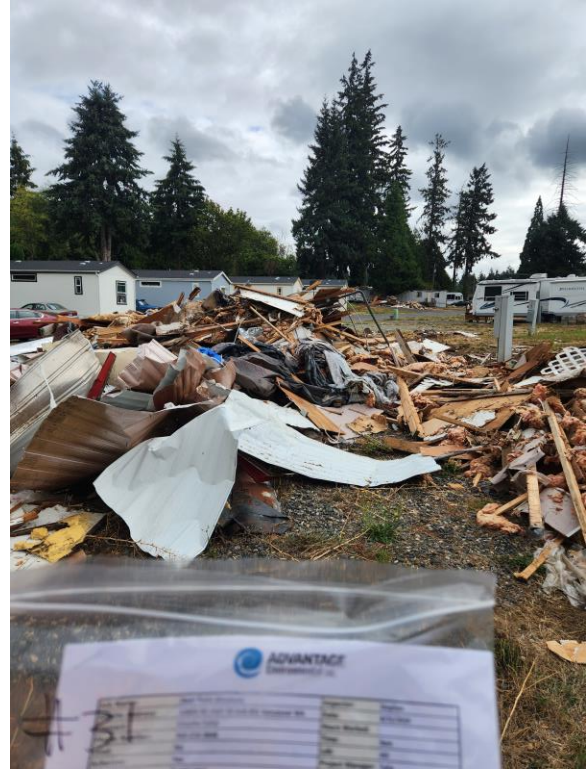
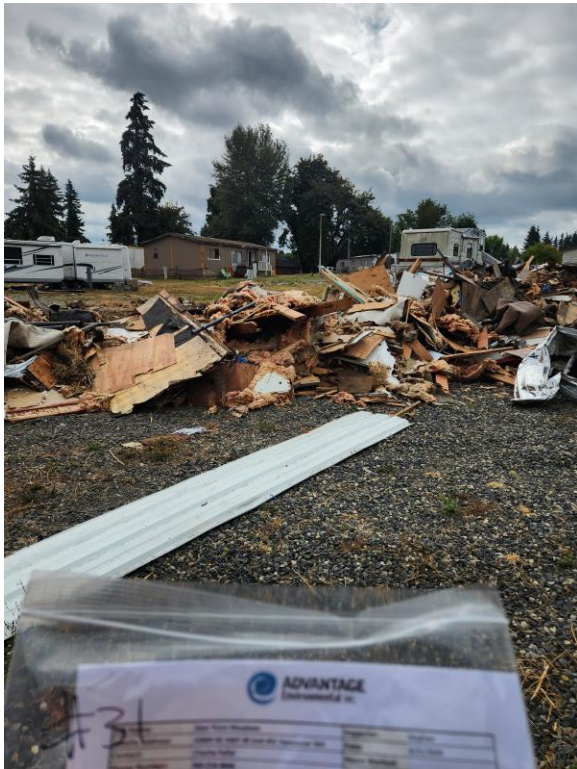
## Inspection Photos

Greater Than 1% Asbestos Containing Materials						
Sample Group Number	Material Type	Material Location	Condition	Quantity	Friable Or Non-Friable	Asbestos Concentration
3	Yellow sheet flooring	Mixed throughout the debris pile on site. <i>Additional material may be present in other areas as the debris pile was sorted through by unknown persons presumably with mechanized equipment.</i>	Poor	Debris covers approximately a 50' X 20' area	Friable	15% Chrysotile
4	Off-white/tan sheet flooring	Mixed throughout the debris pile on site. <i>Additional material may be present in other areas as the debris pile was sorted through by unknown persons presumably with mechanized equipment.</i>	Poor	Debris covers approximately a 50' X 20' area	Friable	15% Chrysotile

Asbestos-containing material must be removed by a licensed asbestos abatement contractor prior to any renovation, demolition, or repair work that will impact those materials.

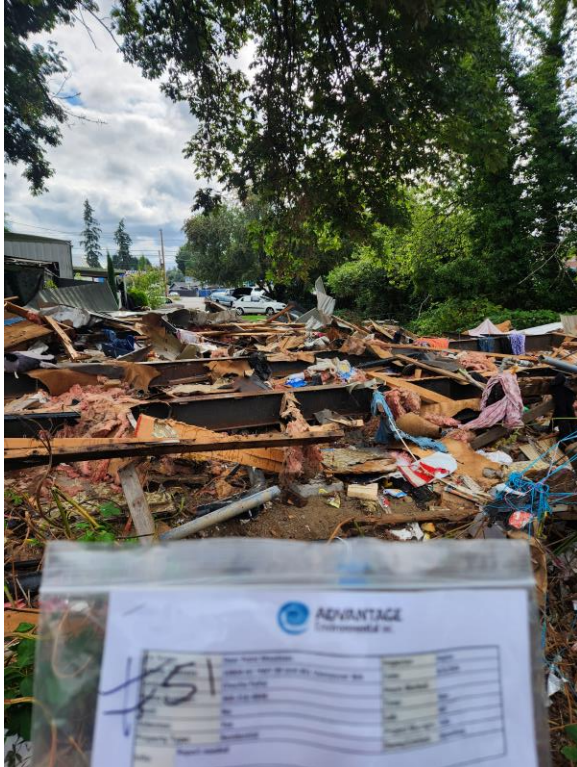
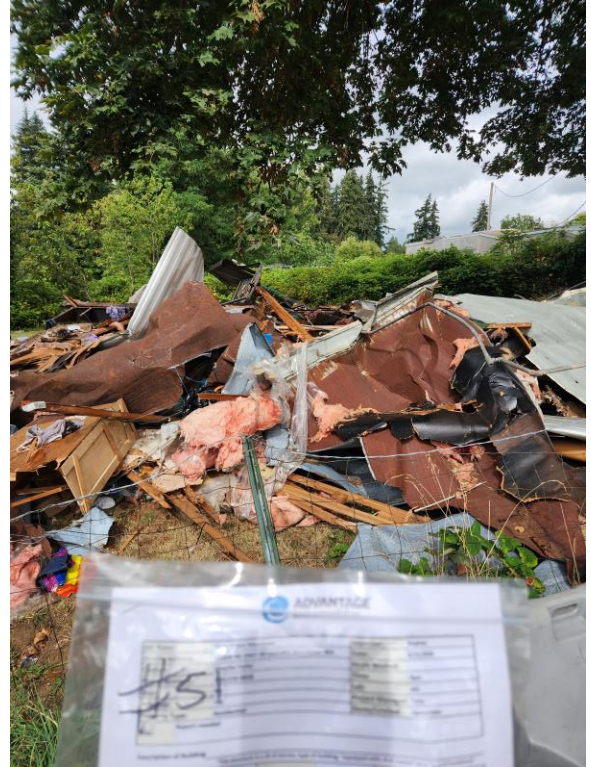
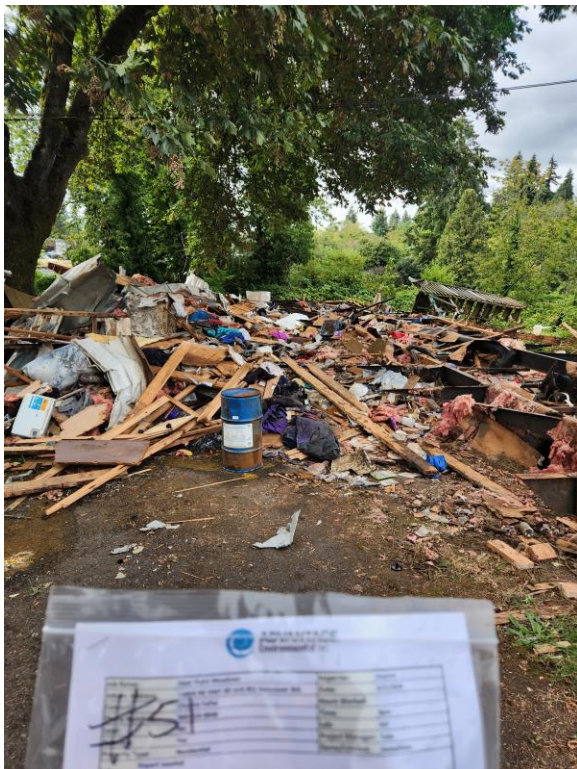
## Inspection Photos

<b>6</b>	Gray caulking	Yard debris				Asbestos Not Present
<b>7</b>	Pink insulation Brown paper backing	Yard debris Yard debris				Asbestos Not Present Asbestos Not Present
<b>8A</b>	Silver roof coating	Yard debris	Poor	See Page 4	No	4% Chrysotile
<b>8B</b>	Silver roof coating	Yard debris	Poor	See Page 4	No	4% Chrysotile
<b>8C</b>	Silver roof coating	Yard debris	Poor	See Page 4	No	4% Chrysotile

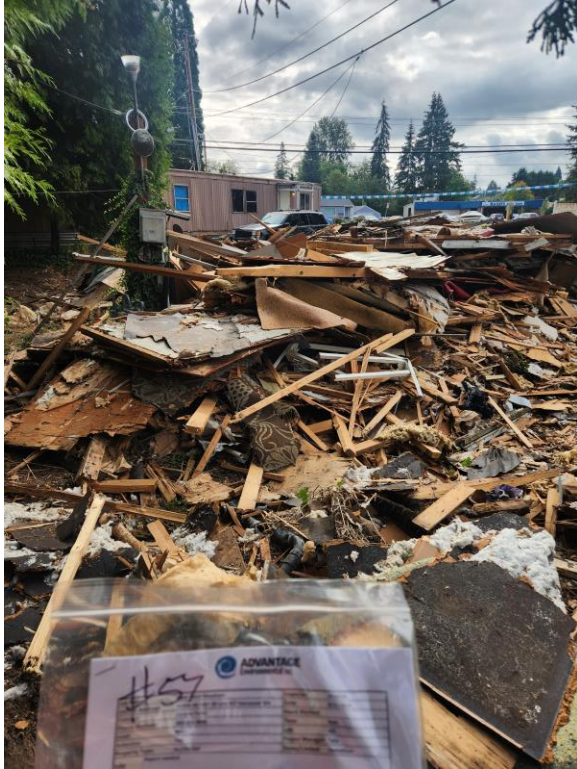
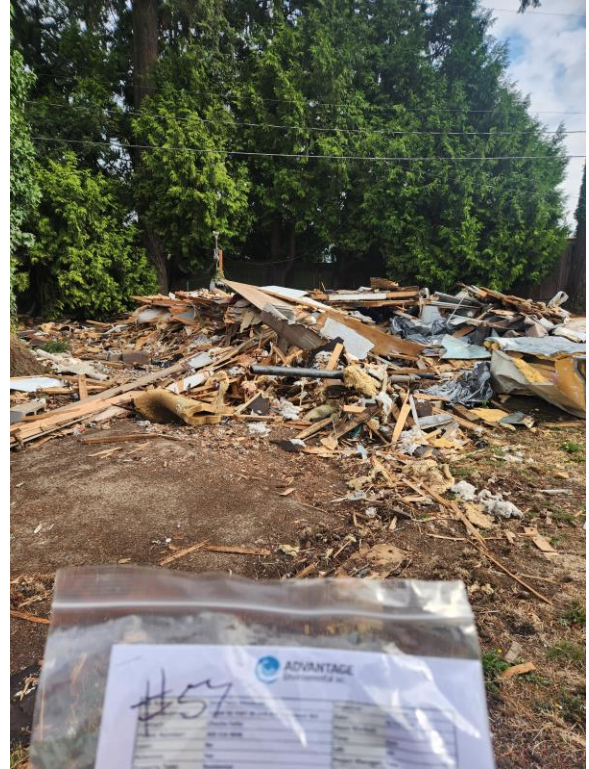
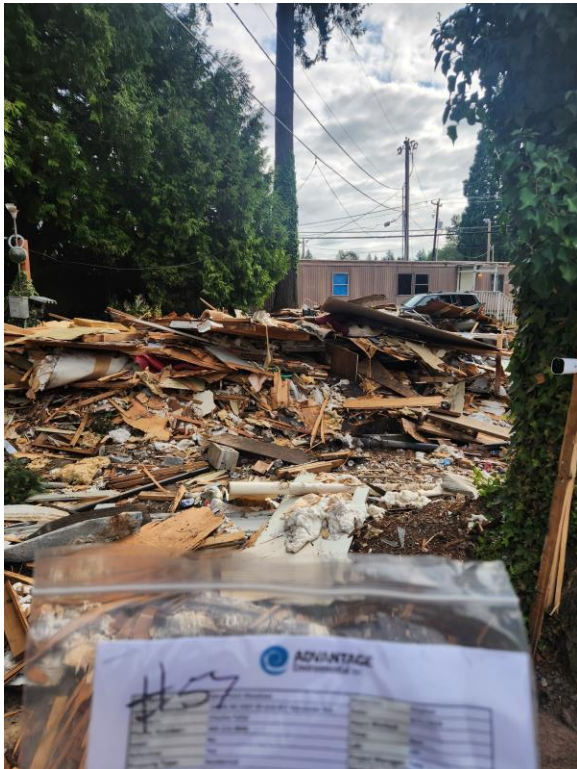
## Inspection Photos

Black tar	Yard debris	Poor	See Page 4	No	3% Chrysotile
<b>7B</b>	Silver roof coating	Yard debris	Poor	See Page 4	No	2% Chrysotile
	Black tar	Yard debris	Poor	See Page 4	No	3% Chrysotile
<b>7C</b>	Silver roof coating	Yard debris	Poor	See Page 4	No	2% Chrysotile
	Black tar	Yard debris	Poor	See Page 4	No	3% Chrysotile
<b>8</b>	Brown carpet	Yard debris				Asbestos Not Present

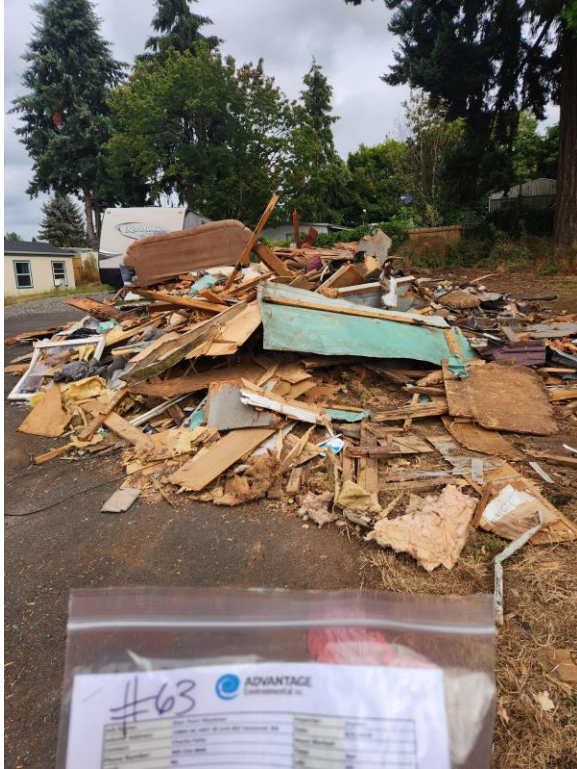
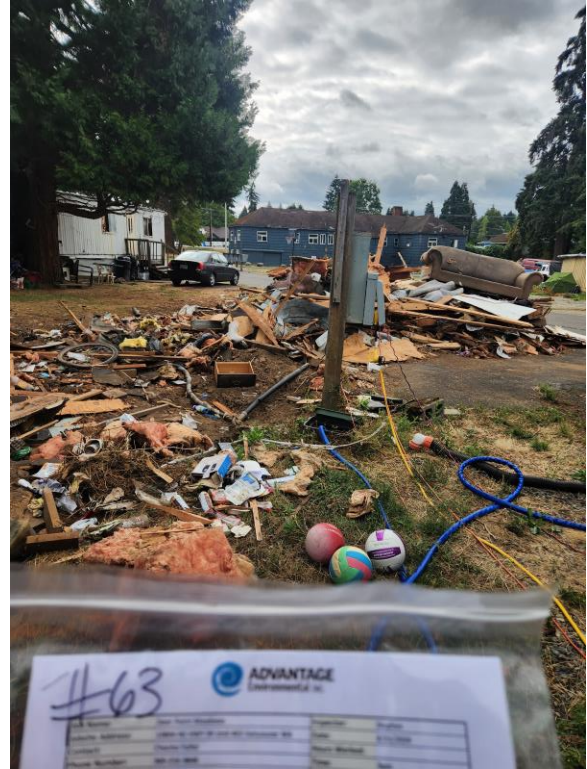
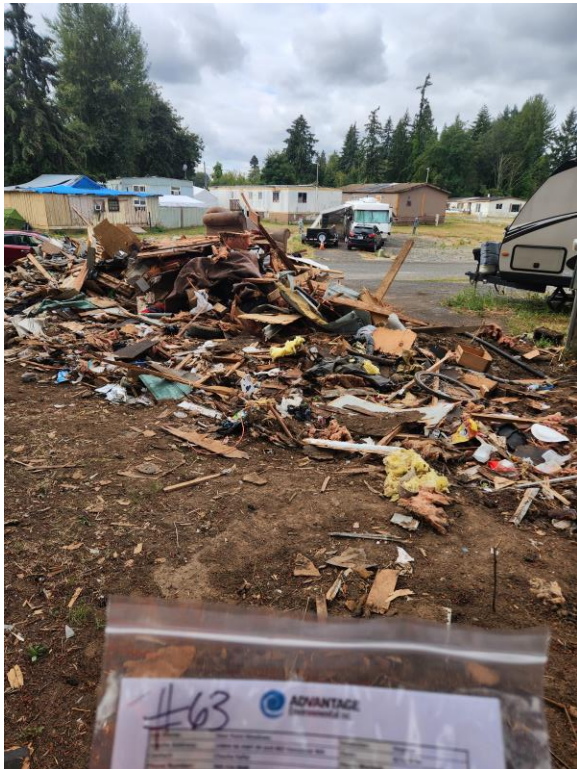
## Inspection Photos

7	Beige caulking	Yard debris				Asbestos Not Present
8A	Silver roof coating	Yard debris	Poor	See Page 4	No	2% Chrysotile
8B	Silver roof coating	Yard debris	Poor	See Page 4	No	2% Chrysotile
8C	Silver roof coating	Yard debris	Poor	See Page 4	No	2% Chrysotile
