# Notification of Demolition

## HAZARDOUS MATERIALS INVESTIGATION ASBESTOS SURVEY

PROPERTY KNOWN AS:  
411 S KING ST.  
CENTRALIA, WA 98531

DECEMBER 14, 2018

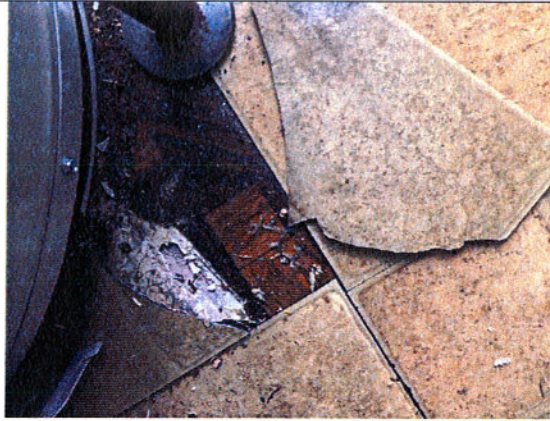
Sample #	Location	% ACM Category	Description of Material	Friable/ Non- Friable	Total SF
411-6	Kitchen Pantry Floor	50% Chrysotile Misc.	Sheet Vinyl on Wood	Friable	18sf
411-7	Utility Room Floor	50% Chrysotile Misc.	Multiple Layers of Flooring (Bottom Layer Sheet Vinyl is Positive)	Friable	71sf

Utility Room Floor Bottom Layer Sheet Vinyl  
**POSITIVE**

All identified asbestos containing material is regulated material and must be abated prior to any demolition or remodeling activity which may disturb these materials at the subject property. A Washington State Certified Asbestos Contractor must conduct abatement of asbestos containing materials. The asbestos containing materials identified in the subject property fall into the Miscellaneous Category. This is an asbestos project.

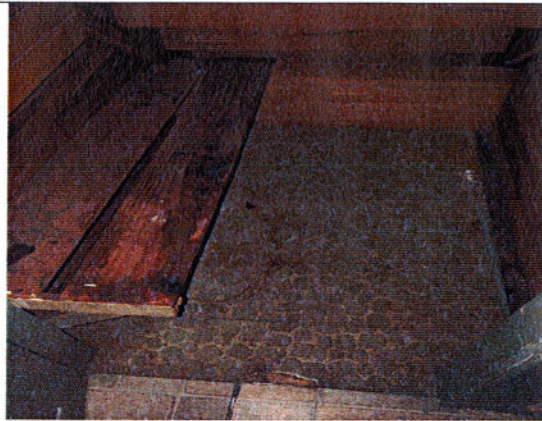
Sample #	Location	% ACM Category	Description of Material	Friable/ Non- Friable	Total SF
411-6	Kitchen Pantry Floor	50% Chrysotile Misc.	Sheet Vinyl on Wood	Friable	18sf
411-7	Utility Room Floor	50% Chrysotile Misc.	Multiple Layers of Flooring (Bottom Layer Sheet Vinyl is Positive)	Friable	71sf

Kitchen Pantry Floor **POSITIVE**

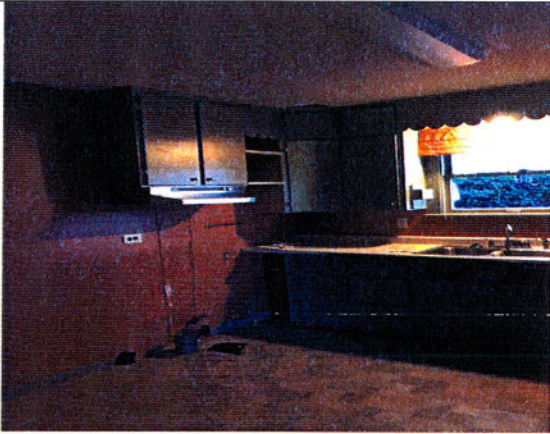
Kitchen **NEGATIVE**

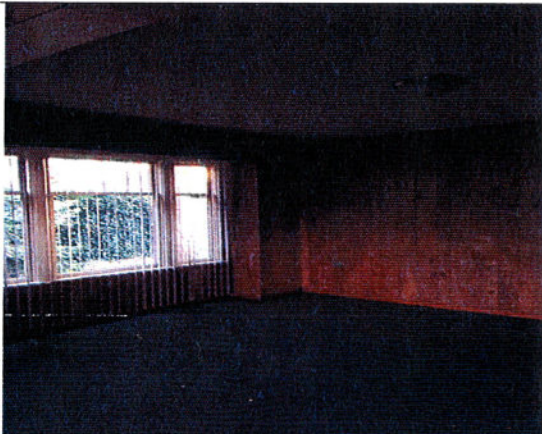
Dining Room **NEGATIVE**

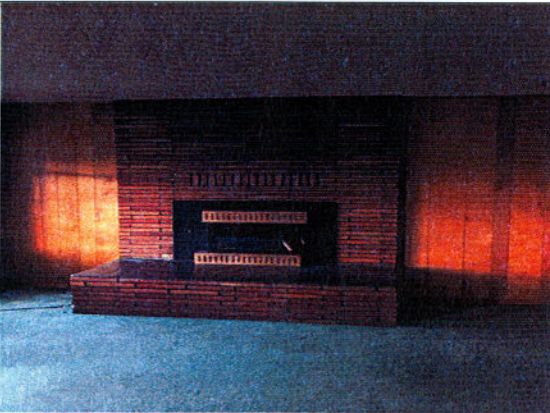
Living Room **NEGATIVE**

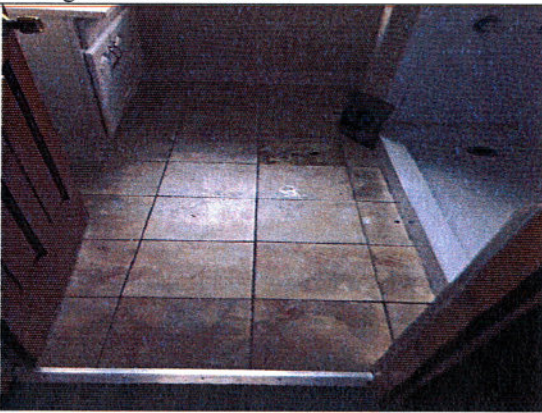
Bathroom **NEGATIVE**

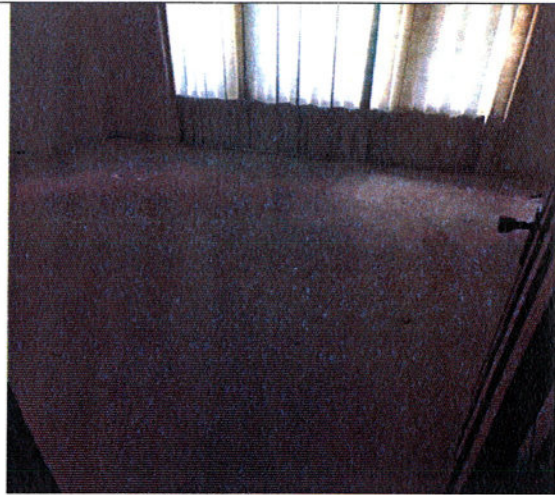
Bedroom 1 NEGATIVE

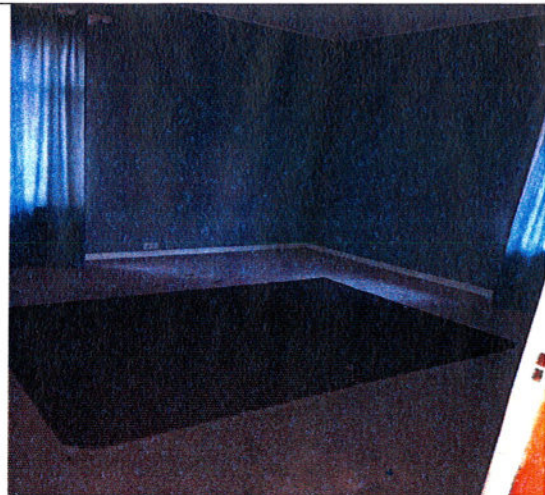
Bedroom 2 NEGATIVE

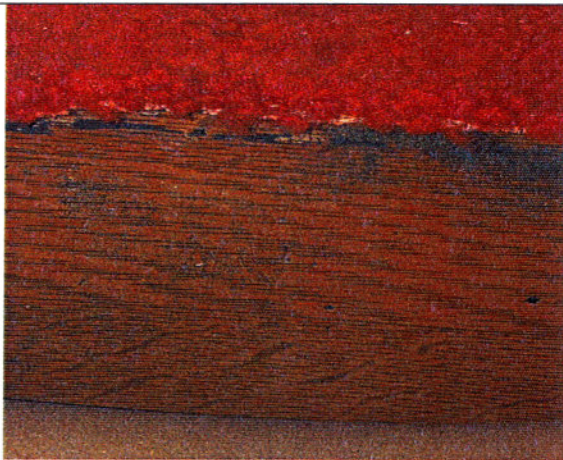
Bedroom 3 NEGATIVE

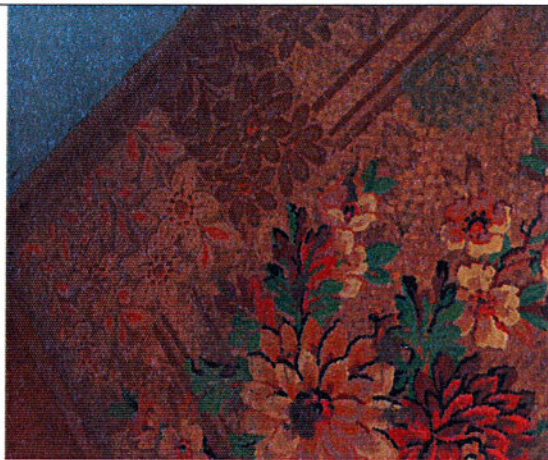
Bedroom 4 NEGATIVE
