Notice of Intent to Remove Asbestos

Site Name: Fibre Federal Credit Union

HAZARDOUS BUILDING MATERIALS SURVEY

Hazardous Building Materials Survey
770 11th Avenue, Longview, WA
September 2023

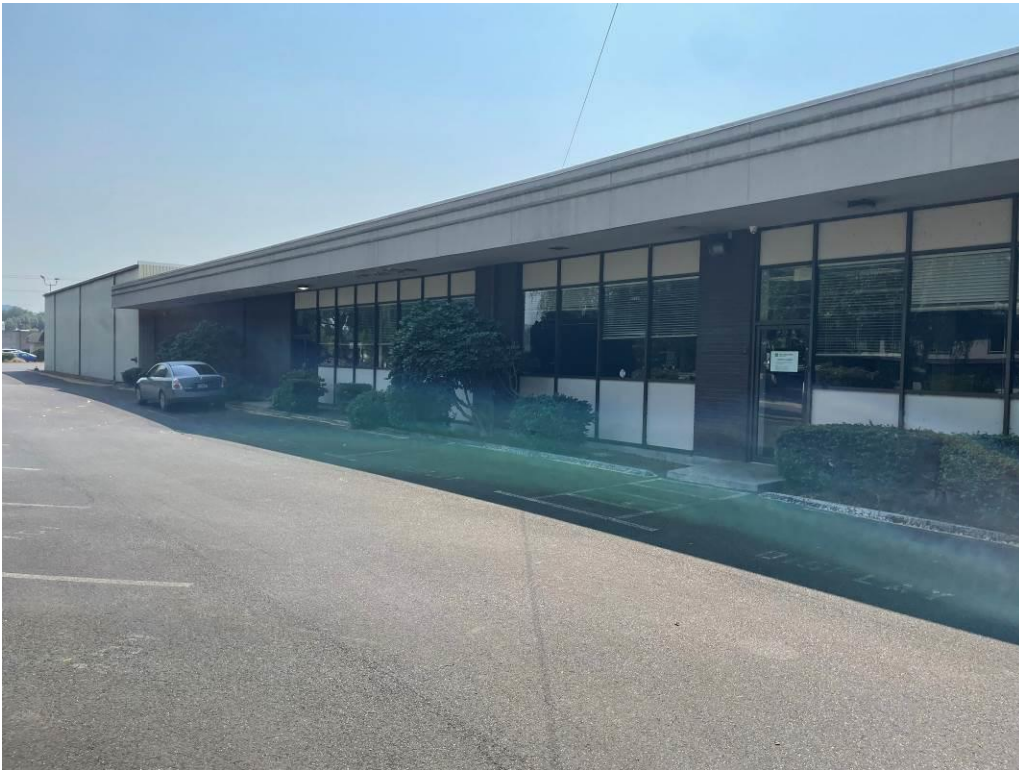
Photo 2: Exterior of the building facing southeast. The white window infill panels are cement asbestos board. The GWB soffit is also asbestos containing.

Med-Tox Northwest recommends, and state law requires, that all asbestos materials identified in **Table 1** be removed prior to demolition.

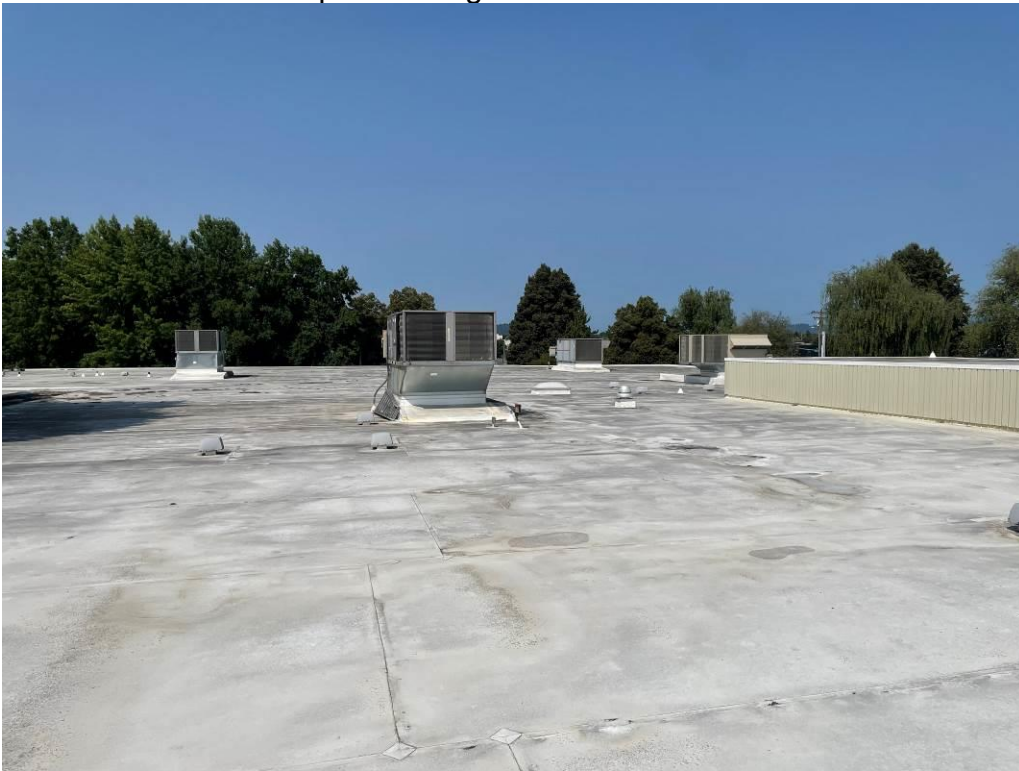
Photo 4: Roof of the building facing west. The roof is assumed ACM as it was unclear if existing layers of roofing are present underneath the white sealed membrane.

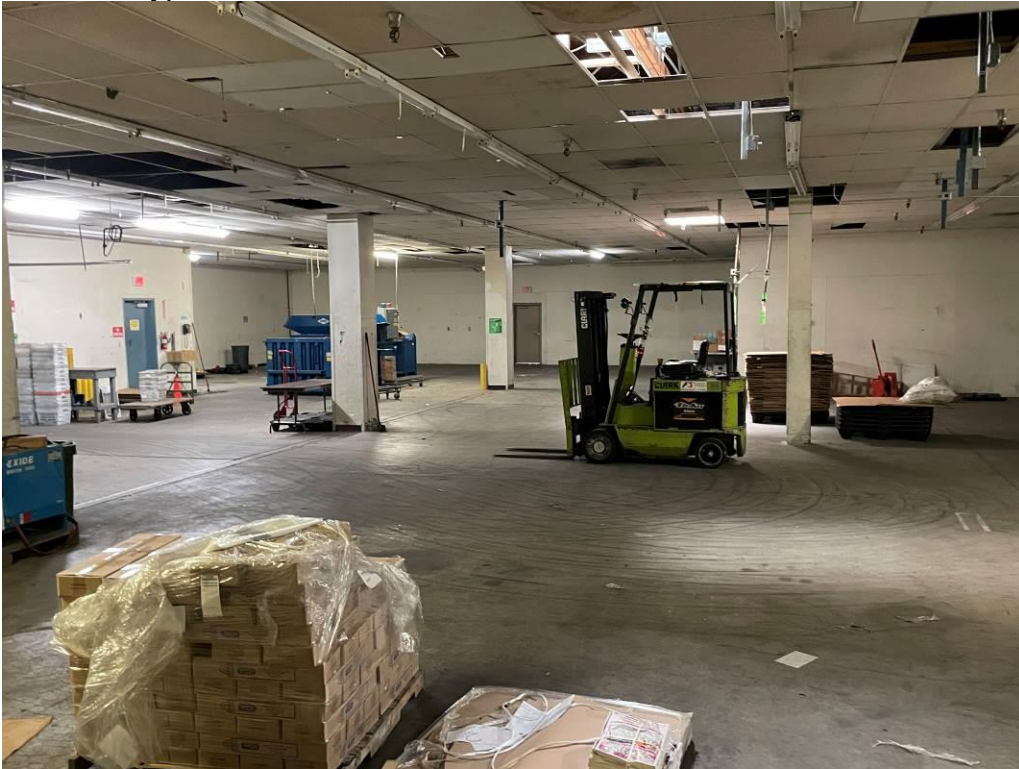
Photo 6: Mailroom facing south. The ACT previously identified as ACM has been removed. All samples collected from the ACT were negative for asbestos.

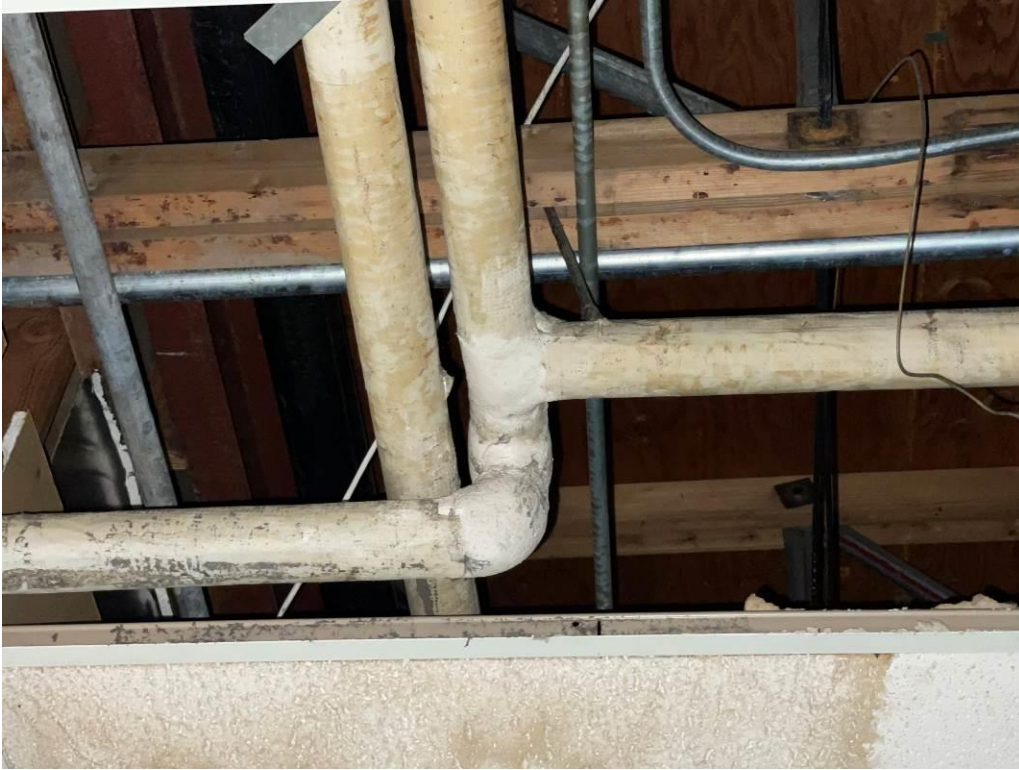
- **Mudded fittings***. This material was observed above the drop ceiling in the mailroom. Most of the fittings appear to have been abated, but there may be additional fittings not observed by MTNW.
- **Fiberglass pipe insulation***. This material was observed on the pipes throughout most of the building.

Photo 7: Asbestos containing mudded pipe fittings observed above the drop ceiling in the Mailroom.

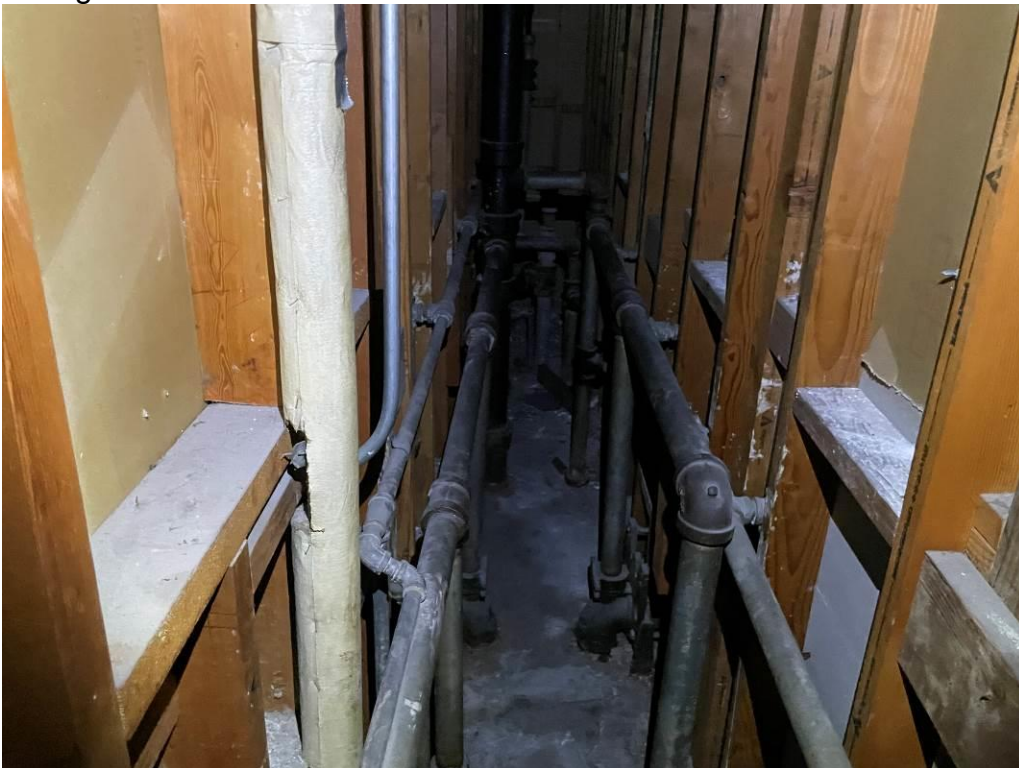
Photo 8: Mechanical chase closet located between the restrooms. The previously identified ACM pipe fitting insulation has been abated.

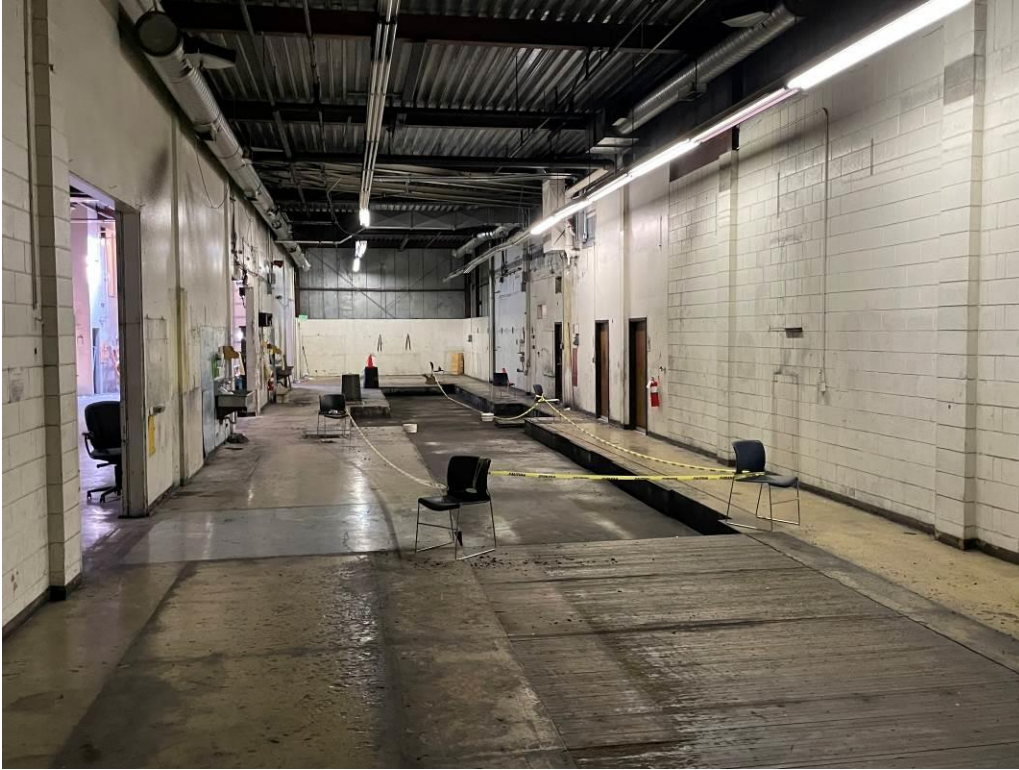
Photo 9: Press Room facing east. The SVF on the floor is asbestos containing.

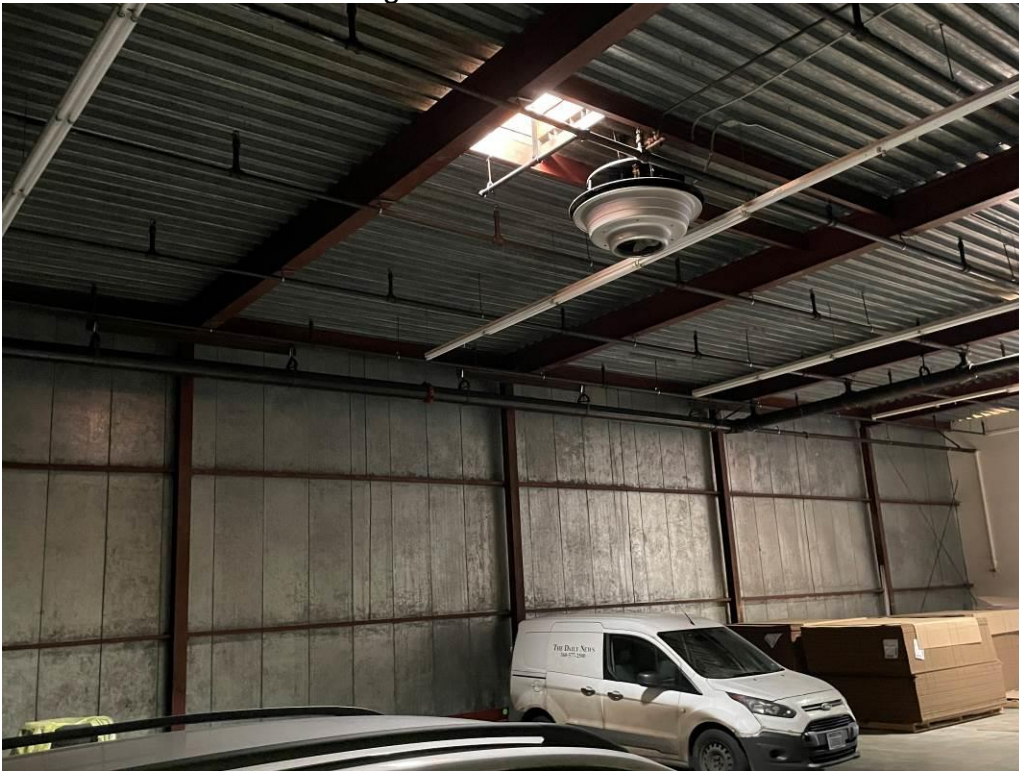
Photo 10: Reel Room facing southeast. The walls and ceiling were previously identified to have ACM spray-on fireproofing. There was none observed.

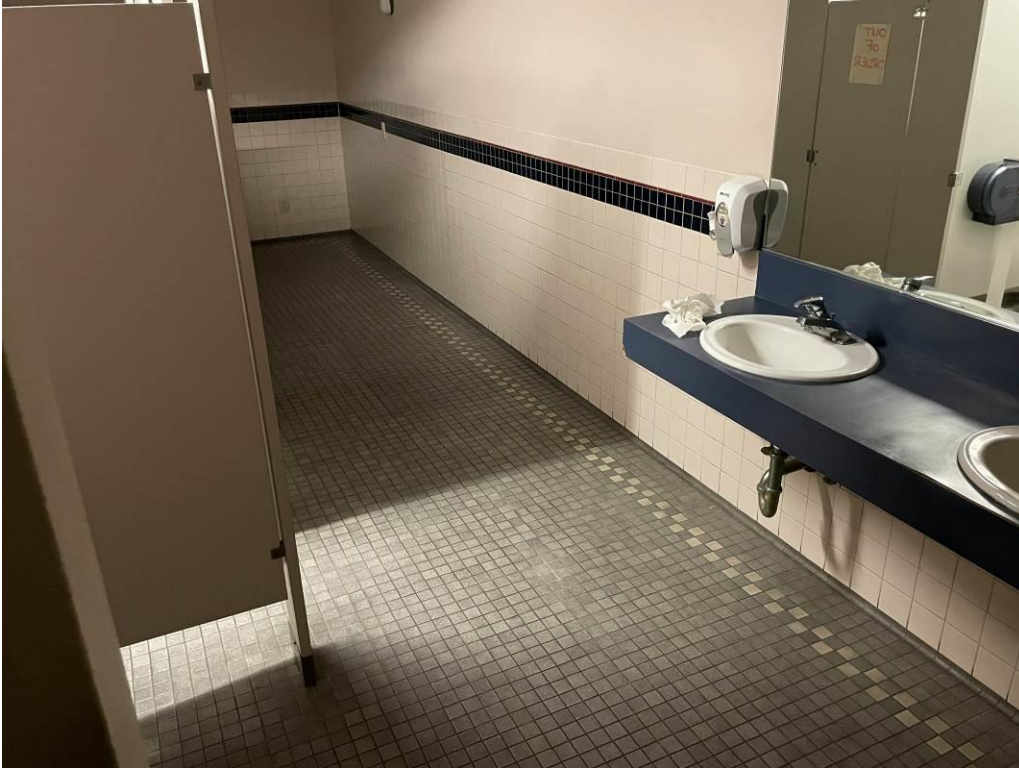
Photo 11: Assumed asbestos containing ceramic floor and wall tile mastic located in the restrooms.

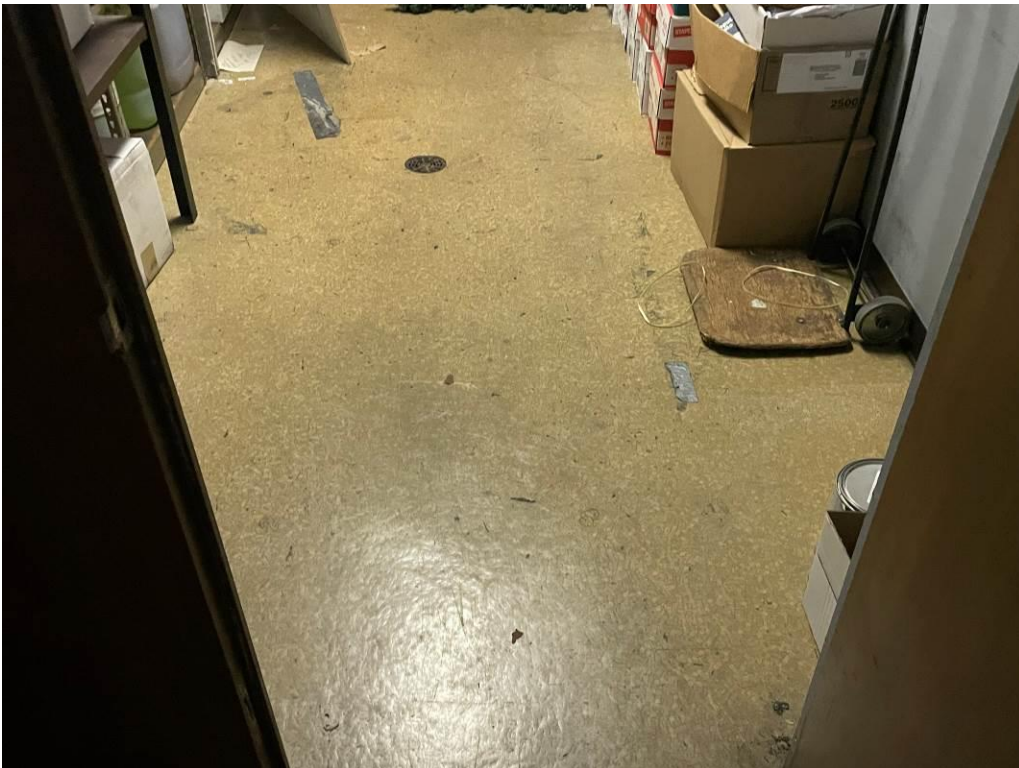
Photo 12: Asbestos containing SVF in the Plate Making storage room.

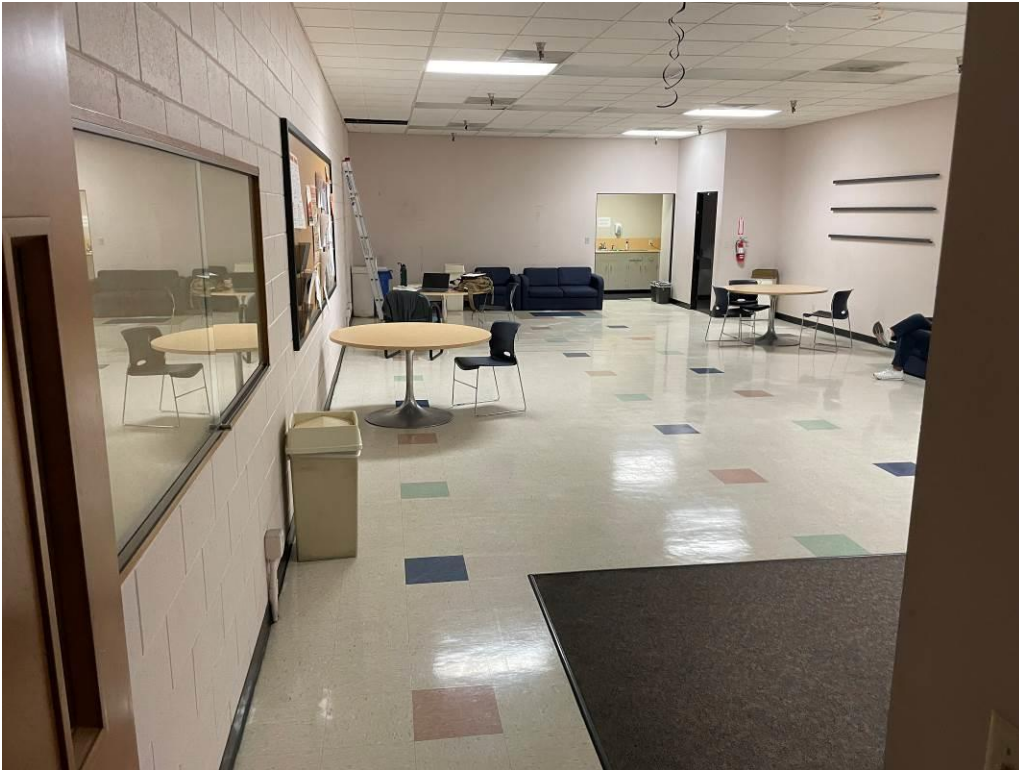
Photo 13: Lunchroom facing east. The VFT and mastic are negative for asbestos.
