## Notice of Intent to Remove Asbestos

Case #: 25-005

Site Name: Date park Condominiums

Site address: 3701 & 3701 1/2 E 18th St

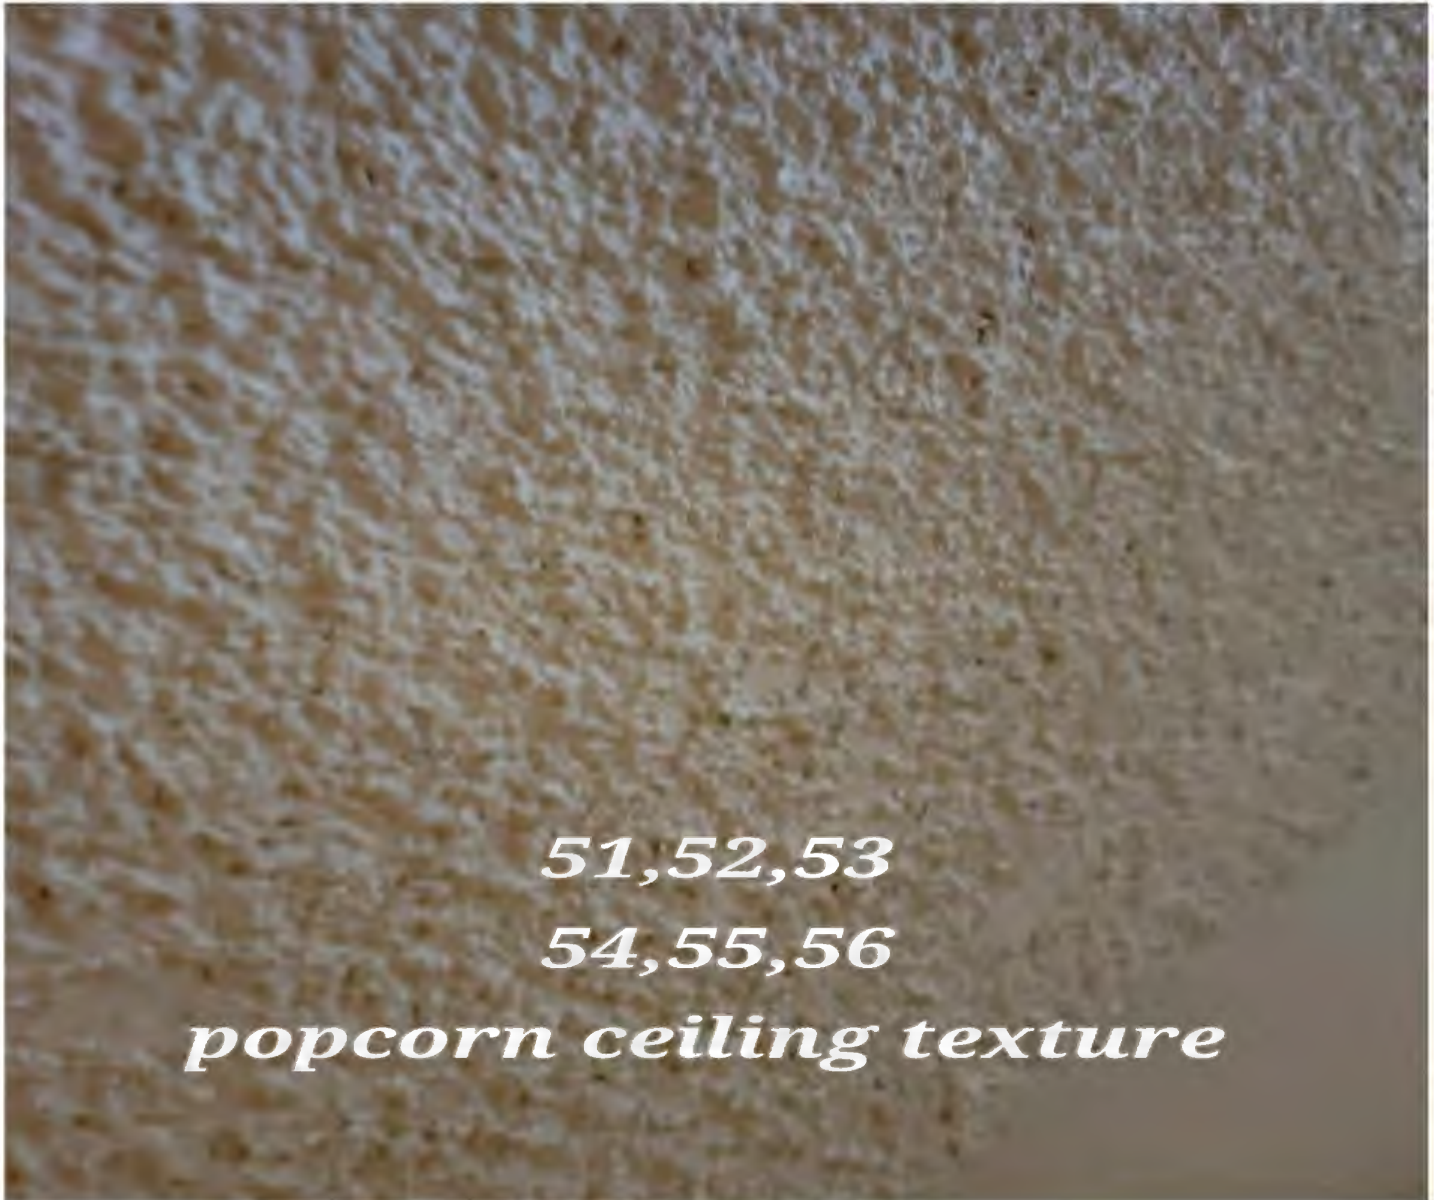
*51,52,53*  
*54,55,56*  
*popcorn ceiling texture*

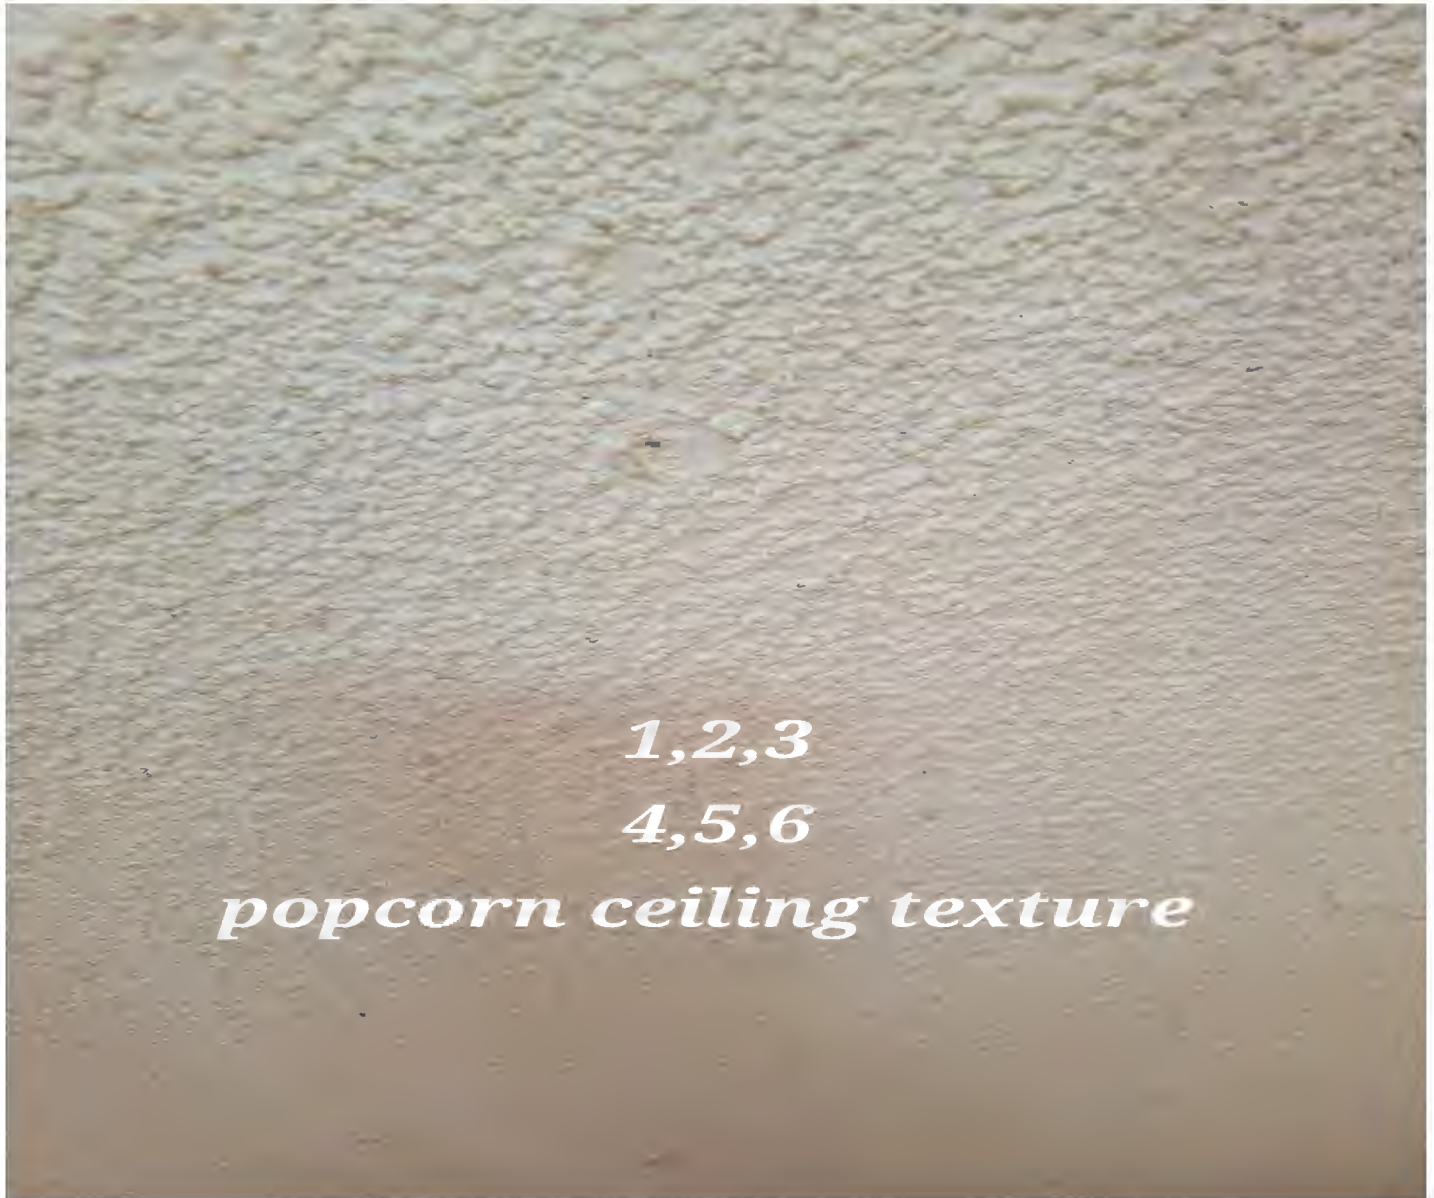
*1,2,3  
4,5,6  
popcorn ceiling texture*
