### **Notification of Demolition**

### Asbestos Containing Materials Inspection

13018 NE 71st Ave. Project:

RE: Pre-Demolition Good Faith Asbestos Survey

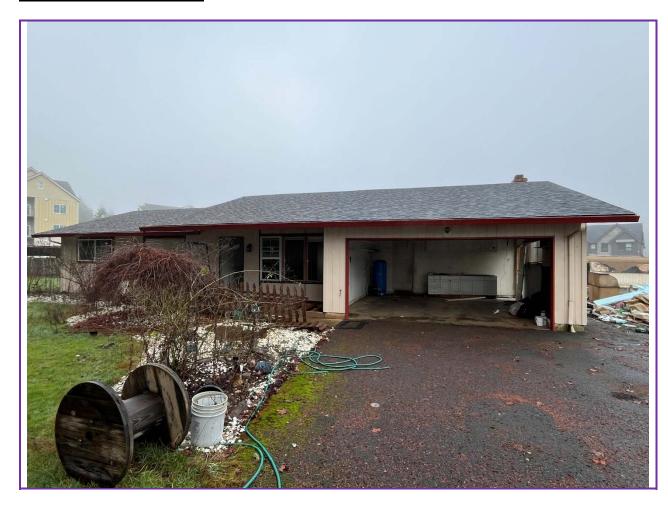
### FRONT OF STRUCTURE

The structure was a wood framed single family residence. The home was on a concrete foundation with a attached garage with a concrete slab.

The exterior of home consisted of vinyl windows, wood siding, wood trim and asphalt type roofing shingles.
