Notice of Intent to Remove Asbestos

LIMITED ASBESTOS/LEAD SURVEY
Commercial Property

OYO Hotel
702 Harrison Street
Centralia, WA 98531

Project Number: N23-0316

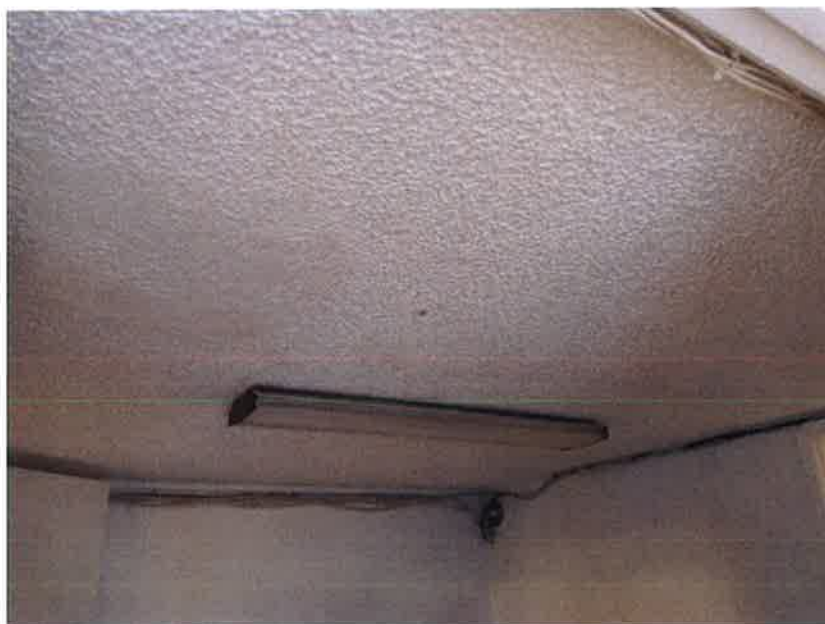
SM-1 SM-3

Description: Popcorn Ceiling Texture

Material Location: Throughout all Rooms first and Second Floors and the Lobby

Asbestos Content: 2% to 4%
Chrysotile

Friable: Yes

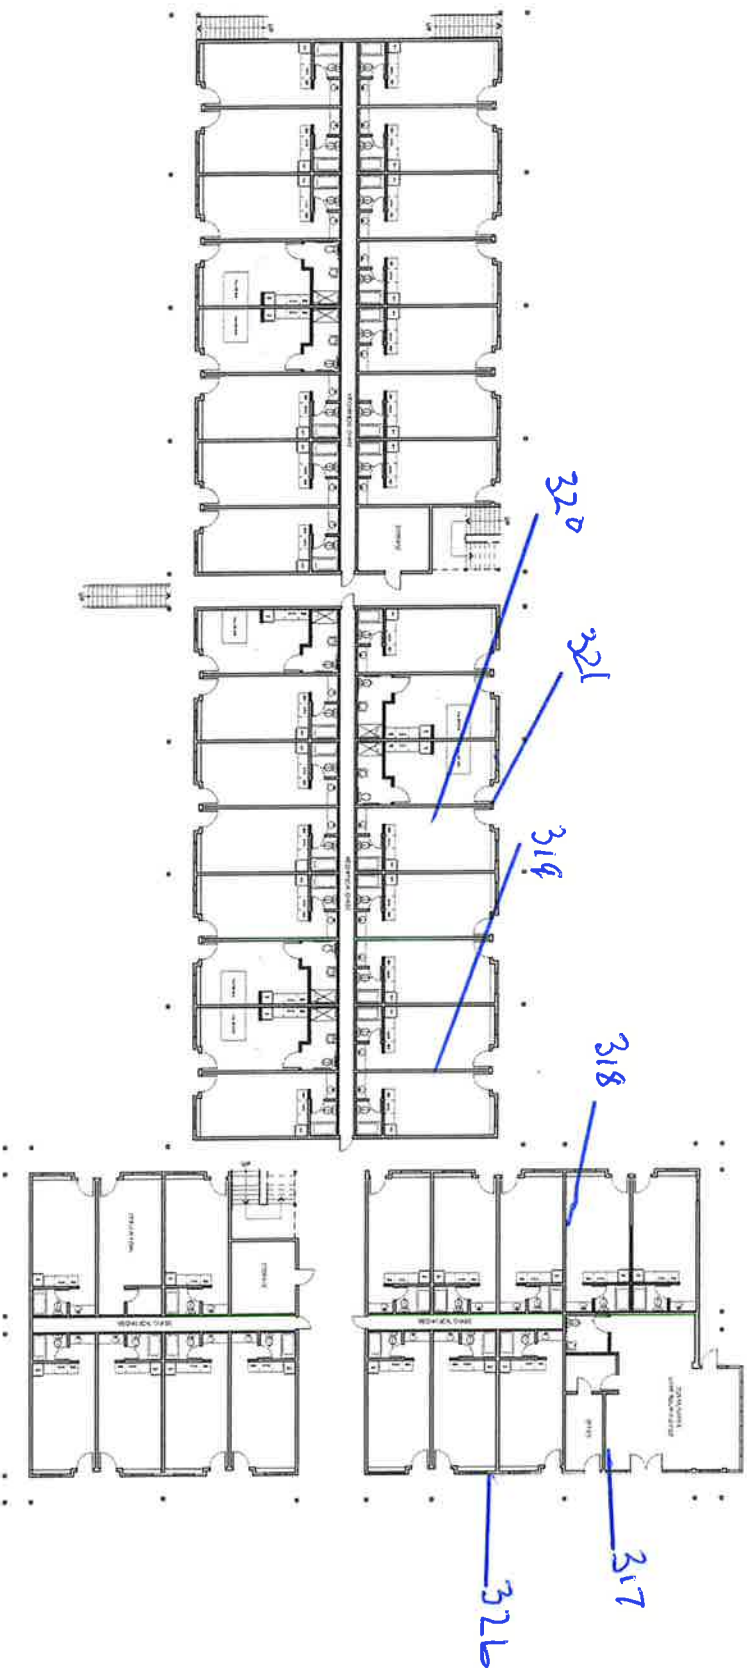
LEAD Sample Locations First Floor

Lead Paint was tested using a Nikon Lead Gun, work was performed by Mike McKay a certified Lead Risk Assesor (See Attached Certification) ten (10) shots were taken of the interior and exterior of the building with no detectable amount of lead found.
