Notice of Intent to Remove Asbestos

Asbestos Survey Report

Survey Location: 2022 Wind River Hwy, Carson, WA 98610 Office #2

Inspection Date: January 11th, 2024

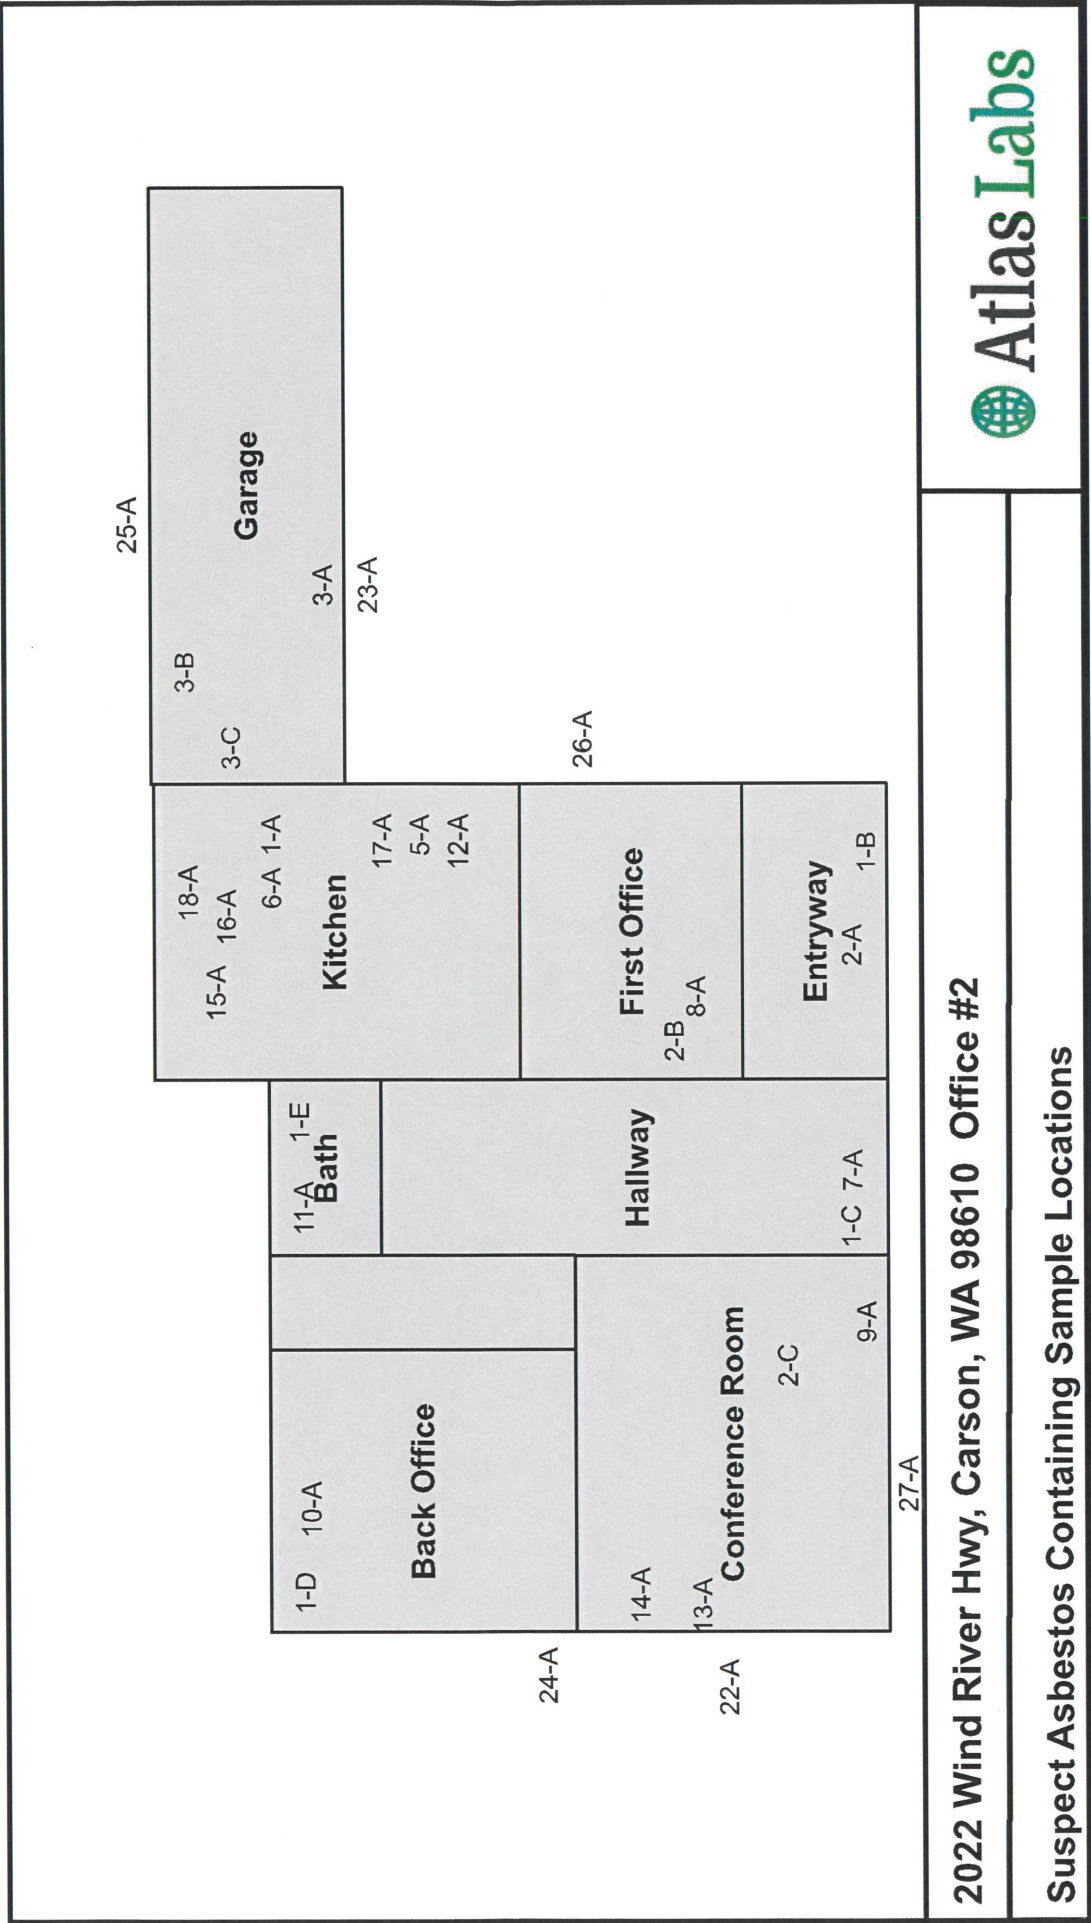
2022 Wind River Hwy, Carson, WA 98610 Office #2

Suspect Asbestos Containing Sample Locations

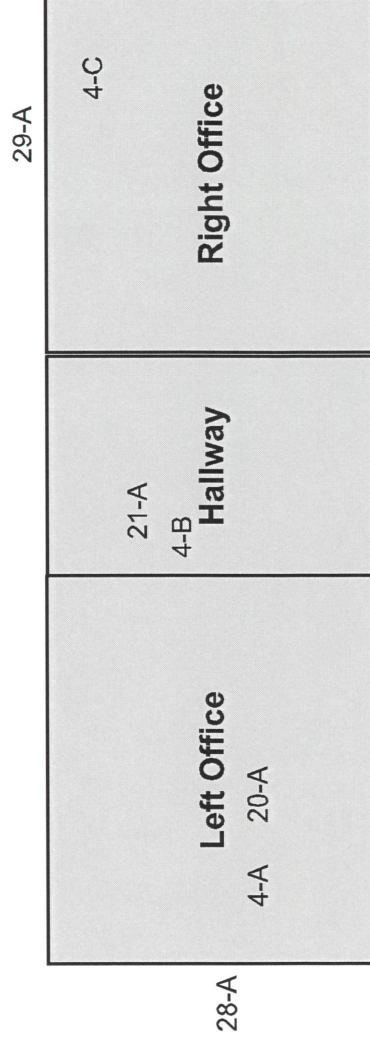
2022 Wind River Hwy, Carson, WA 98610 Office #2 - Upstairs

Suspect Asbestos Containing Sample Locations
