Notice of Intent to Remove Asbestos

“Good Faith” Asbestos Survey Report

**Located at:
1206 Rush Rd.
Napavine, WA 98532**

January 10, 2024

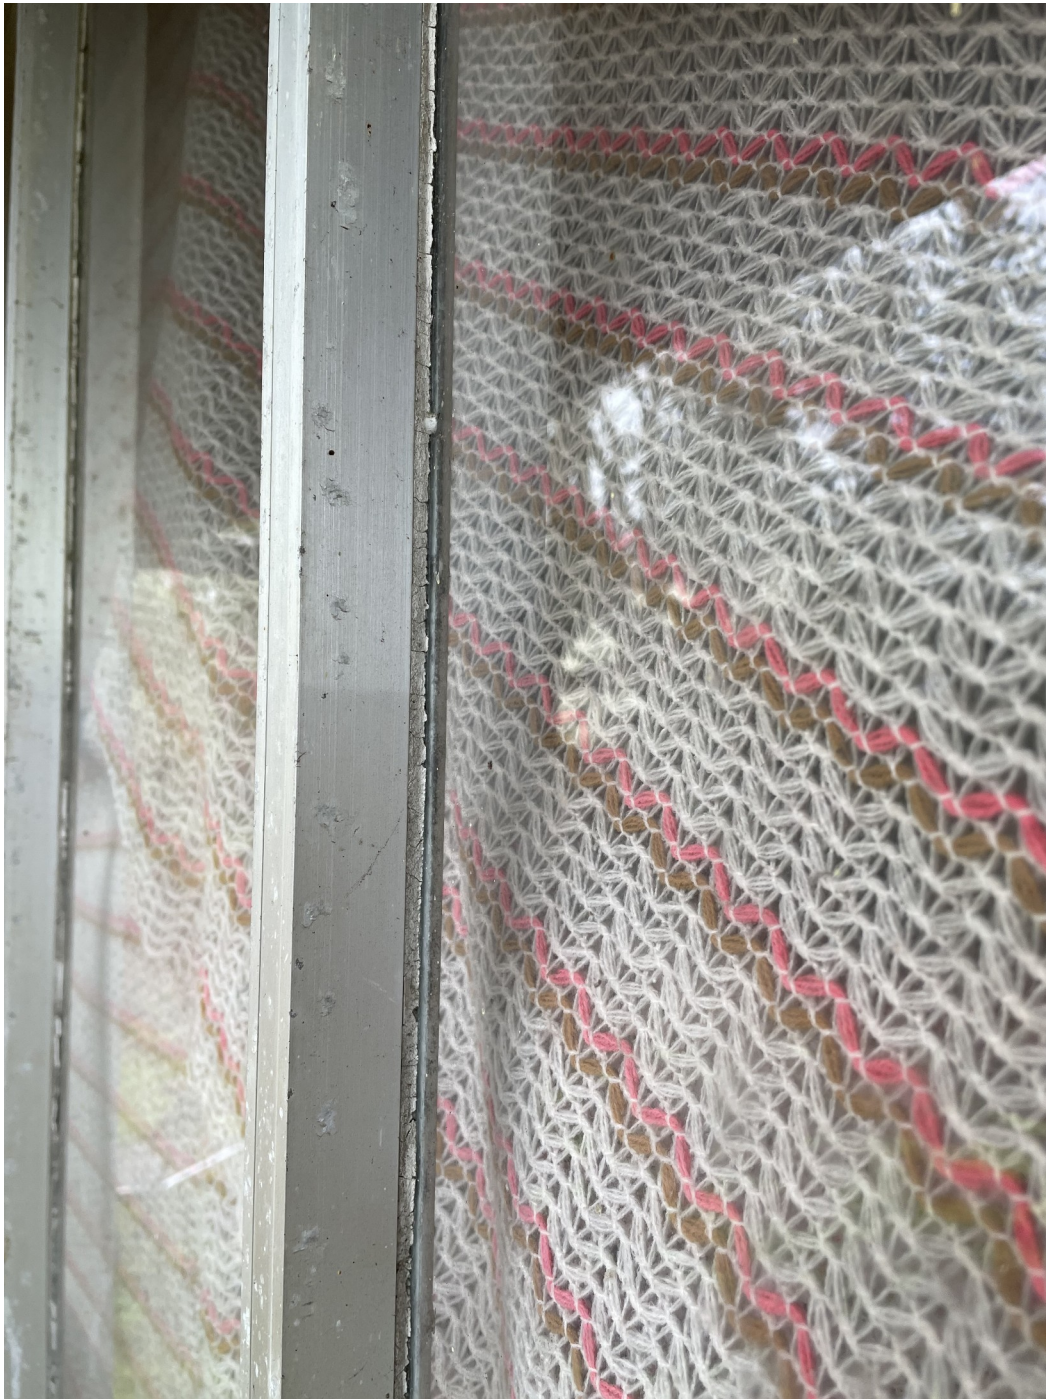
Sample Numbers	Material	Location of Material	Approximate Quantity
R-13	Putty	House & Pump House Window Putty	5 @ 30 square feet each = Total: 150 square feet
R-14	Putty	House & Pump House Window Putty	5 @ 30 square feet each = Total: 150 square feet
R-15	Putty	House & Pump House Window Putty	5 @ 30 square feet each = Total: 150 square feet

R-13 – R-15: Putty – House & Pump House Window Putty

Regulated ACM are required to be handled in accordance with Washington State Regulations prior to any demolition, renovation, or remodeling that would disturb these materials. Washington State Department of Labor and Industries require that the abatement be performed using Certified Asbestos Workers under the direct on site supervision of an Asbestos Supervisor. The only exemption of this is for residential owners performing removal of asbestos materials other than furnace interiors, or direct applied mudded asbestos insulation. The requirements for handling, packaging, and disposing of asbestos-containing materials can be found in WAC Chapter 296-62, Volume I, Part I-1.
