# Notice of Intent to Remove Asbestos

## **Asbestos Survey Report**

**Survey Location: 318 S Maple Hill Rd, Kelso, WA 98626**

**Inspection Date: February 9th 2024**

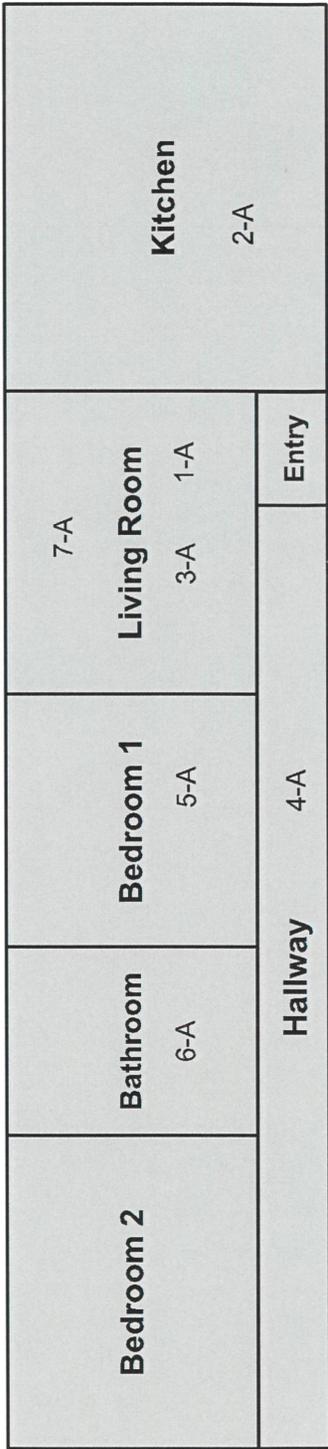
Suspect Asbestos Containing Sample Locations

318 S Maple Hill Rd, Kelso, WA 98626
