ASBESTOS SURVEY

For the mobile home located at:

**4717 NE 372ND STREET
LA CENTER, WASHINGTON**

**CERTIFIED ENVIRONMENTAL CONSULTING, LLC
615 SE CHKALOV DRIVE SUITE 12
VANCOUVER, WASHINGTON 98683-5280**

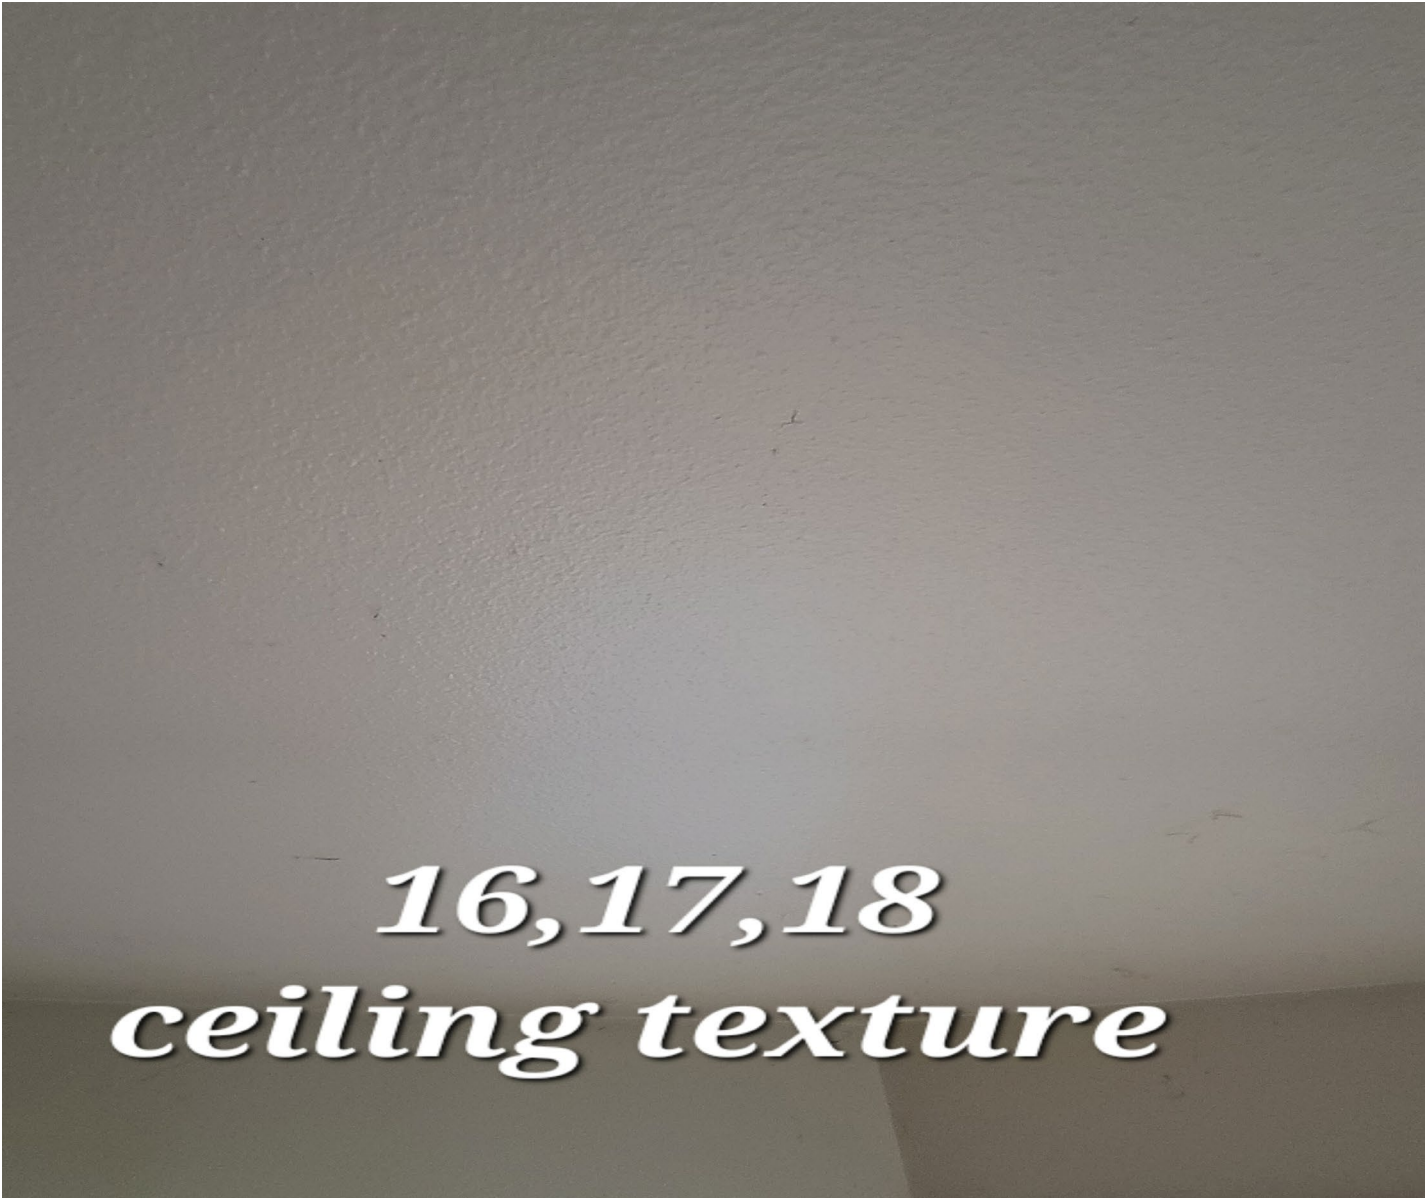
*16,17,18
ceiling texture*
