## Notification of Demolition

Case #: 24-134

## **Asbestos Northwest, LLC - Survey Report**

**Survey Location: 2126 Gallagher Rd Centralia WA**

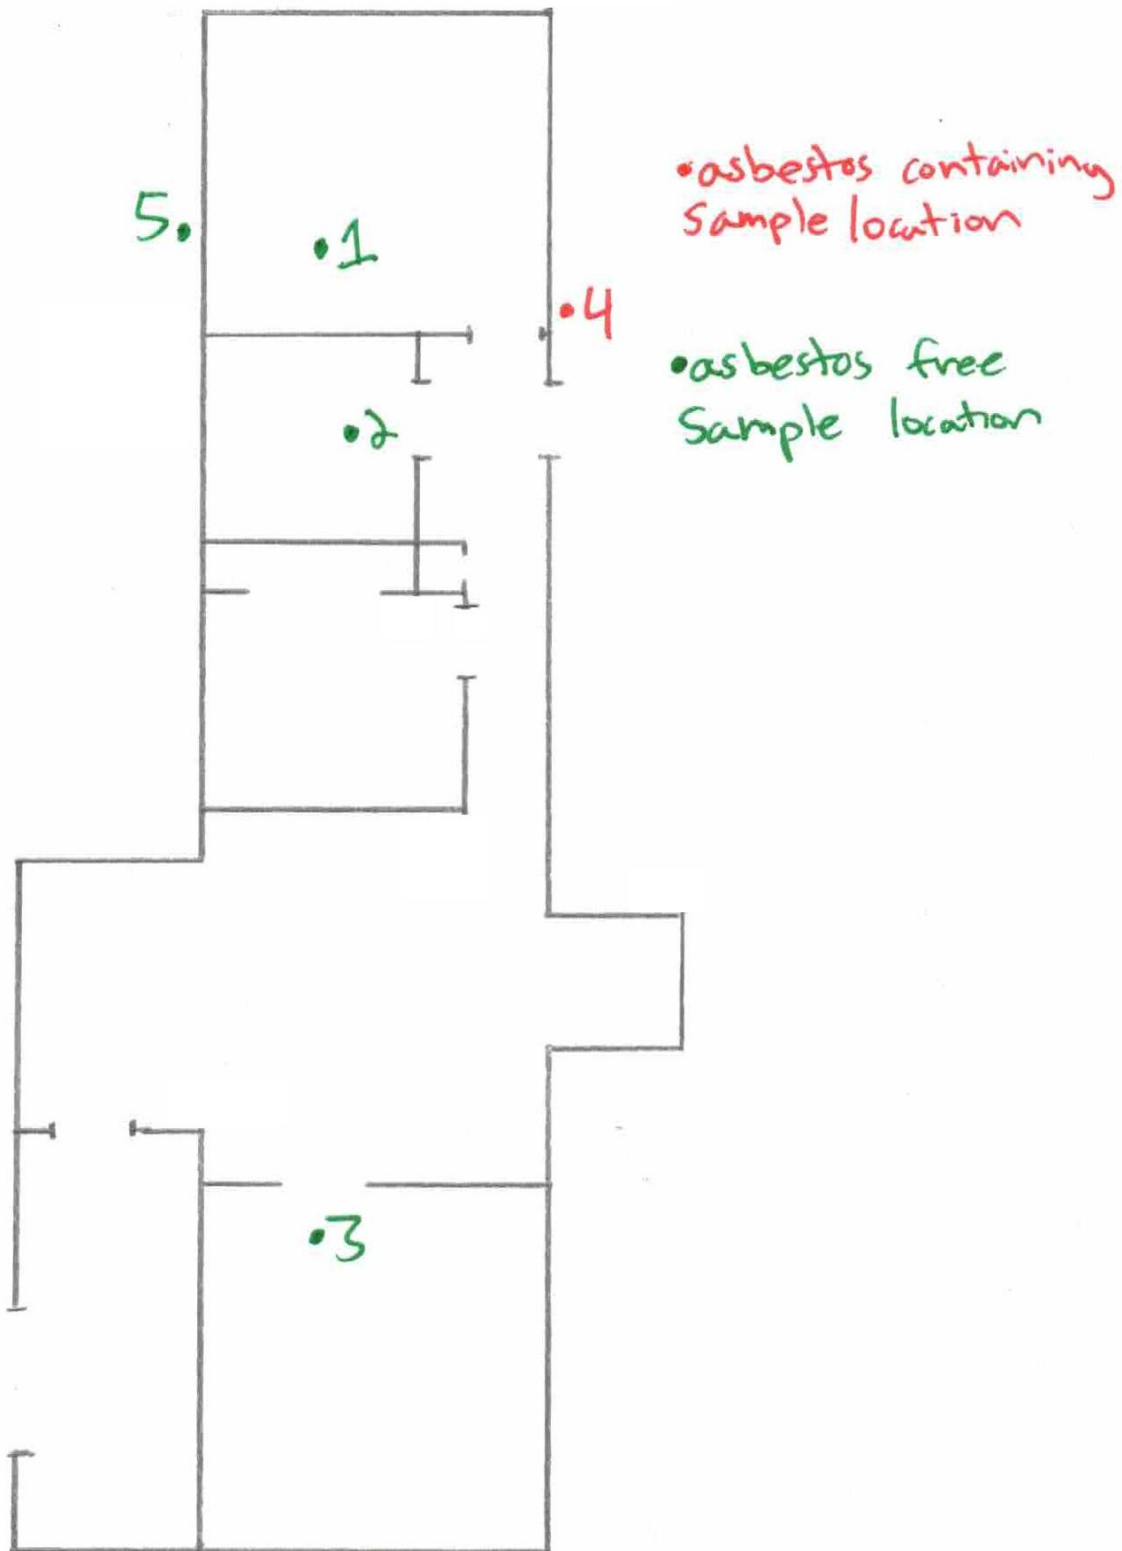
## Appendix B – Building Layout

The building had been through some alterations in the past, this included both the addition of porch and the construction of a pitched roof. There was no clear distinction between different eras of work or types of materials in use. For the purposes of this inspection the structure was considered to be a single homogenous area. Samples were taken from the interior and exterior of the building. All areas of the building were accessible to the inspector with the exception of the covered portions of the original roof. See the attached layout drawing with sample locations in Appendix B.

Description and Asbestos Type	Material Type and Estimated Quantity	Locations
Silver Paint <b>Point Counted 5.50% Chrysotile Asbestos</b>	Non-Friable Miscellaneous Material ~850ft <sup>2</sup>	<b>4- Original Roof Edge</b>

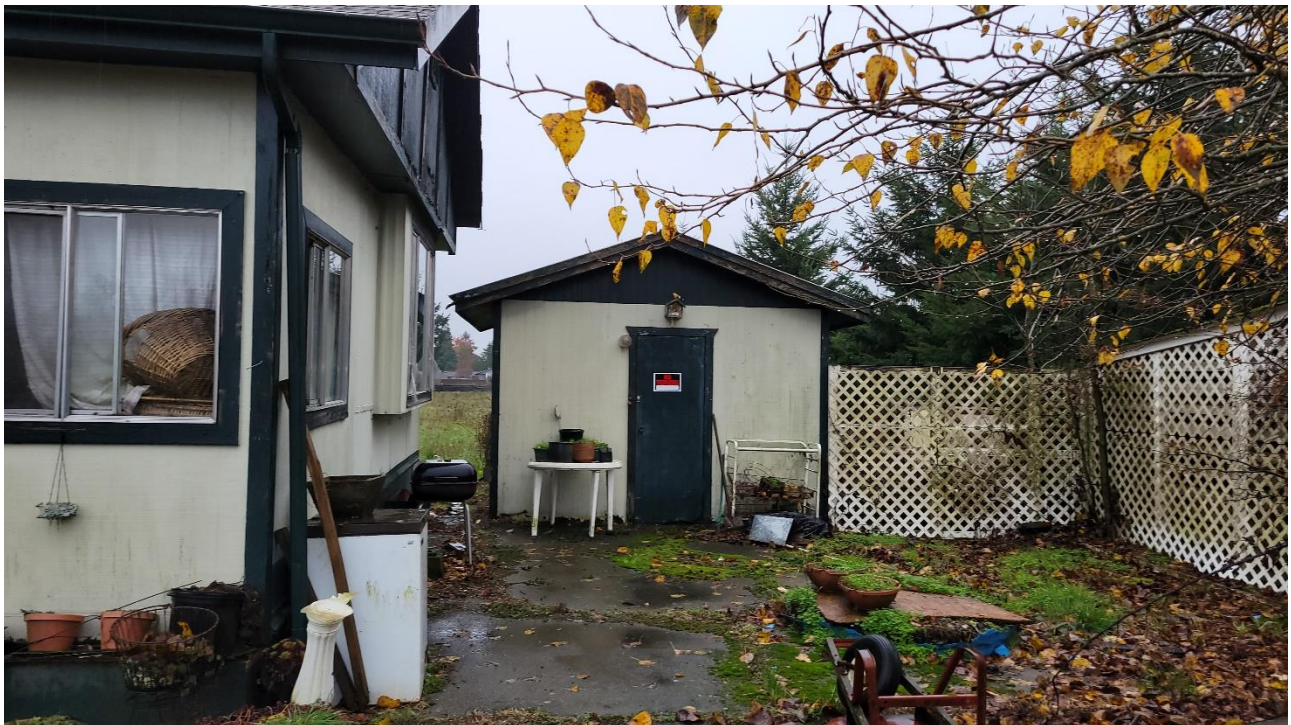
Shed

A small wooden shed was located to the side of the residence, but no other structures were associated with this home. The shed was of simple construction and contained no suspect building materials. It was distinctly newer than the home itself.
