Notification of Demolition

Case #: 24-136

“Good Faith” Asbestos Survey Report

**Located at:
113 Kennicott Rd.
Chehalis, WA 98532**

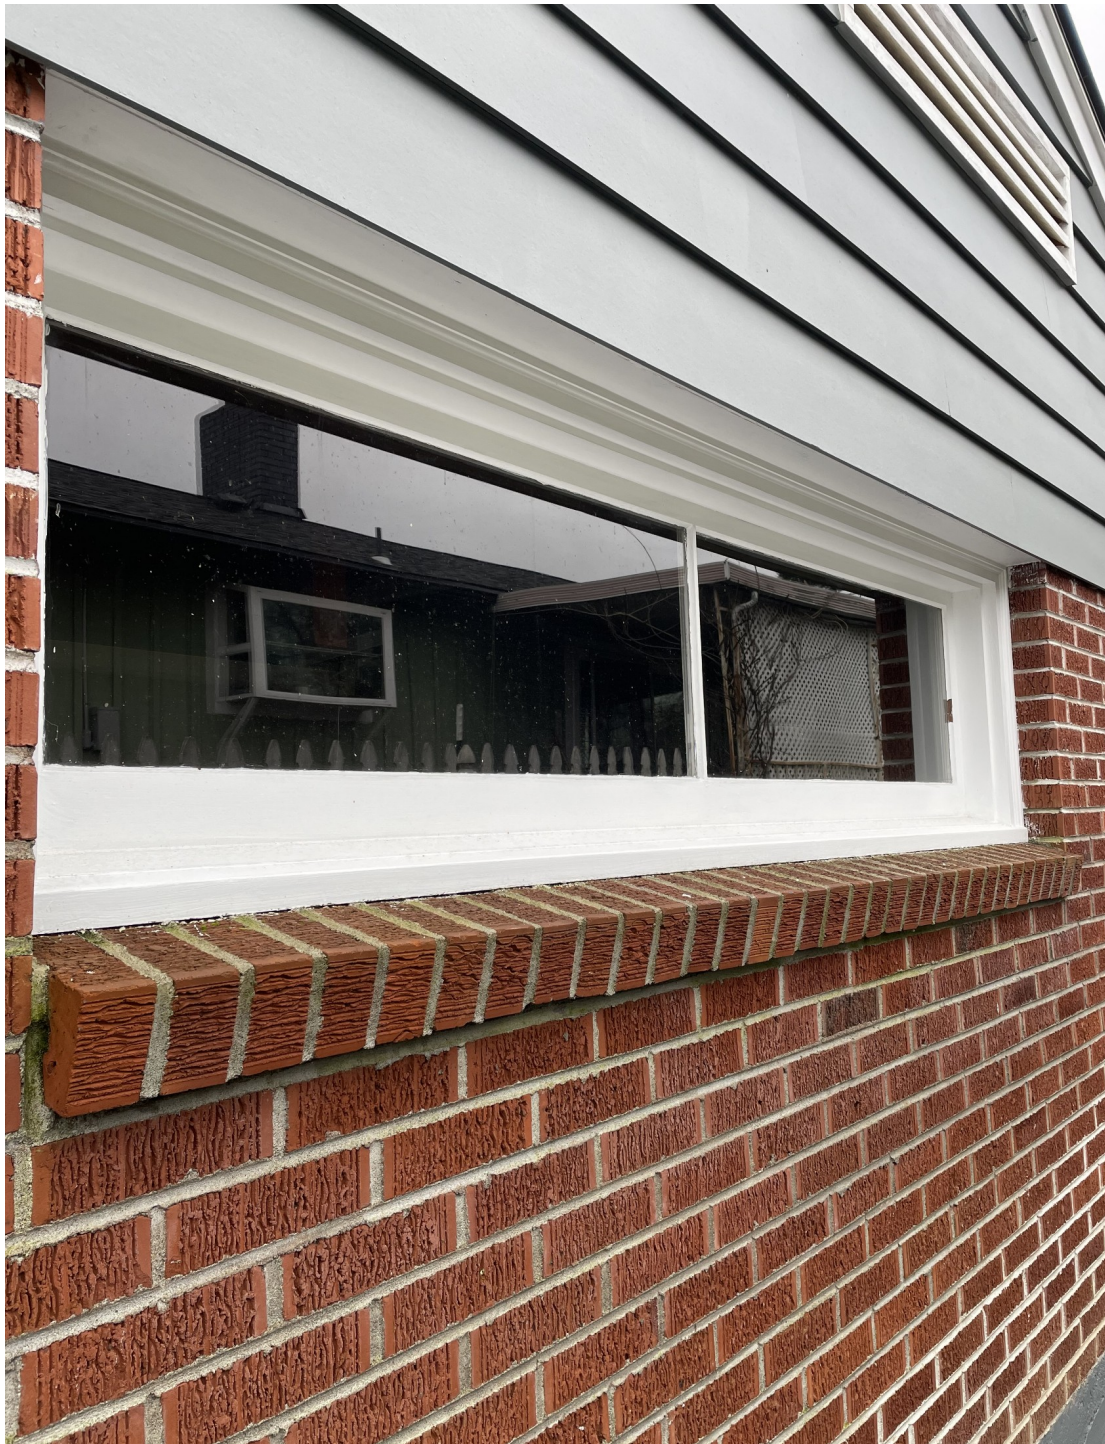
Sample Numbers	Material	Location of Material	Approximate Quantity
K-7 – K-9	Glaze	Garage Window System	1 Window – 16 Square Feet

K-7 – K9: Glaze – Garage Window System

Regulated ACM are required to be handled in accordance with Washington State Regulations prior to any demolition, renovation, or remodeling that would disturb these materials. Washington State Department of Labor and Industries require that the abatement be performed using Certified Asbestos Workers under the direct on site supervision of an Asbestos Supervisor. The only exemption of this is for residential owners performing removal of asbestos materials other than furnace interiors, or direct applied mudded asbestos insulation. The requirements for handling, packaging, and disposing of asbestos-containing materials can be found in WAC Chapter 296-62, Volume I, Part I-1.

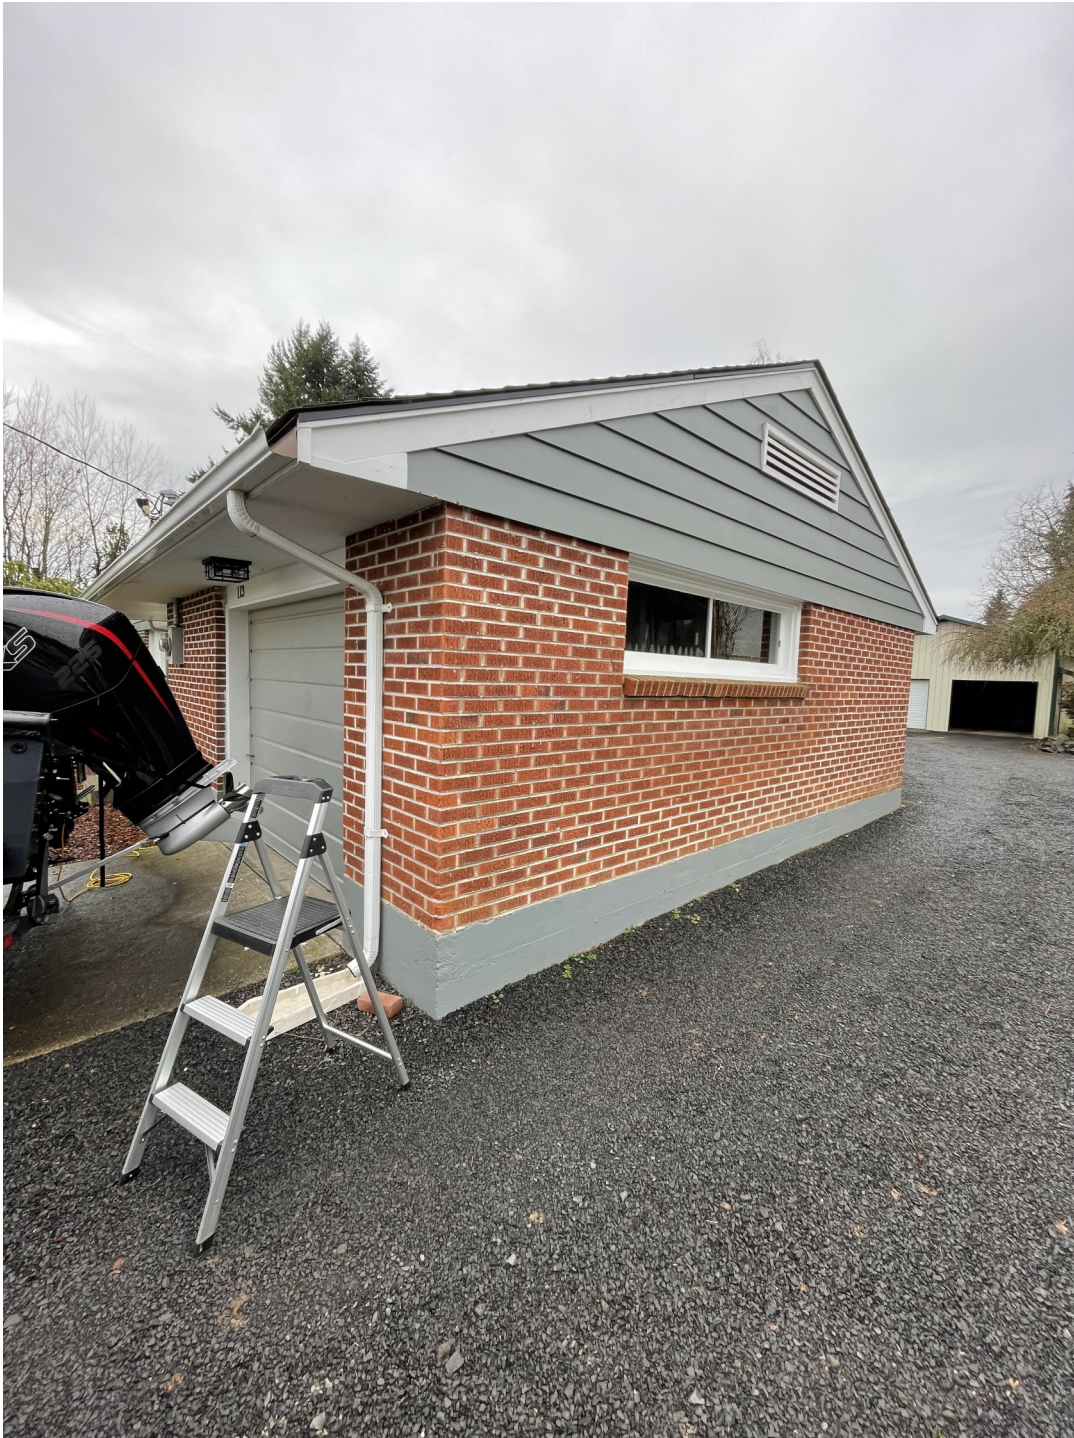
K-11 – Brick & Mortar – Garage Siding System
