## Notice of Intent to Remove Asbestos

## **“Good Faith” Asbestos Survey Report**

**Located at:  
113 Kennicott Rd.  
Chehalis, WA 98532**

**February 7, 2024**

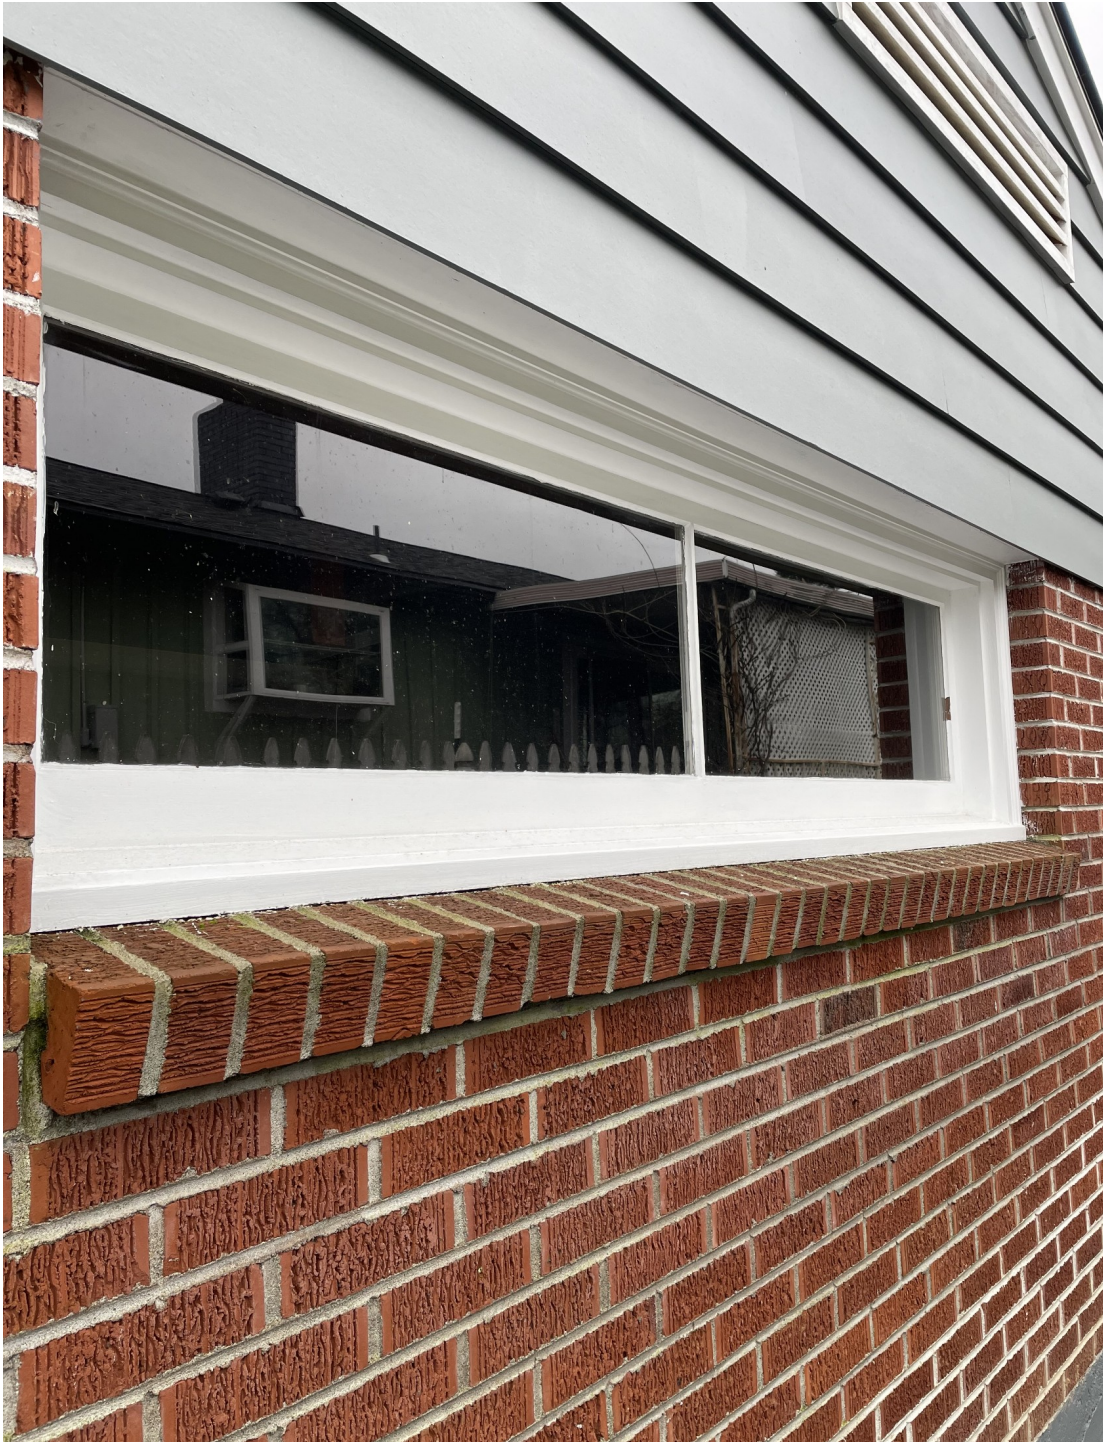
**K-7 – K9: Glaze – Garage Window System**

Sample Numbers	Material	Location of Material	Approximate Quantity
K-7 – K-9	Glaze	Garage Window System	1 Window – 16 Square Feet

Regulated ACM are required to be handled in accordance with Washington State Regulations prior to any demolition, renovation, or remodeling that would disturb these materials. Washington State Department of Labor and Industries require that the abatement be performed using Certified Asbestos Workers under the direct on site supervision of an Asbestos Supervisor. The only exemption of this is for residential owners performing removal of asbestos materials other than furnace interiors, or direct applied mudded asbestos insulation. The requirements for handling, packaging, and disposing of asbestos-containing materials can be found in WAC Chapter 296-62, Volume I, Part I-1.
