Notice of Intent to Remove Asbestos

Asbestos Survey Report

Survey Location: 111 NE 95th Ave, Vancouver, WA 98664

Inspection Date: April 5th, 2023

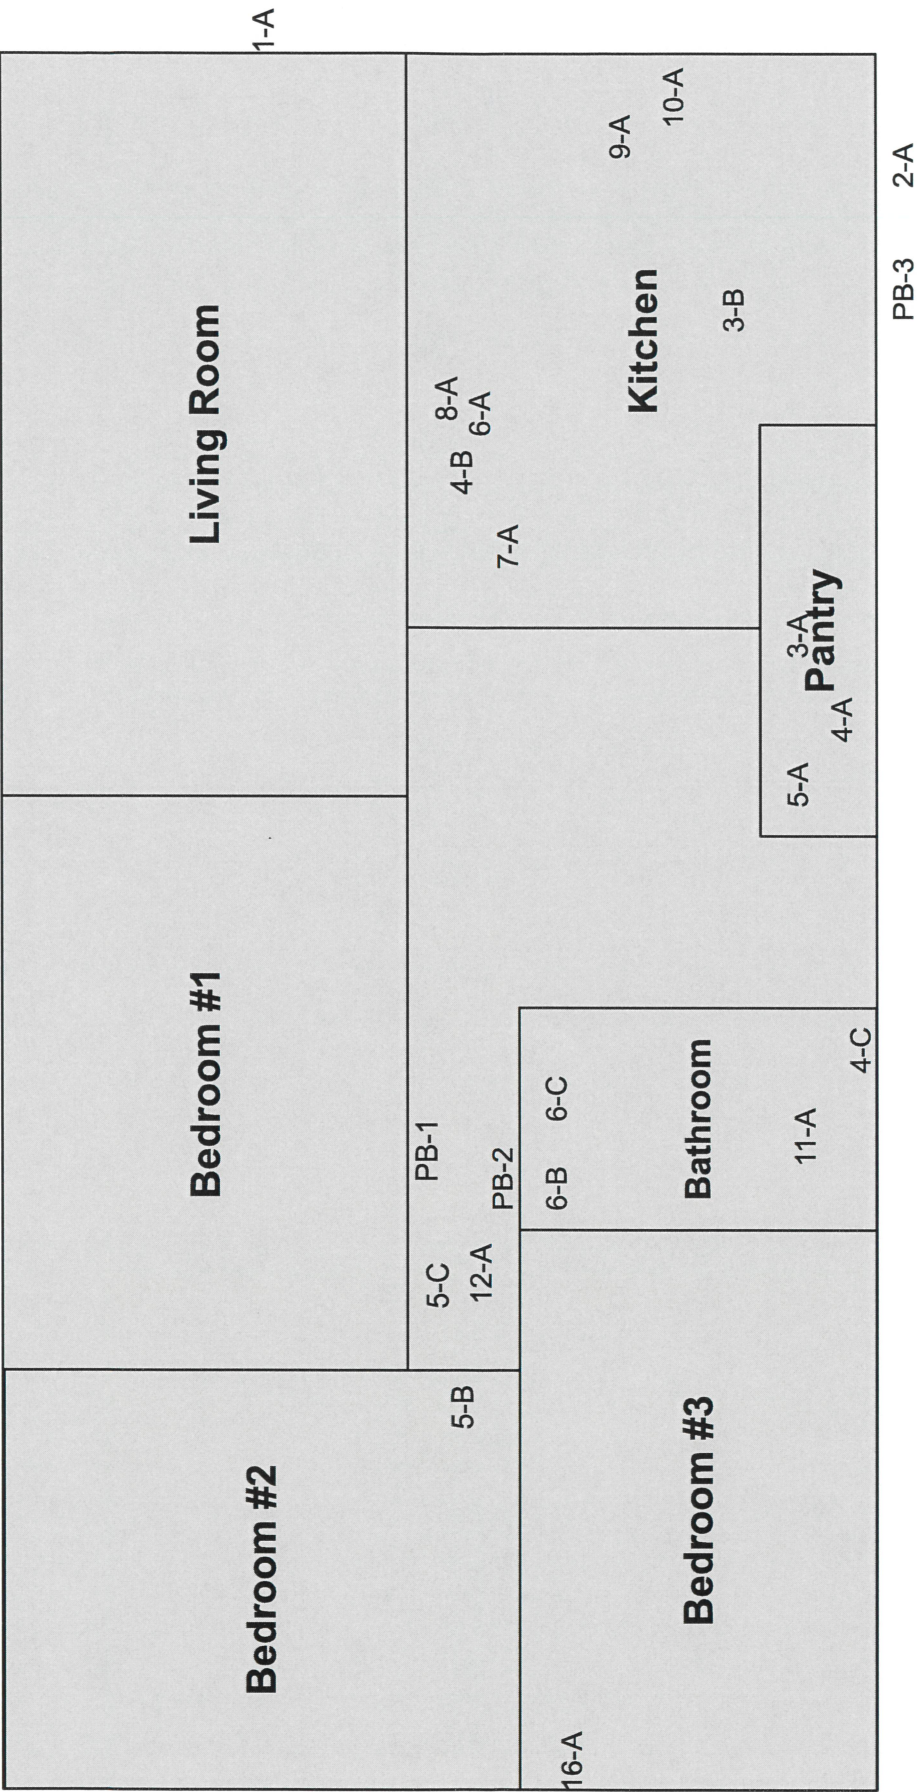
Suspect Asbestos Containing Sample Locations

111 NE 95th Ave, Vancouver, WA 98664

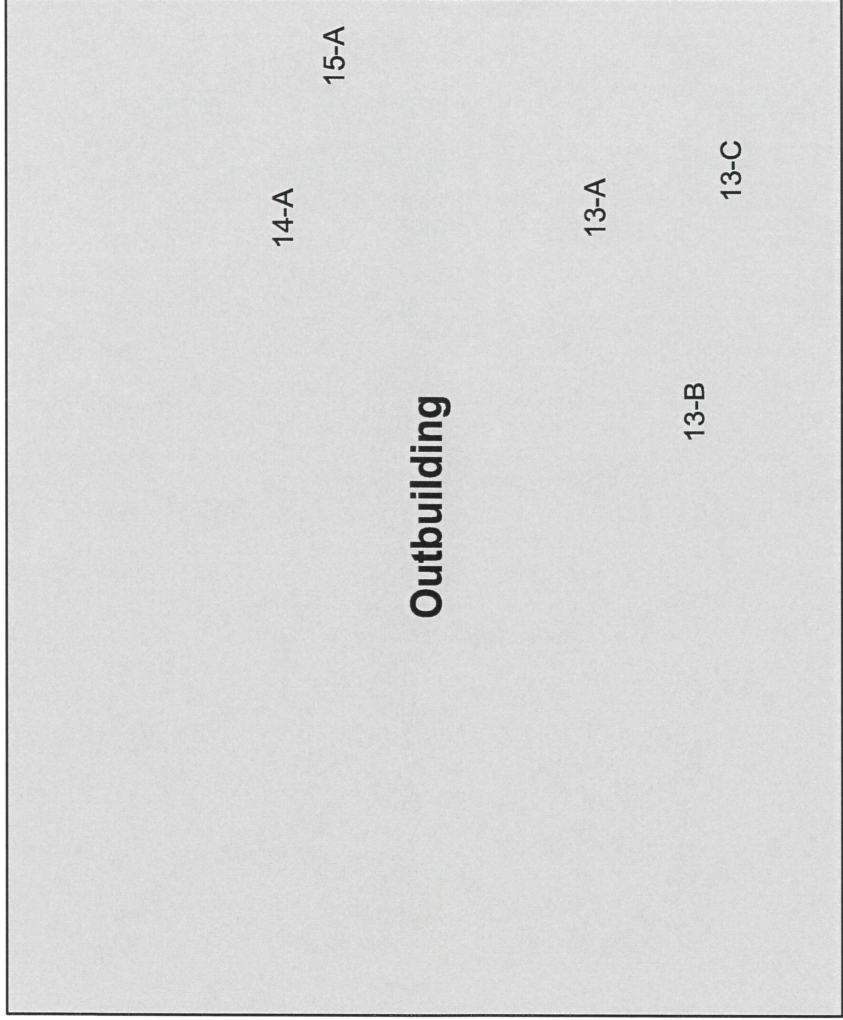
111 NE 95th Ave, Vancouver, WA 98664 - Outbuilding		  Atlas Labs
Suspect Asbestos Containing Sample Locations
