## Notice of Intent to Remove Asbestos

### GENERAL CONDITION SURVEY

**DERRICK BARGE “BD-6065”**

Re: Navigation Base Float Crane—Pre-Renovation Hazardous Building Materials Survey

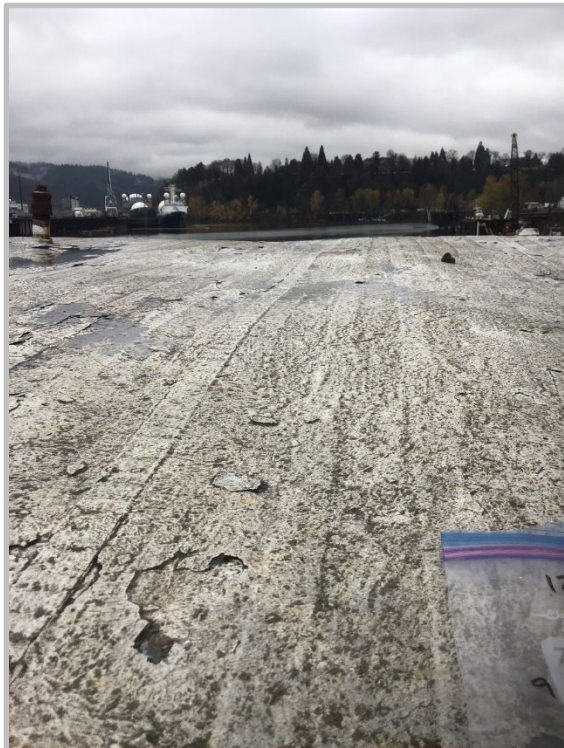
**Sample Name:** 10-ROOF-JT-15

**Assessment Category:** Asbestos-containing building material (ACBM) with potential for damage

**Quantity:** 600 square feet

Prior to any disturbance activities at the Property, identified hazardous materials should be abated by a licensed abatement contractor or safely managed in place consistent with a written operations and maintenance plan. The Port should inform contractors that other hazardous materials or conditions may be discovered during the renovation and/or demolition activities, which may warrant remediation and/or corrective actions.

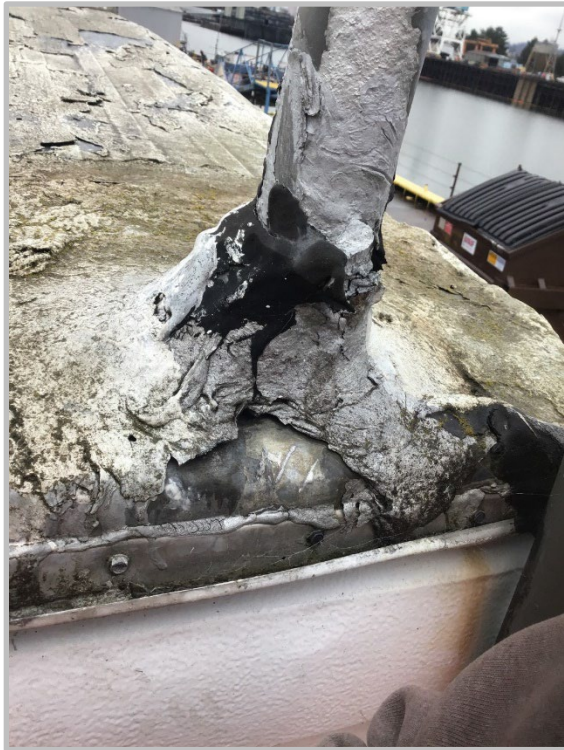
**Sample Name:** 9-ROOF-JT-16

**Assessment Category:** ACBM with potential for damage

**Quantity:** Less than 5 square feet

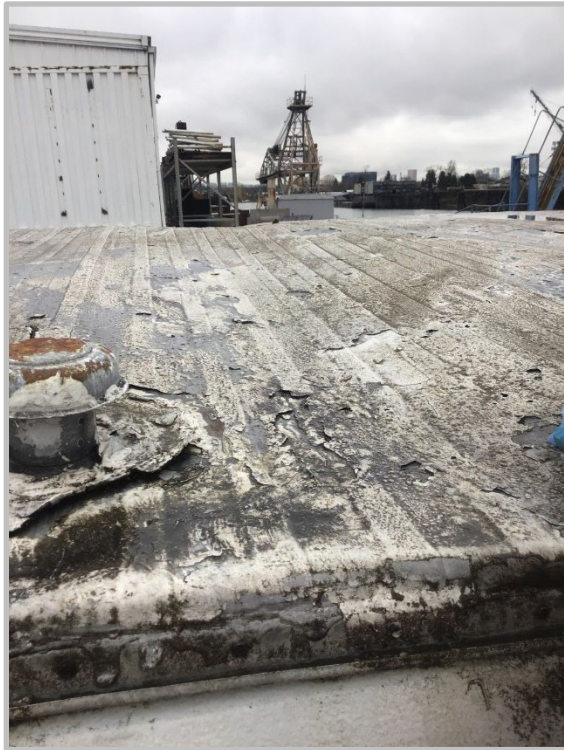
**Sample Name:** 1-FTM-BD6065-1

**Assessment Category:** ACBM with potential for damage

**Quantity:** Less than 5 square feet

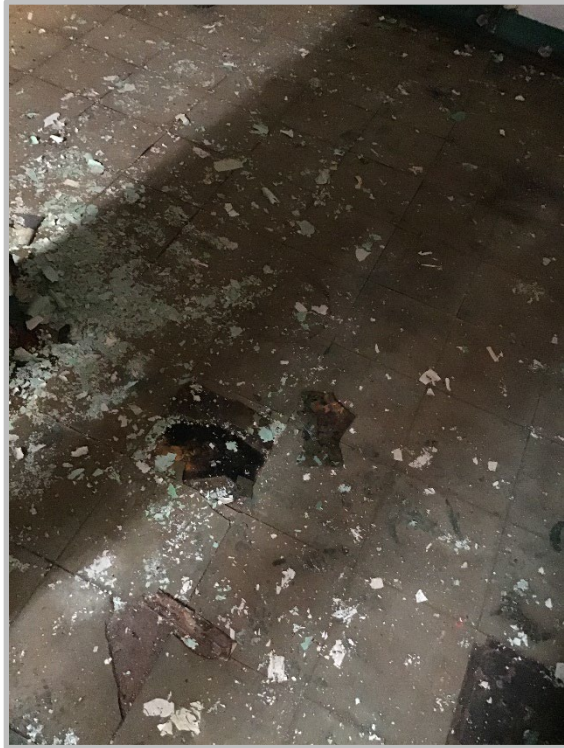
**Sample Name:** 1-FTM-BD6065-2

**Assessment Category:** ACBM with potential for damage

**Quantity:** 375 square feet

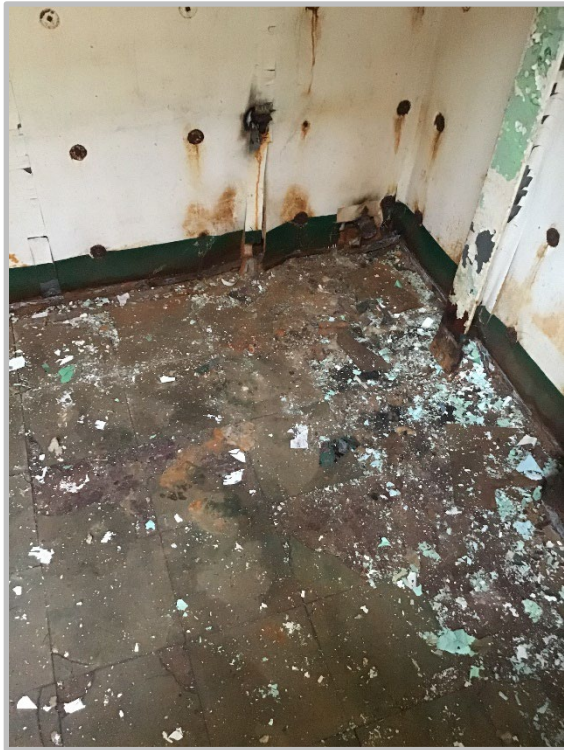
**Sample Name:** 5-PB-BD6065-8

**Assessment Category:** ACBM with potential for damage

**Quantity:** 375 square feet

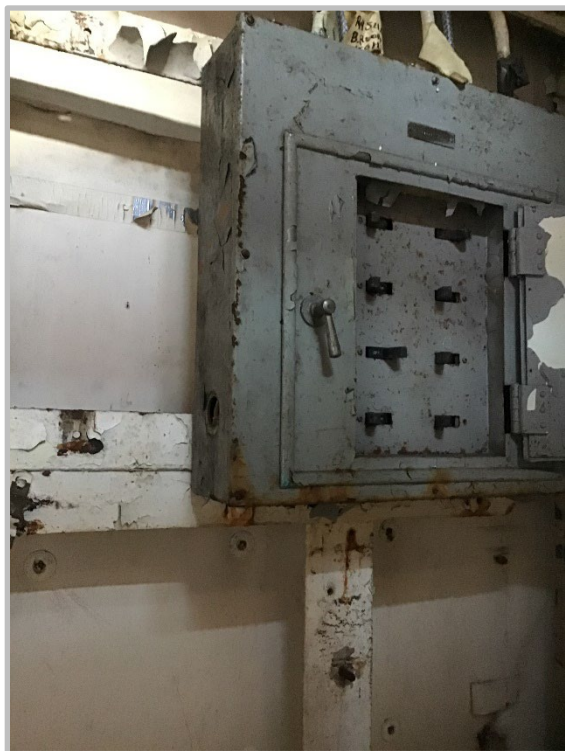
**Sample Name:** 6-PB-BD6065-10

**Quantity:** 6 square feet

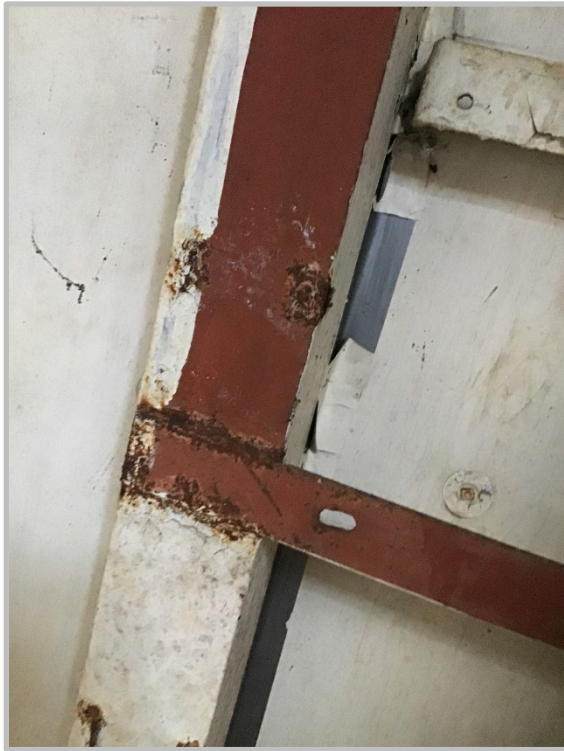
**Sample Name:** 7-PB-BD6065-11

**Quantity:** 2 square feet

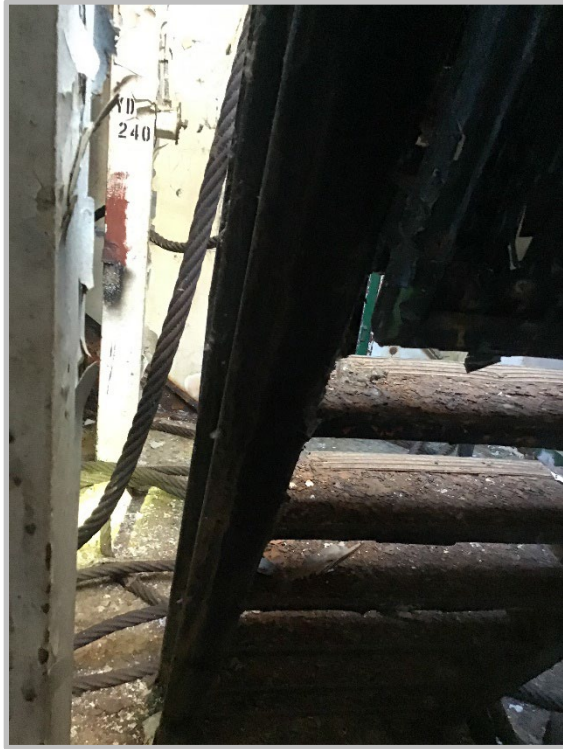
**Sample Name:** 7-PB-BD6065-12

**Quantity:** 80 square feet

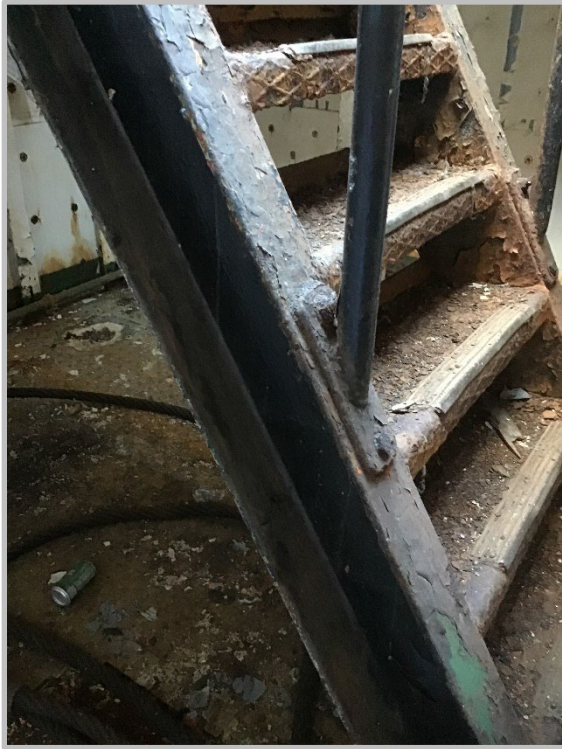
**Sample Name:** 9-PB-BD6065-14

**Quantity:** 80 square feet

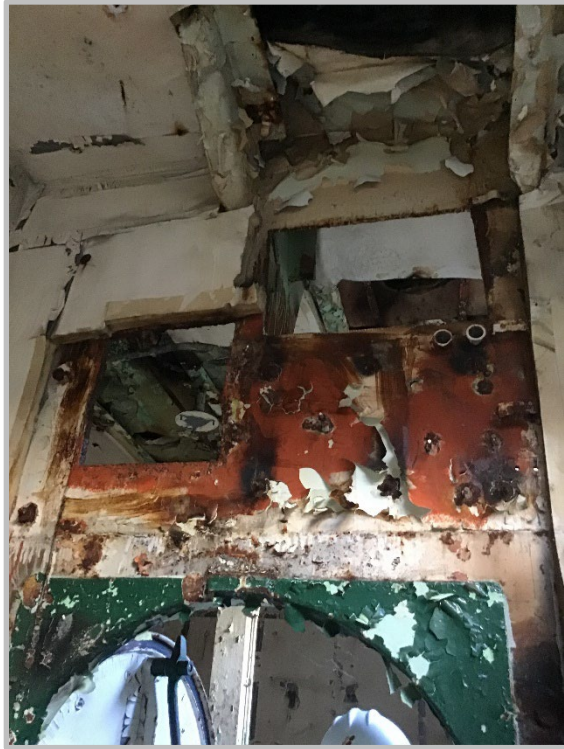
**Sample Name:** 9-PB-BD6065-15

**Quantity:** 4 square feet

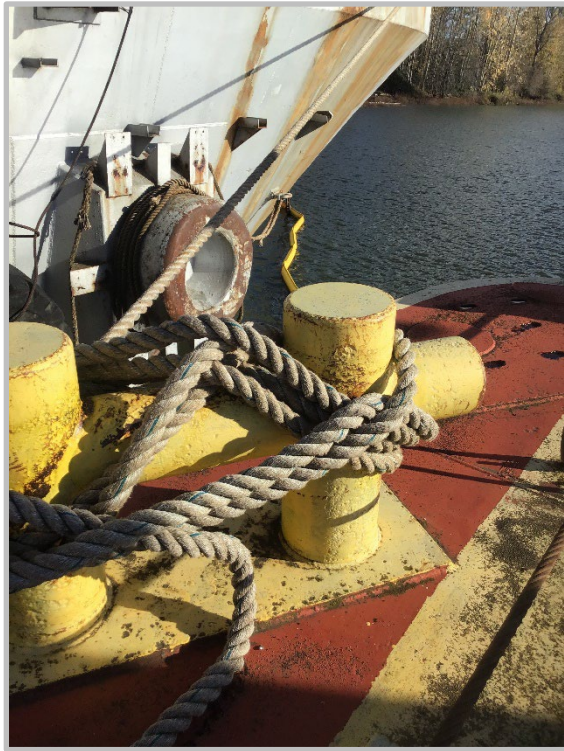
**Sample Name:** 13-PB-BD6065-20

**Quantity:** 200 square feet

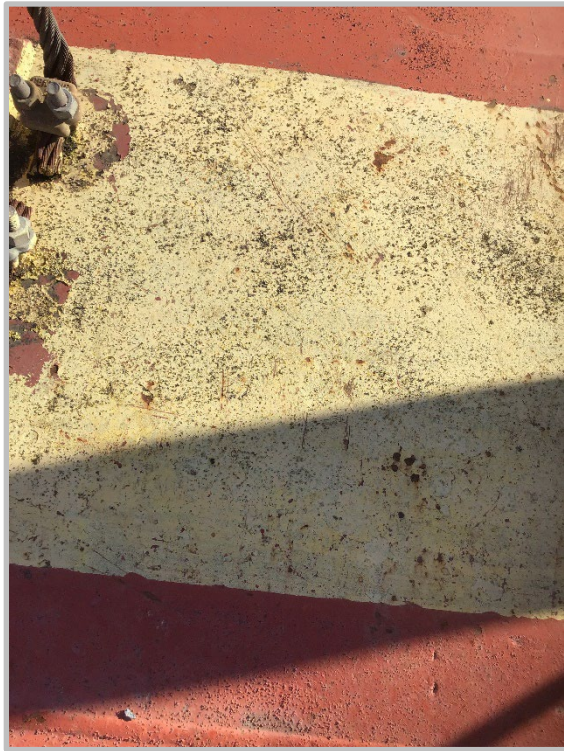
**Sample Name:** 12-PB-BD6065-31

**Quantity:** 400 square feet

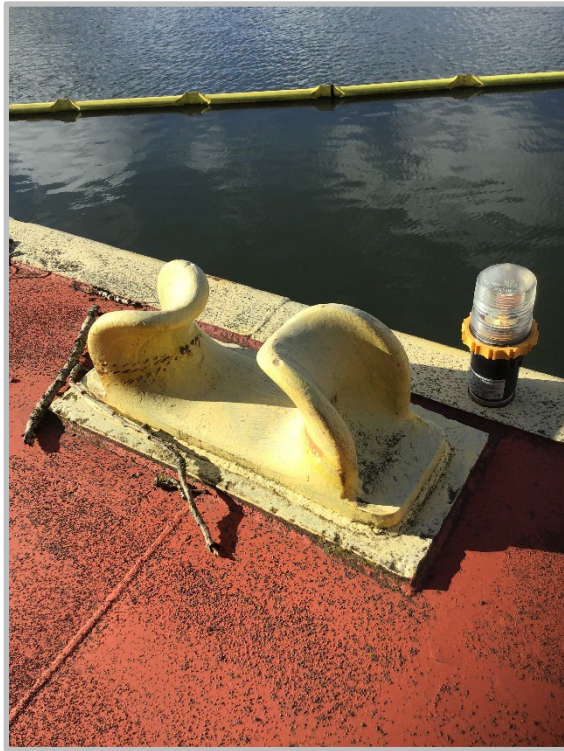
**Sample Name:** 13-PB-BD6065-32

**Quantity:** 200 square feet

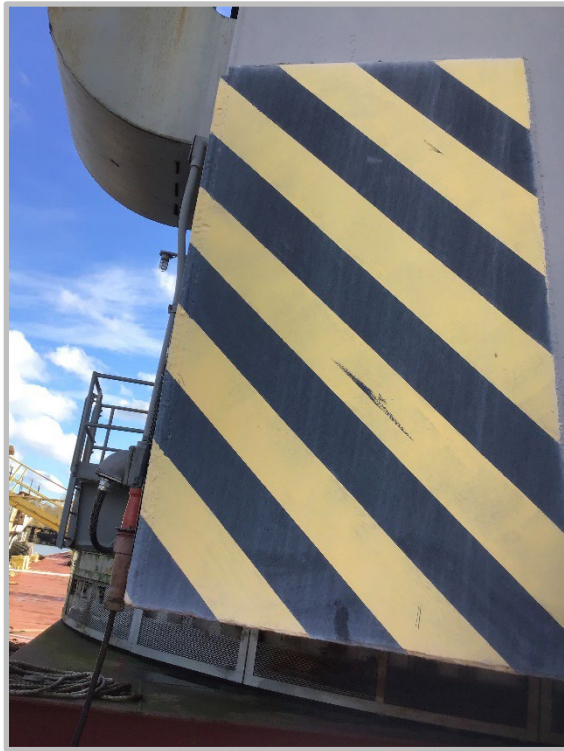
**Quantity:** 32 square feet
