Notification of Demolition

ASBESTOS SURVEY

**610 WEST 27TH STREET
VANCOUVER, WASHINGTON**

LIMITED ASBESTOS SURVEY

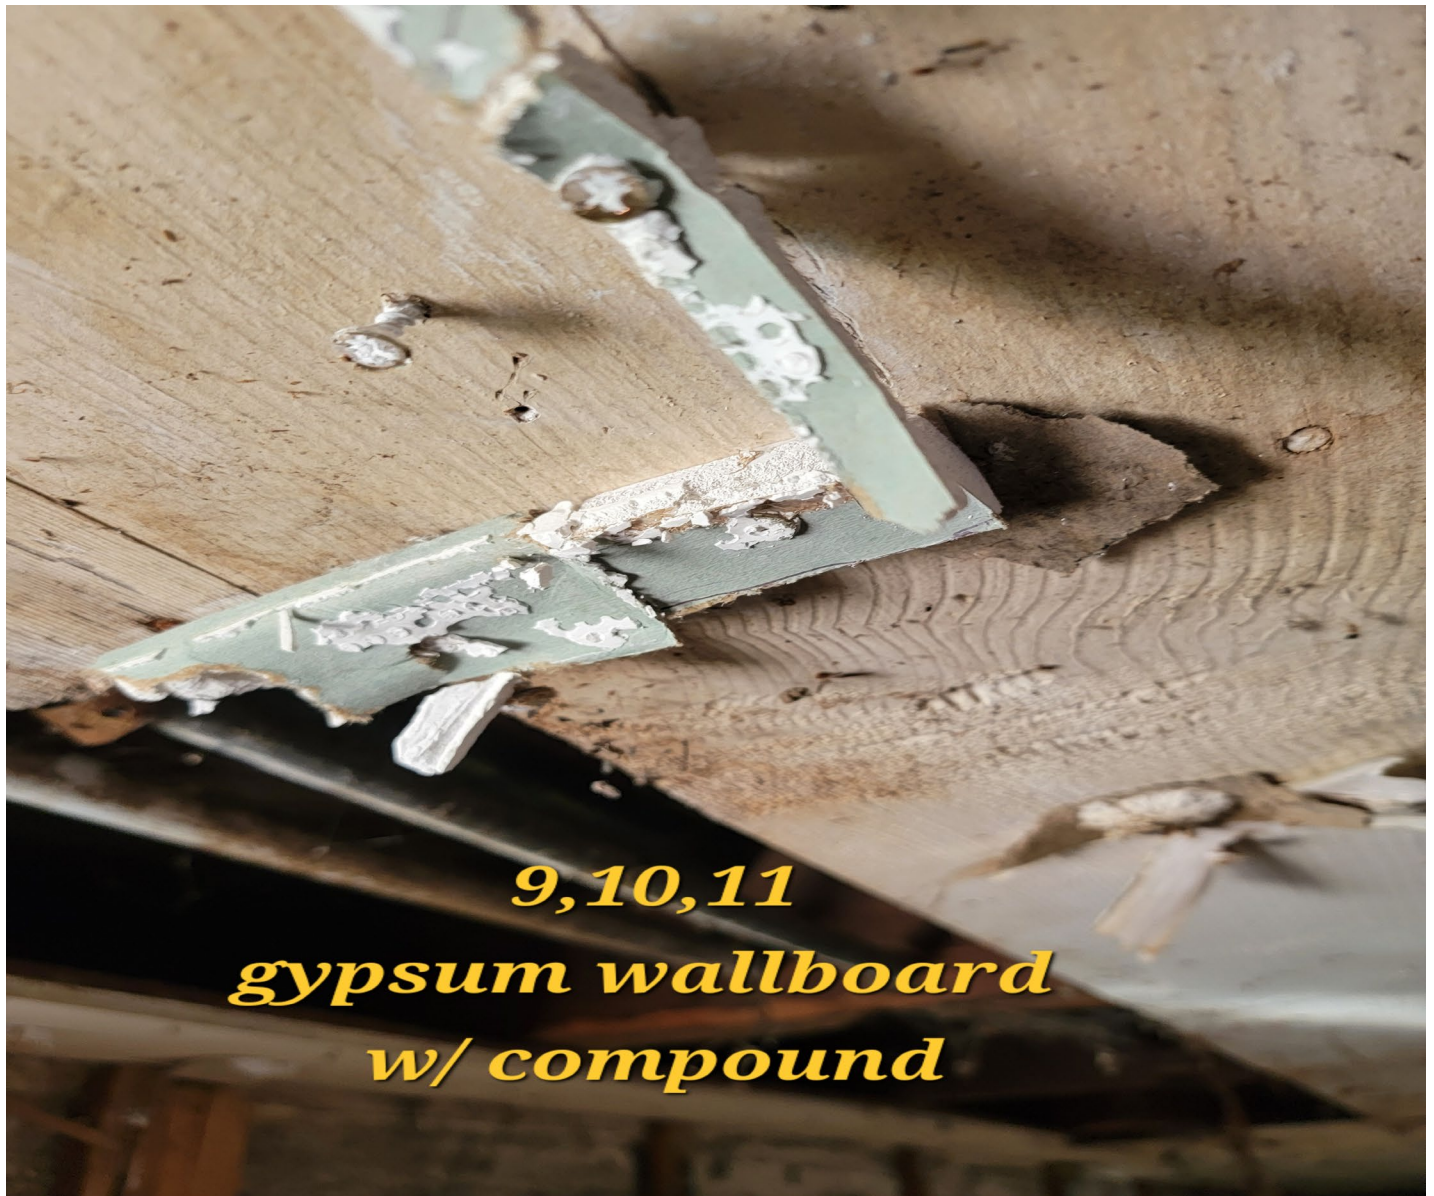
***9,10,11
gypsum wallboard
w/ compound***
