Notification of Demolition

ASBESTOS SURVEY

For the barn located at:

**3513 NW 179TH STREET
RIDGEFIELD, WASHINGTON**

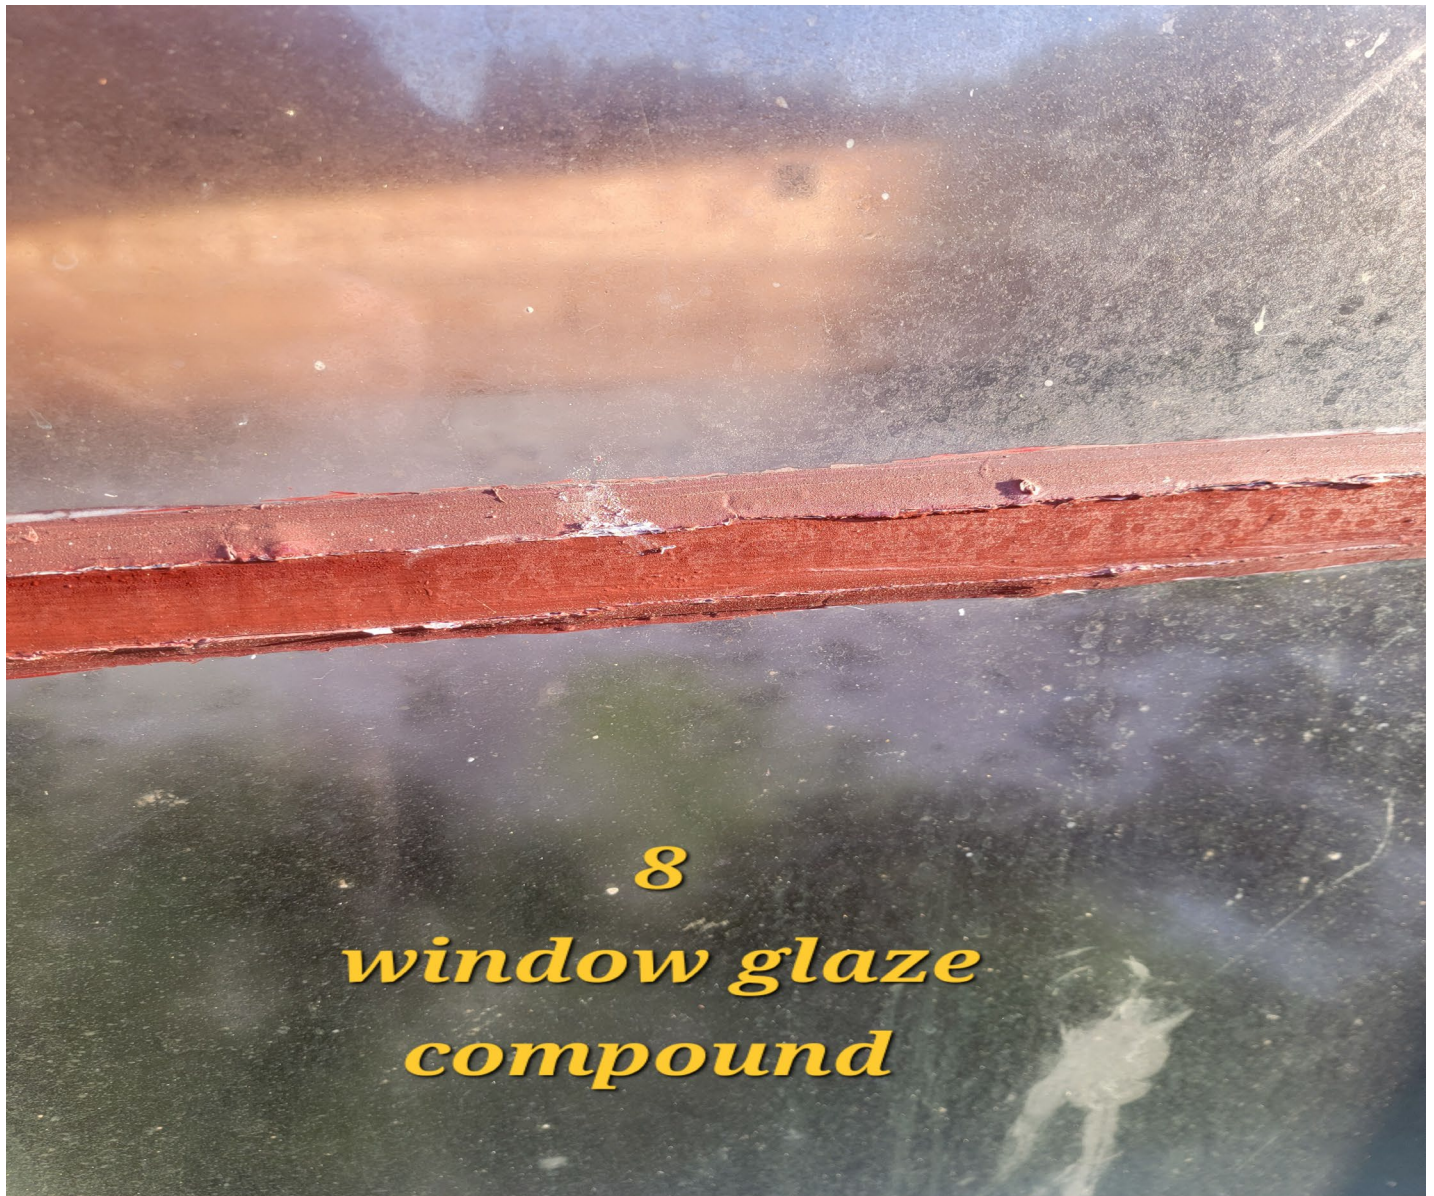
8
*window glaze
compound*
