Notice of Intent to Remove Asbestos

Limited Lead and Asbestos Survey Report

**Discovery High School
2742 Harding Street
Longview, Washington**

Report Date: June 6, 2023

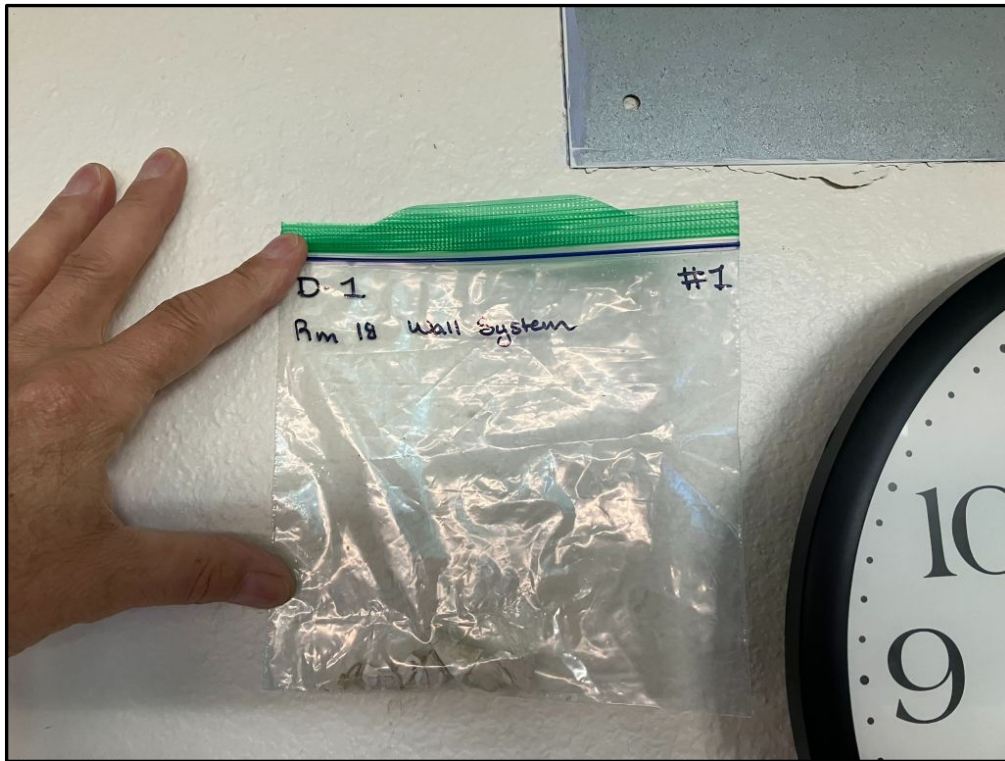
Sample ID.: D-1	Location: Classroom 18 - wall system - #1
Friable (Y/N): N/A	Approx. Qty. (Sq. Ft./Linear Ft.): N/A.
Description	Result
White drywall with brown paper	ND
White joint compound	ND
Sample ID.: D-2	Location: Classroom 18 – ceiling tile - #1
Friable (Y/N): N/A	Approx. Qty. (Sq. Ft./Linear Ft.): N/A.
Description	Result
Brown ceiling tile with white surface	ND
Sample ID.: D-3	Location: Classroom 18 – attic insulation - #1
Friable (Y/N): N/A	Approx. Qty. (Sq. Ft./Linear Ft.): N/A.
Description	Result
Pink insulation	ND
White texture	ND
Sample ID.: D-4	Location: Truancy Office Bathroom – wall system - #2
Friable (Y/N): N/A	Approx. Qty. (Sq. Ft./Linear Ft.): N/A.
Description	Result
White drywall with brown paper and paint	ND
Sample ID.: D-6	Location: Hall outside Classroom 18 – ceiling system - #1
Friable (Y/N): N/A	Approx. Qty. (Sq. Ft./Linear Ft.): N/A.
Description	Result
White drywall	ND
Sample ID.: D-8	Location: Hall outside Classroom 9 – old attic insulation - #1

Sample D-1: Classroom 18 – Wall System

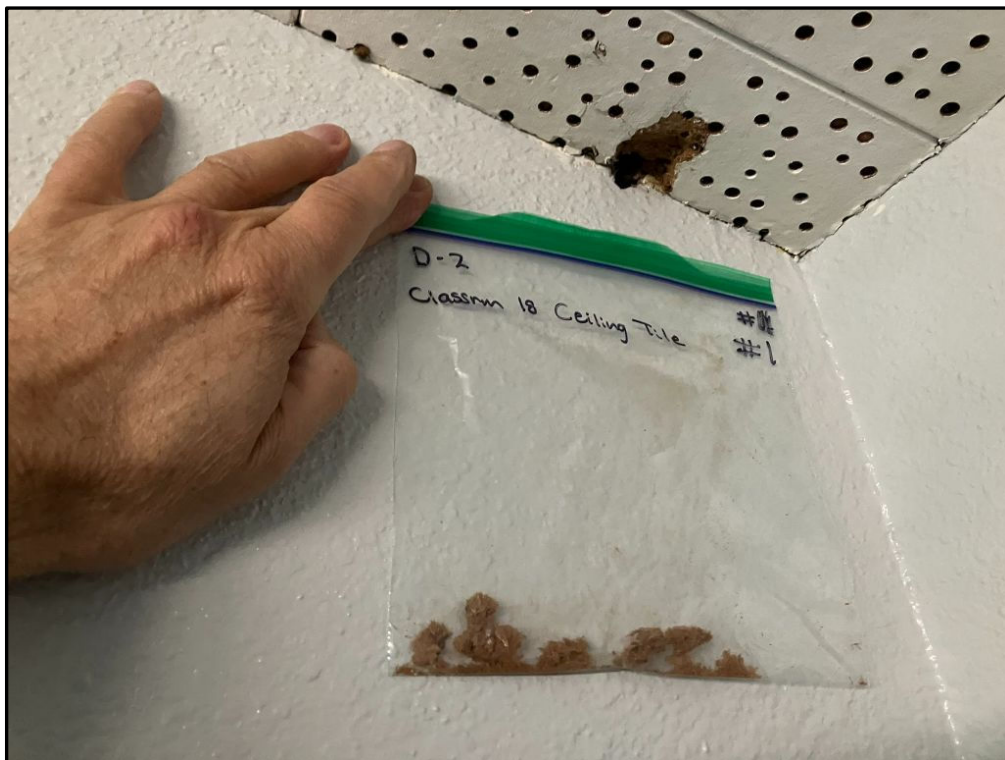
Sample D-2: Classroom 18 – Ceiling Tile

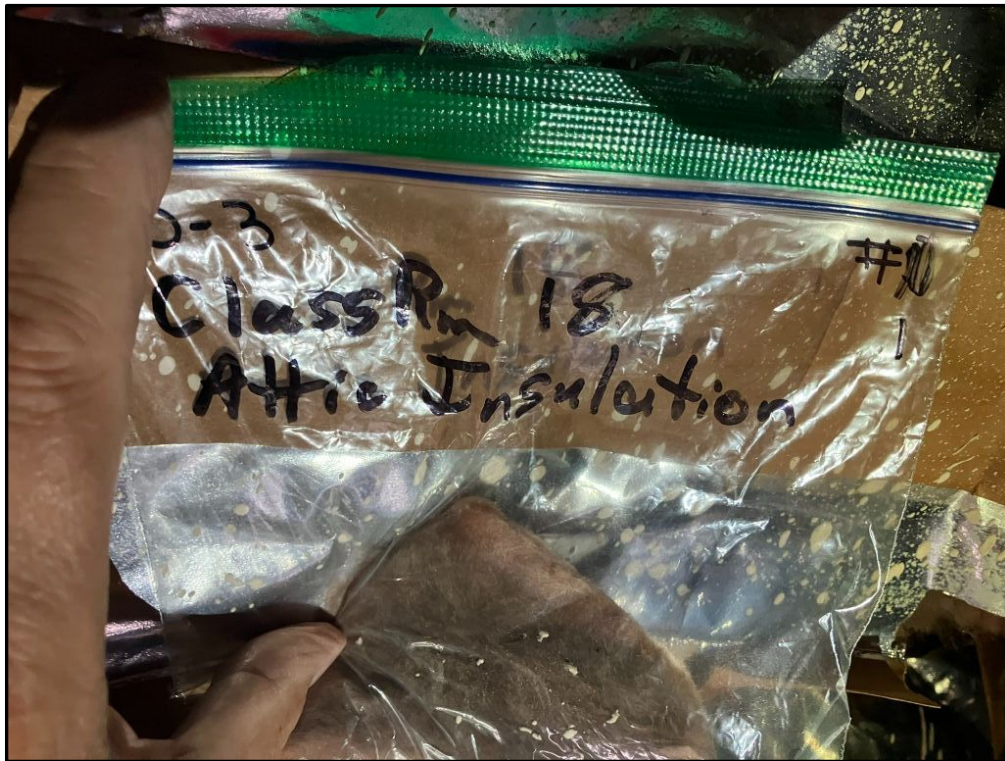
Sample D-3: Classroom 18 – Attic Insulation

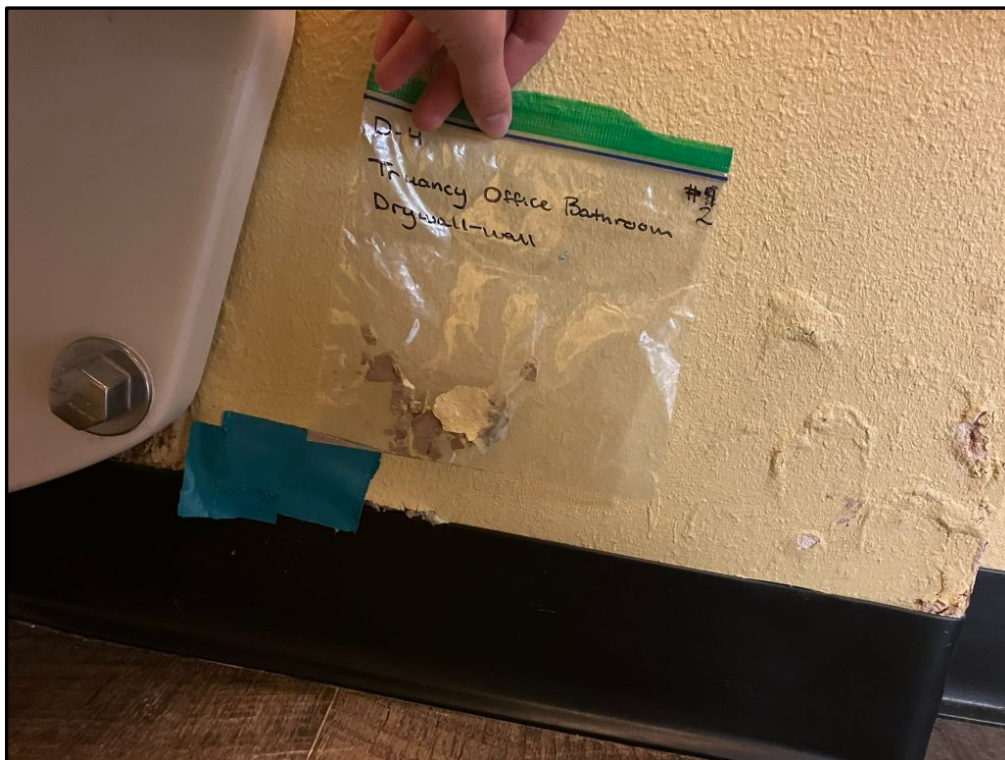
Sample D-4: Truancy Office Bathroom – wall system - #2

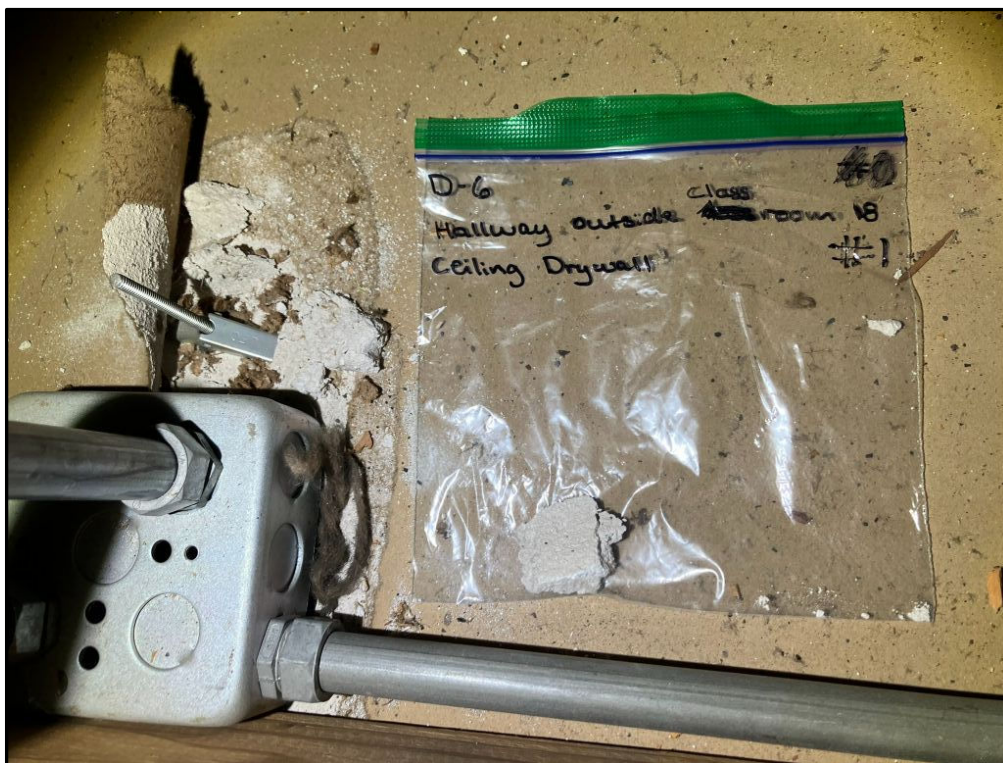
Sample D-6: Hall outside classroom 18 – ceiling system - #1

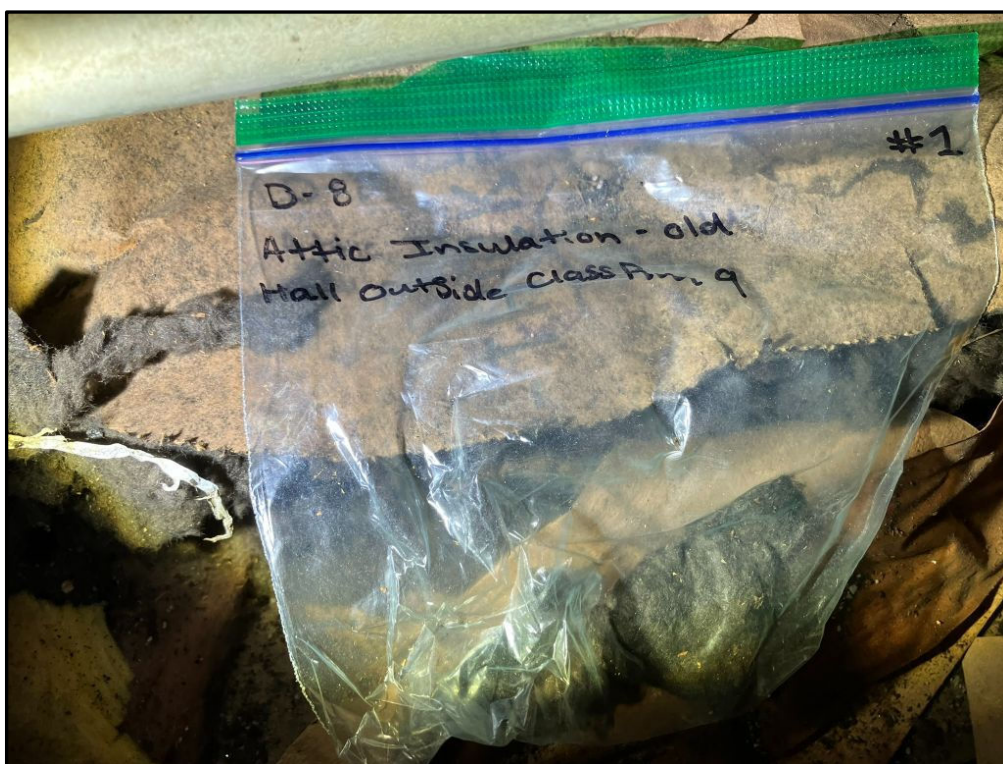
Friable (Y/N): N/A	Approx. Qty. (Sq. Ft./Linear Ft.): N/A.
Description	Result
Black insulation	ND
Sample ID.: D-11	Location: Counselor's Office – ceiling system - #2
Friable (Y/N): N/A	Approx. Qty. (Sq. Ft./Linear Ft.): N/A.
Description	Result
White drywall with brown paper	ND
Sample ID.: D-12	Location: Hall outside Classroom 16A – ceiling system - #3
Friable (Y/N): N/A	Approx. Qty. (Sq. Ft./Linear Ft.): N/A.
Description	Result
White drywall with brown paper	ND

Sample D-8: Hall outside classroom 9 – old attic insulation - #1

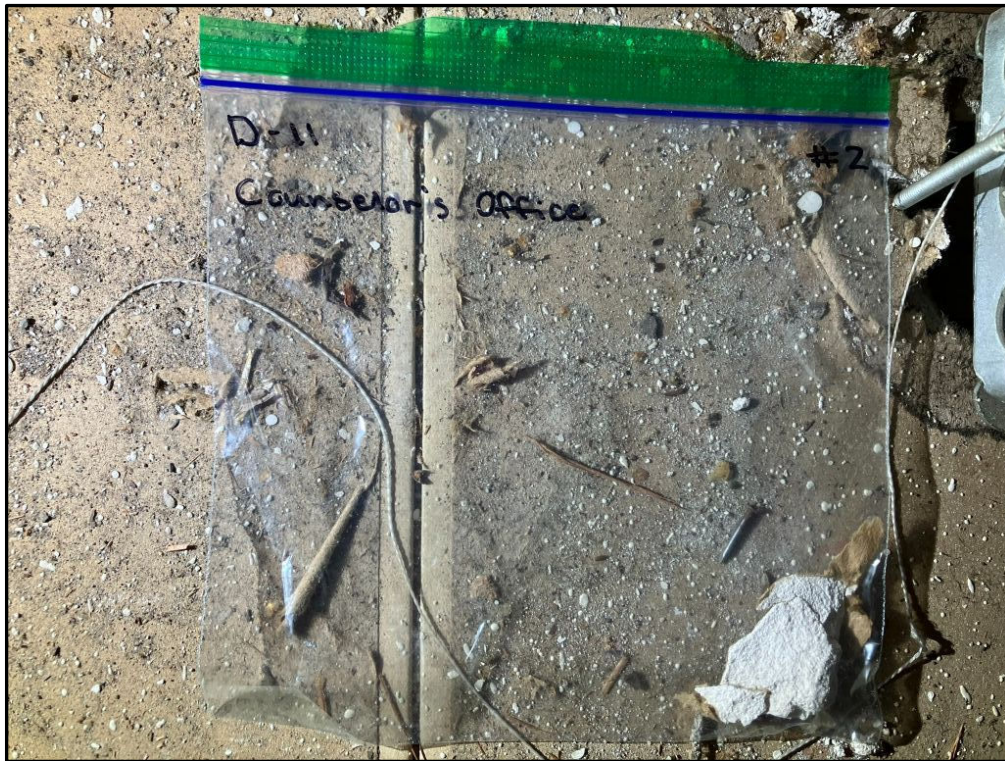
Sample D-11: Counselor's Office – ceiling system - #2

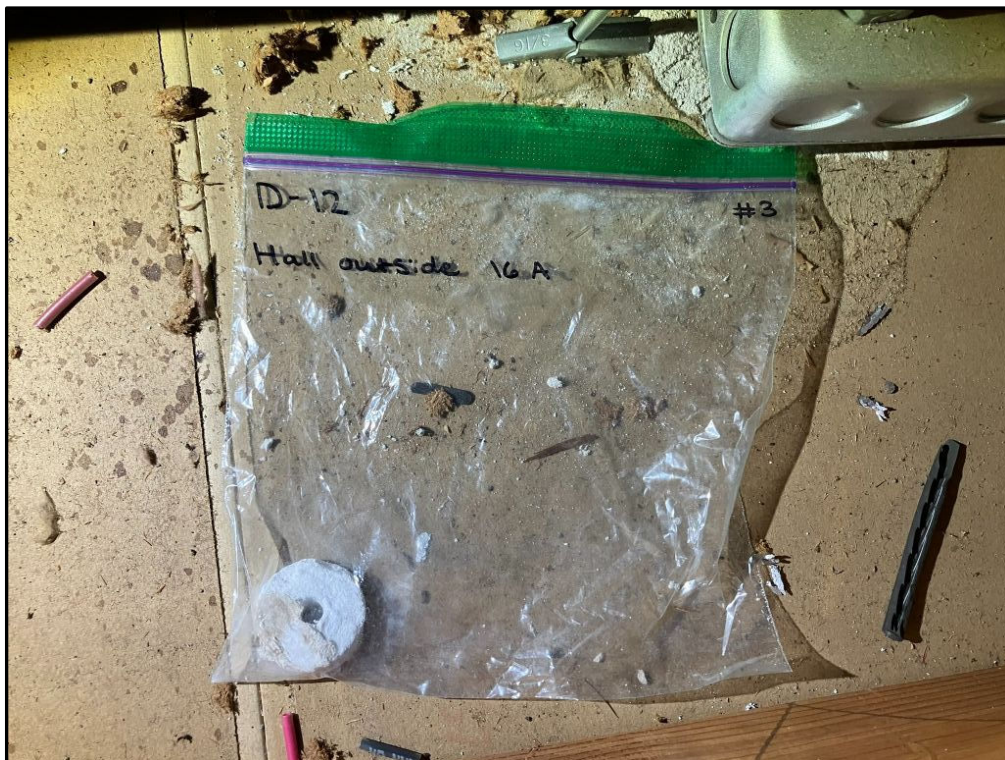
Sample D-12: Hall outside classroom 16A – ceiling system - #3

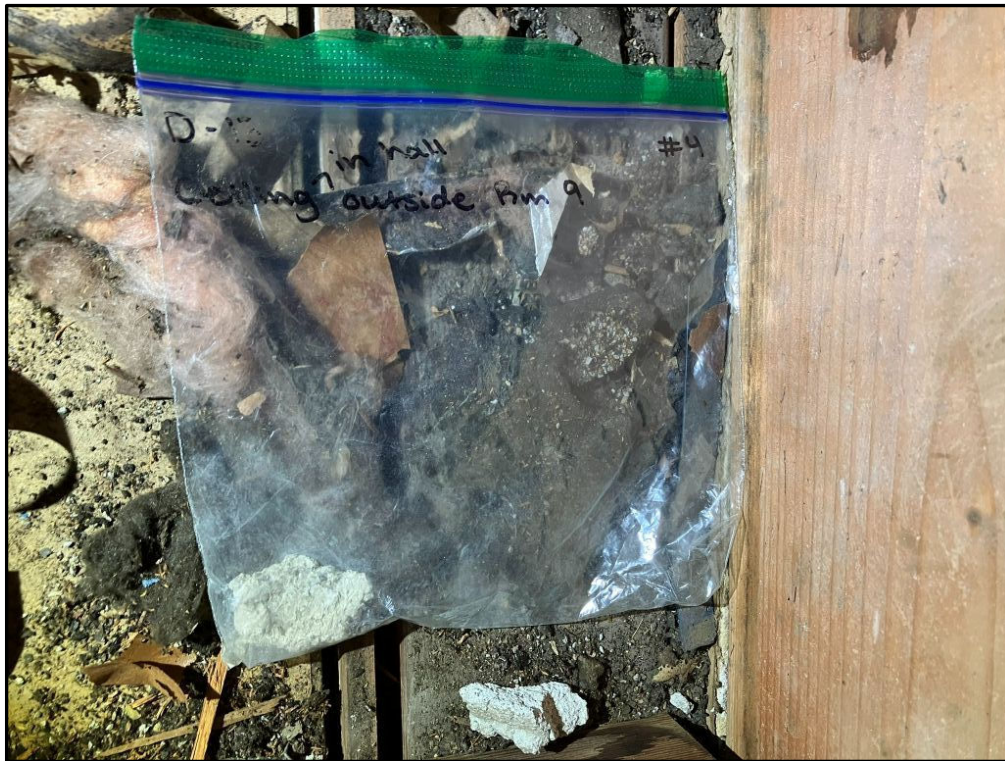
Sample ID.: D-13	Location: Hall outside Classroom 9 – ceiling cavity debris #4
Friable (Y/N): N/A	Approx. Qty. (Sq. Ft./Linear Ft.): For the planned ceiling penetrations in and adjacent to the main east-west hallway of the school, (Integrus drawing M401) the estimated impact to this loose debris is estimated at less than 159 Sq. Ft.
Description	Result
Gray fireproofing	3% Chrysotile

- D-13: Hall outside Classroom 9 – ceiling cavity debris: **gray fireproofing**

As indicated in the tables above, the amount of this asbestos-containing materials that may be impacted by the planned IAQ improvement scope of work is estimated at less than 159 sq. ft. Any impact to this asbestos-containing material should be performed by licensed asbestos abatement contractors in accordance with all applicable local, state, and federal regulations.

Sample D-13: Hall outside classroom 9 – ceiling system #4

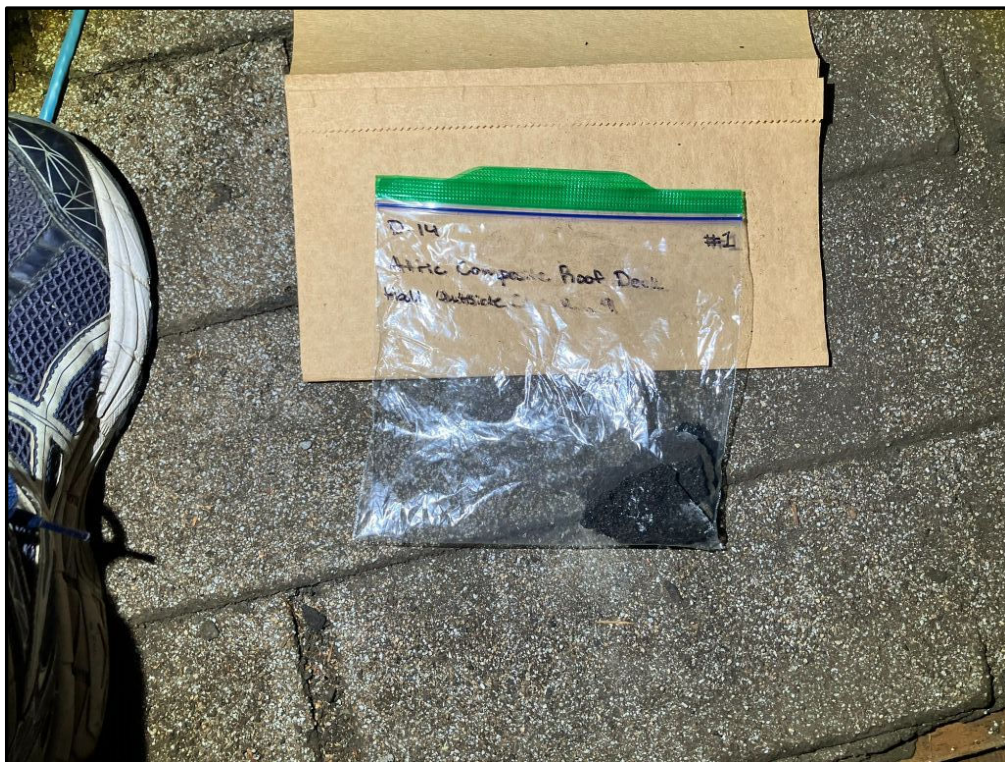
Sample ID.: D-14	Location: Hall outside Classroom 9 – composite roofing #1
Friable (Y/N): N/A	Approx. Qty. (Sq. Ft./Linear Ft.): N/A.
Description	Result
Black roofing material	ND
Black felt paper	ND

Sample D-14: Hall outside classroom 9 – composite roofing #1

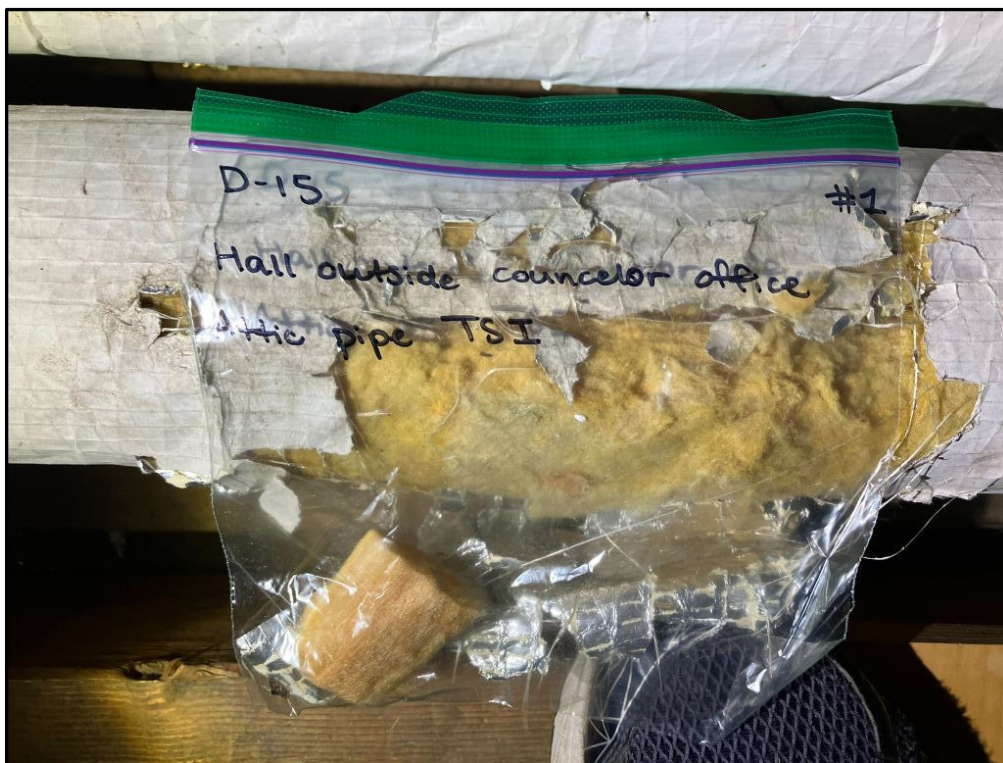
Sample ID.: D-15	Location: Counselors office – attic pipe TSI #1
Friable (Y/N): N/A	Approx. Qty. (Sq. Ft./Linear Ft.): N/A.
Description	Result
Yellow insulation	ND
Silver wrap with paint	ND
Brown paper	ND
Black mastic	ND

Sample D-15: Counselors office – attic pipe TSI #1

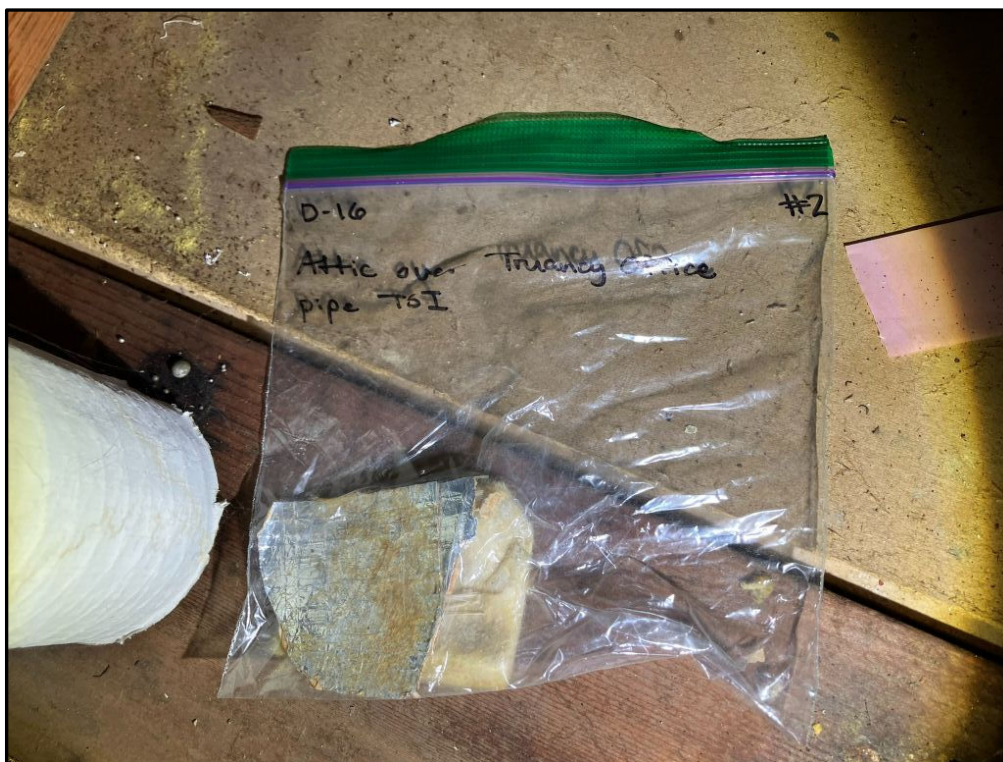
Sample ID.: D-16	Location: Truancy office – attic pipe TSI #2
Friable (Y/N): N/A	Approx. Qty. (Sq. Ft./Linear Ft.): N/A.
Description	Result
Yellow insulation	ND
Silver wrap with fibrous backing	ND
Yellow mastic	ND

Sample D-16: Truancy office – attic pipe TSI #2

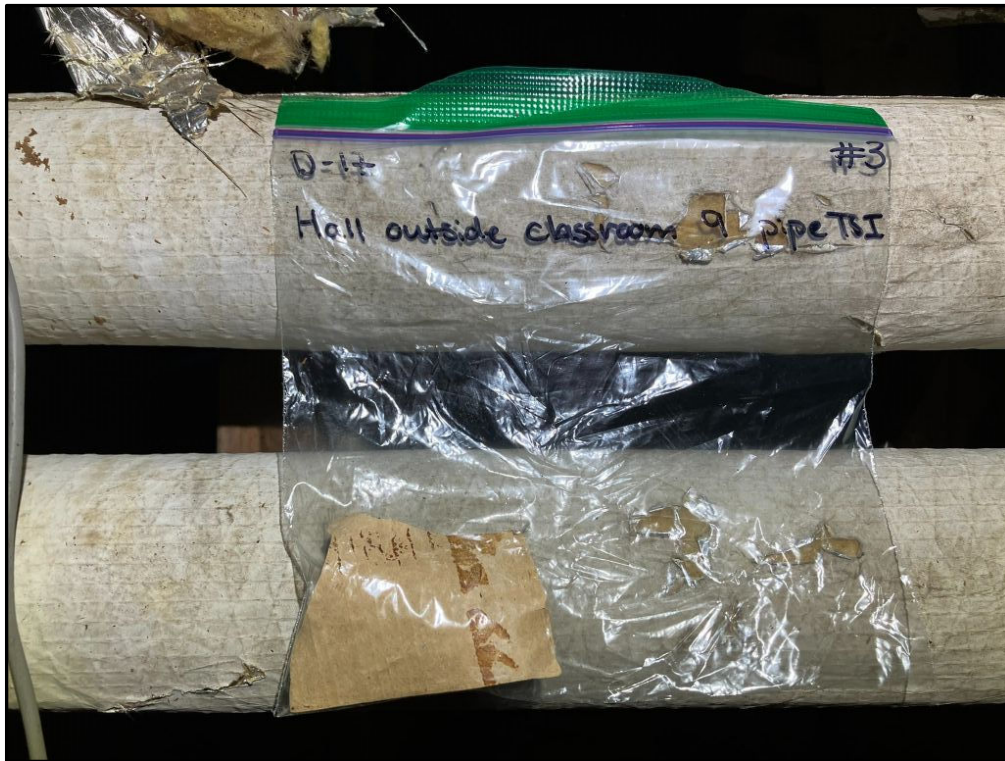
Sample ID.: D-17	Location: Hall outside Classroom 9 – attic pipe TSI #3
Friable (Y/N): N/A	Approx. Qty. (Sq. Ft./Linear Ft.): N/A.
Description	Result
Yellow insulation	ND
Silver wrap with fibrous backing	ND
Yellow mastic	ND

Sample D-17: Hall outside classroom 9 – attic pipe TSI #3

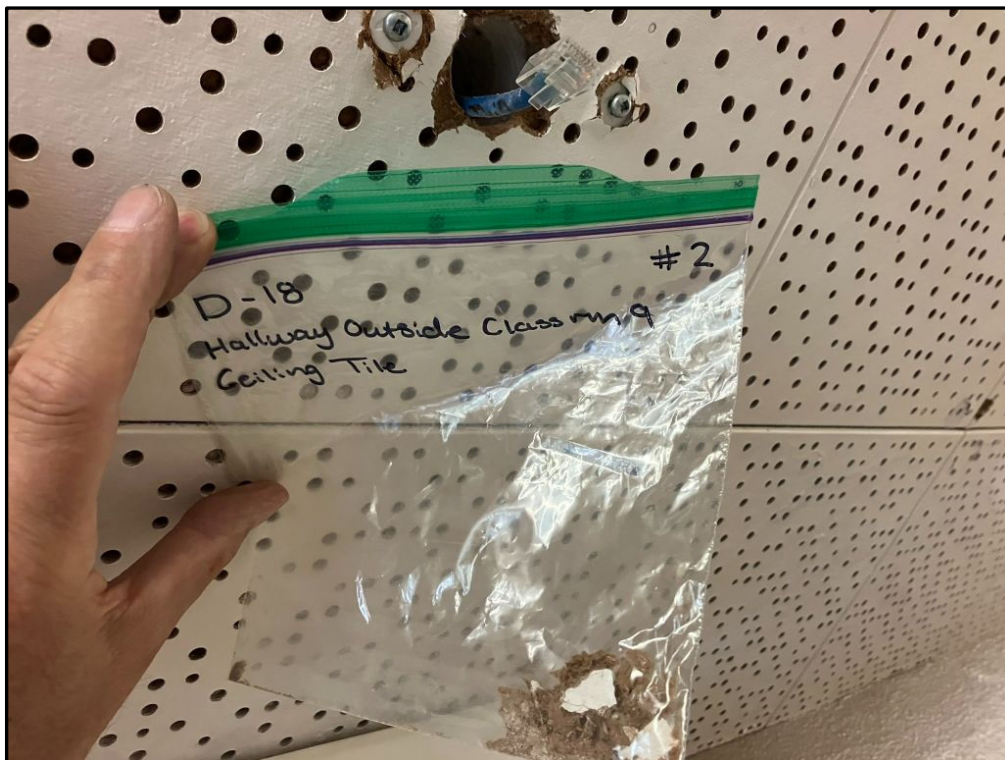
Sample ID.: D-18	Location: Hall outside Classroom 9 – ceiling tile #2
Friable (Y/N): N/A	Approx. Qty. (Sq. Ft./Linear Ft.): N/A.
Description	Result
Brown ceiling tile with white surface	ND

Sample D-18: Hall outside classroom 9 – ceiling tile #2

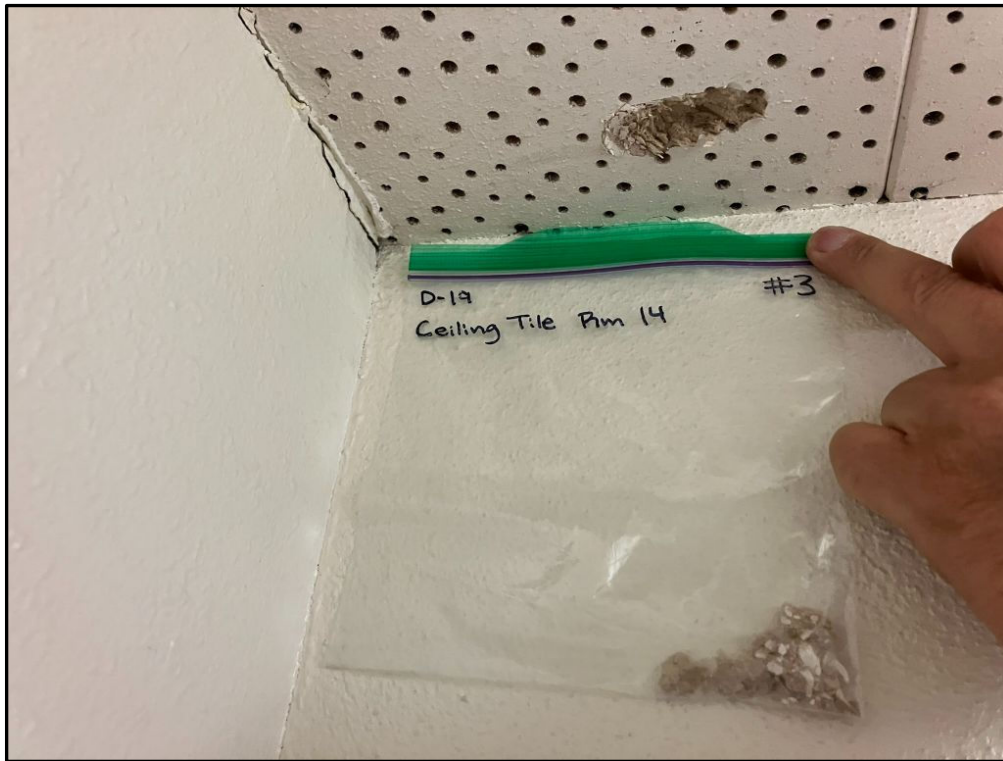
Sample ID.: D-19	Location: Classroom 14 – ceiling tile #3
Friable (Y/N): N/A	Approx. Qty. (Sq. Ft./Linear Ft.): N/A.
Description	Result
Gray ceiling tile with white surface	ND

Sample D-19: Classroom 14 – ceiling tile #3

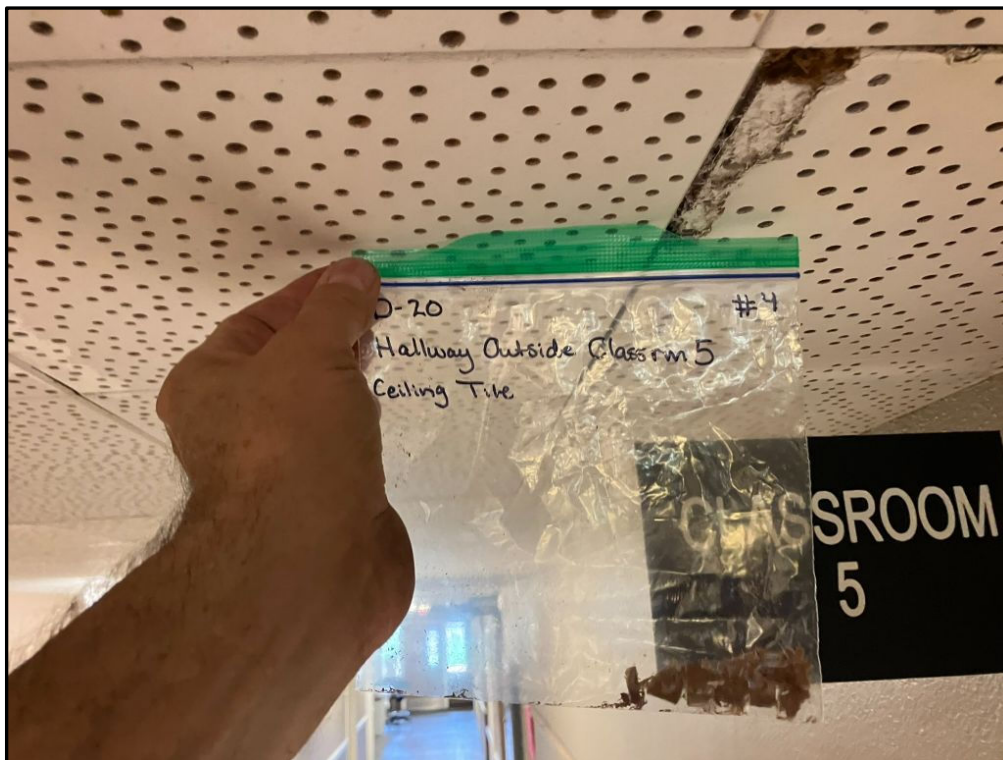
Sample ID.: D-20	Location: Hall outside Classroom 5 – ceiling tile #4
Friable (Y/N): N/A	Approx. Qty. (Sq. Ft./Linear Ft.): N/A.
Description	Result
Brown ceiling tile with white surface	ND

Sample D-20: Hall outside classroom 5 – ceiling tile #4

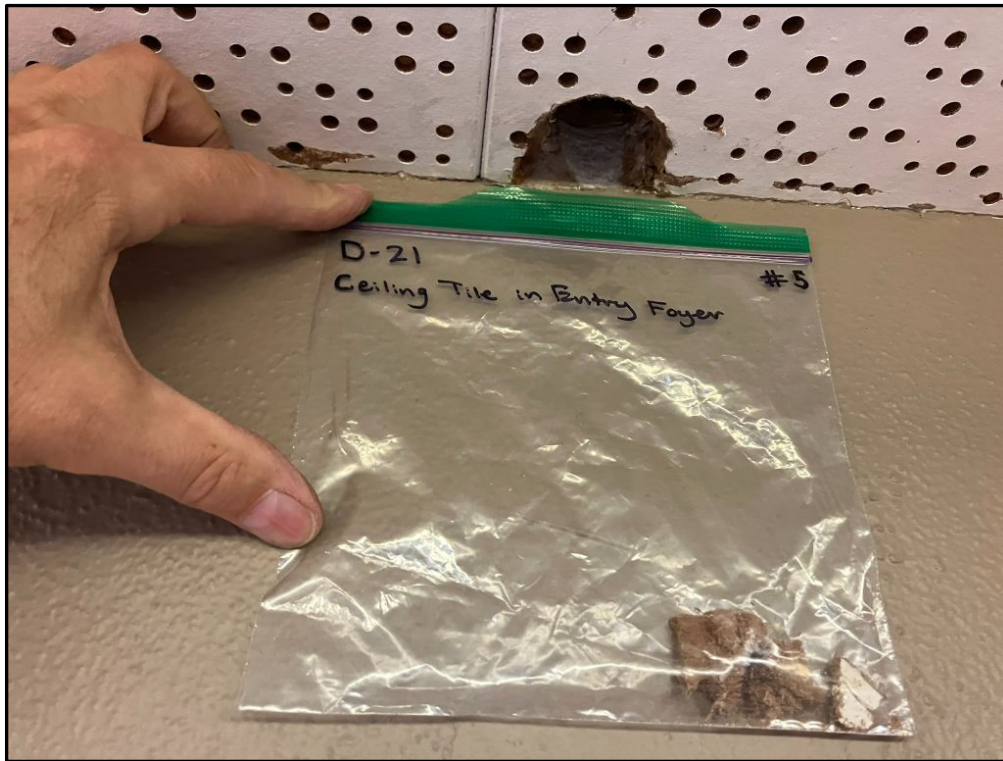
Sample ID.: D-21	Location: School Entry Foyer – ceiling tile #5
Friable (Y/N): N/A	Approx. Qty. (Sq. Ft./Linear Ft.): N/A.
Description	Result
Brown ceiling tile with white surface	ND

Sample D-21: School Entry Foyer – ceiling tile #5

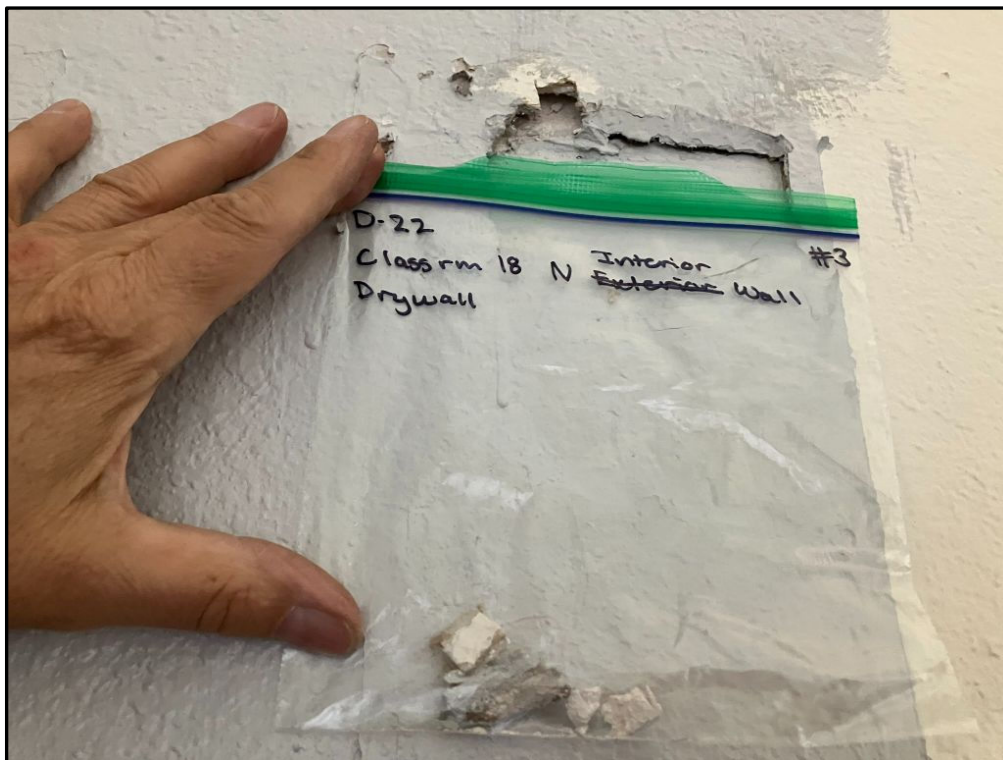
Sample ID.: D-22	Location: Classroom 18 – N. interior wall system #3
Friable (Y/N): N/A	Approx. Qty. (Sq. Ft./Linear Ft.): N/A.
Description	Result
White drywall with brown paper	ND
White joint compound with paint	ND

Sample D-22: Classroom 18 – N. interior wall system #3

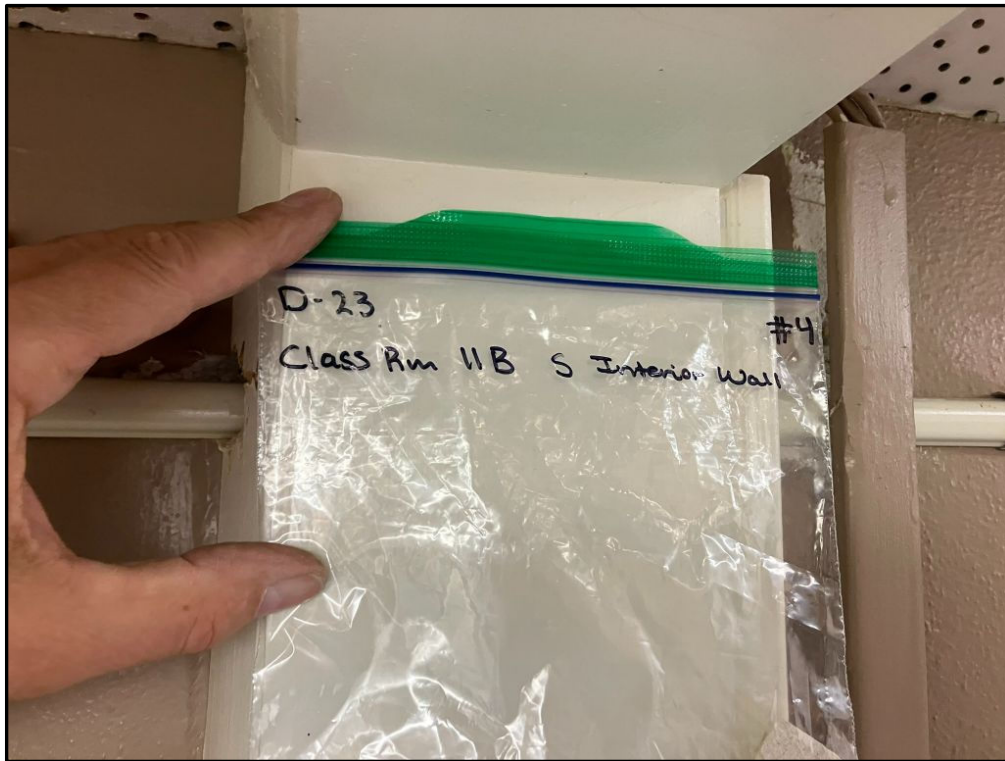
Sample ID.: D-23	Location: Classroom 11B – S. interior wall system #4
Friable (Y/N): N/A	Approx. Qty. (Sq. Ft./Linear Ft.): N/A.
Description	Result
White plaster with paint	ND

Sample D-23: Classroom 11B – S. interior wall system #4

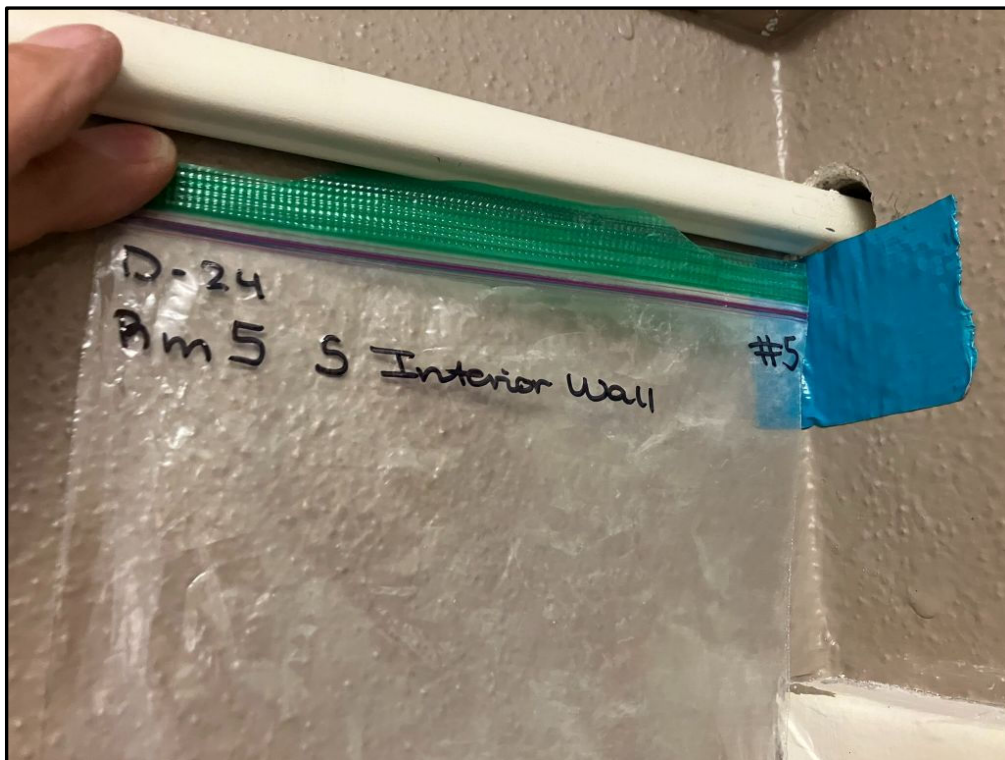
Sample ID.: D-24	Location: Classroom 5 – S. interior wall system #5
Friable (Y/N): N/A	Approx. Qty. (Sq. Ft./Linear Ft.): N/A.
Description	Result
White plaster with paint	ND

Sample D-24: Classroom 5 – S. interior wall system #5

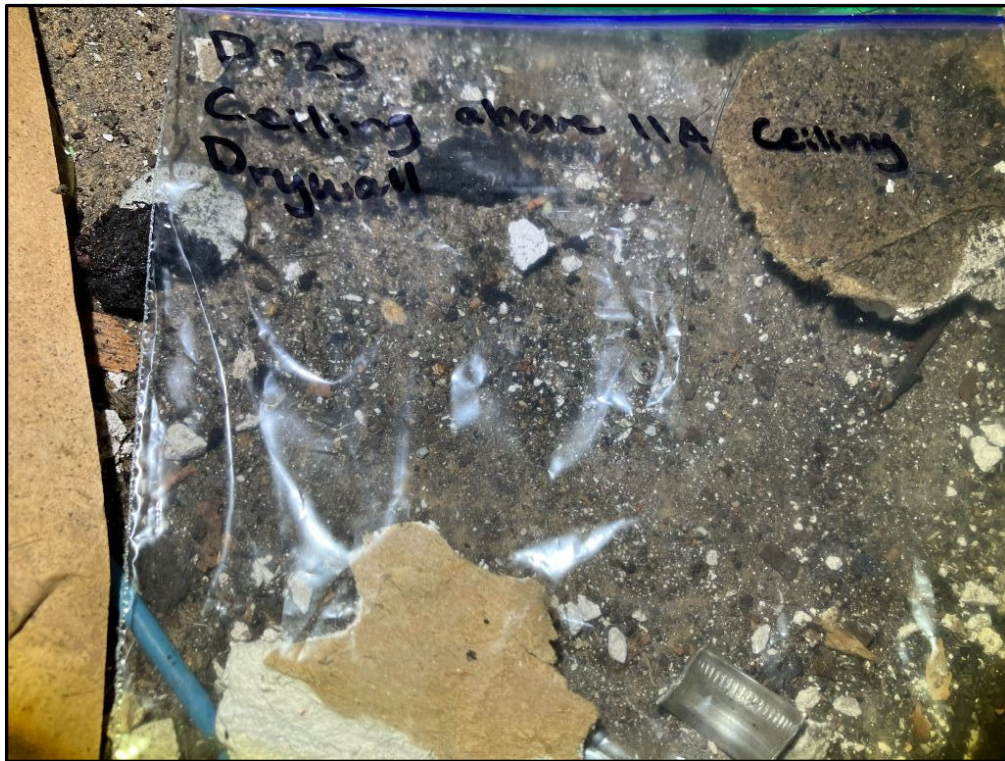
Sample ID.: D-25	Location: Attic above Classroom 11A – ceiling system #5
Friable (Y/N): N/A	Approx. Qty. (Sq. Ft./Linear Ft.): N/A.
Description	Result
White drywall with brown paper	ND

Sample D-25: Attic above classroom 11A – ceiling system #5

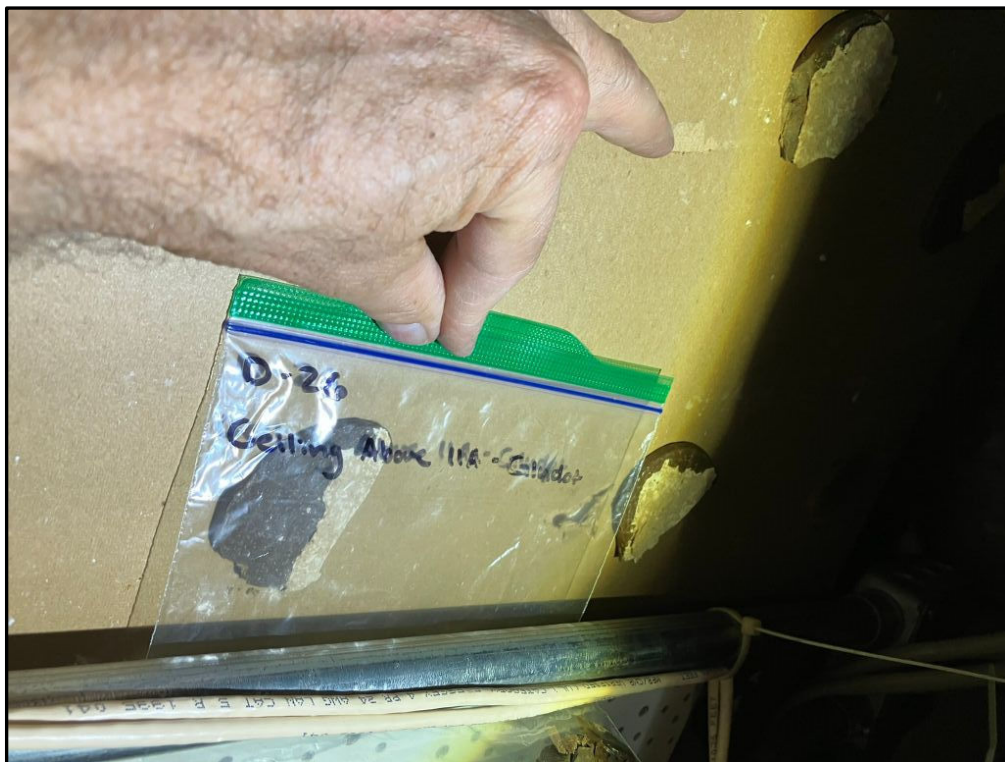
Sample ID.: D-26	Location: Attic above Classroom 11A – glue dot #1
Friable (Y/N): N/A	Approx. Qty. (Sq. Ft./Linear Ft.): N/A.
Description	Result
Brown glue	ND
Brown wood	ND

Sample D-26: Attic above classroom 11A – glue dot #1

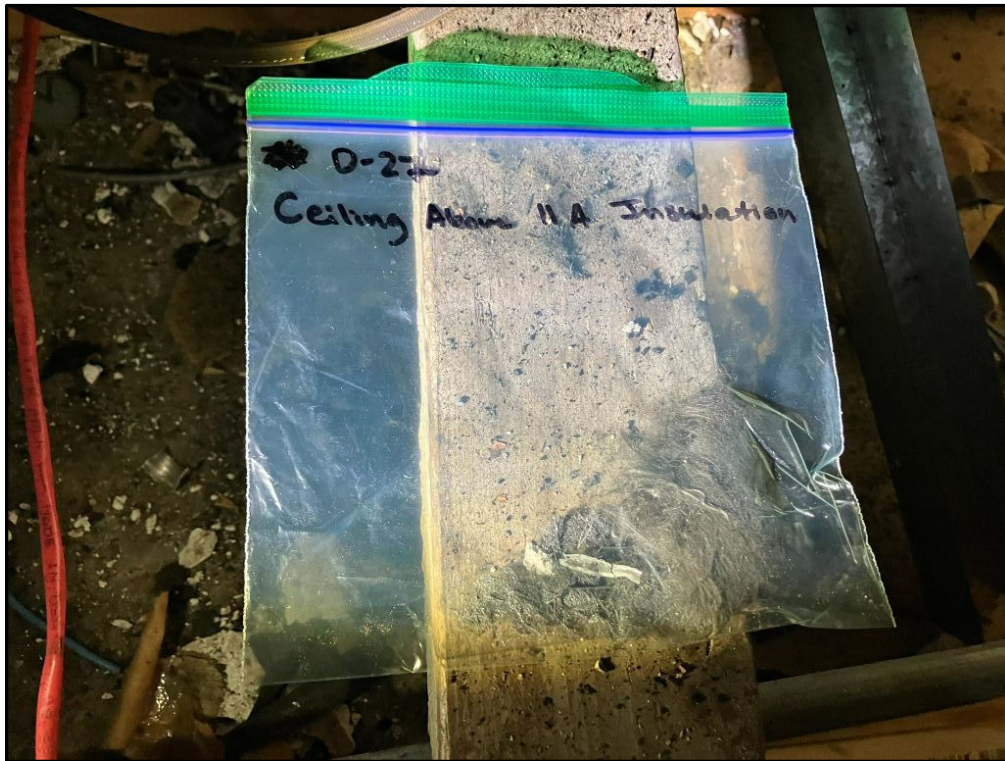
Sample ID.: D-27	Location: Attic above Classroom 11A – old insulation #2
Friable (Y/N): N/A	Approx. Qty. (Sq. Ft./Linear Ft.): N/A.
Description	Result
Black insulation	ND

Sample D-27: Attic above classroom 11A – old insulation #2

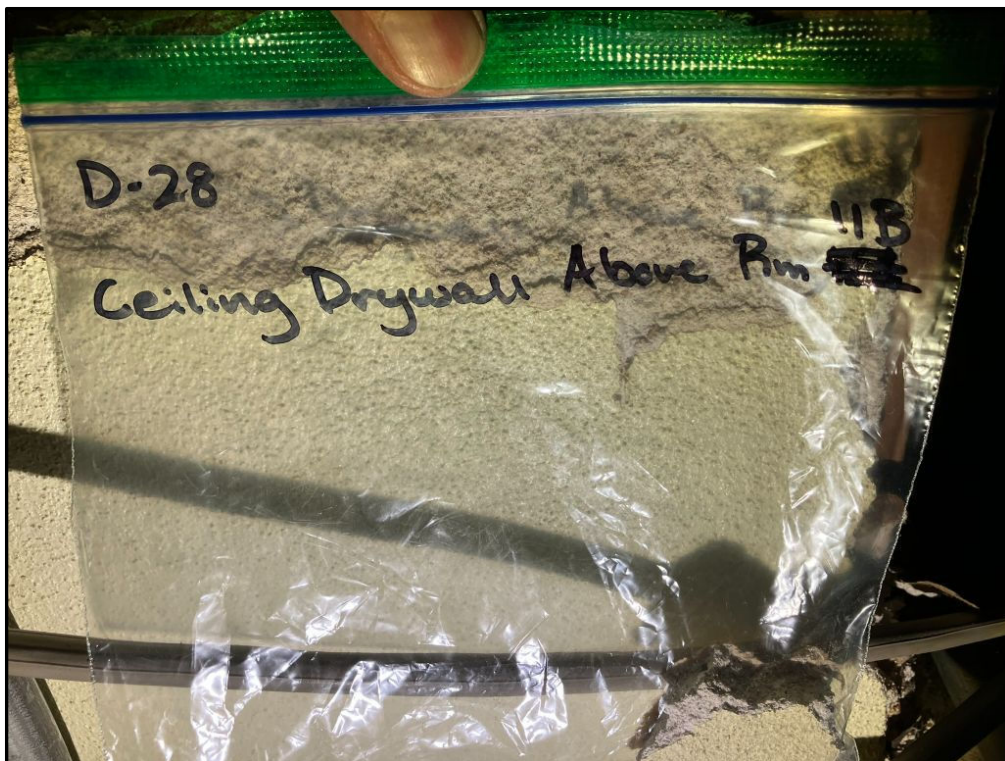
Sample ID.: D-28	Location: Attic above Classroom 11B – ceiling system #6
Friable (Y/N): N/A	Approx. Qty. (Sq. Ft./Linear Ft.): N/A.
Description	Result
White plaster with paint and brown paper	ND

Sample D-28: Attic above classroom 11B – ceiling system #6

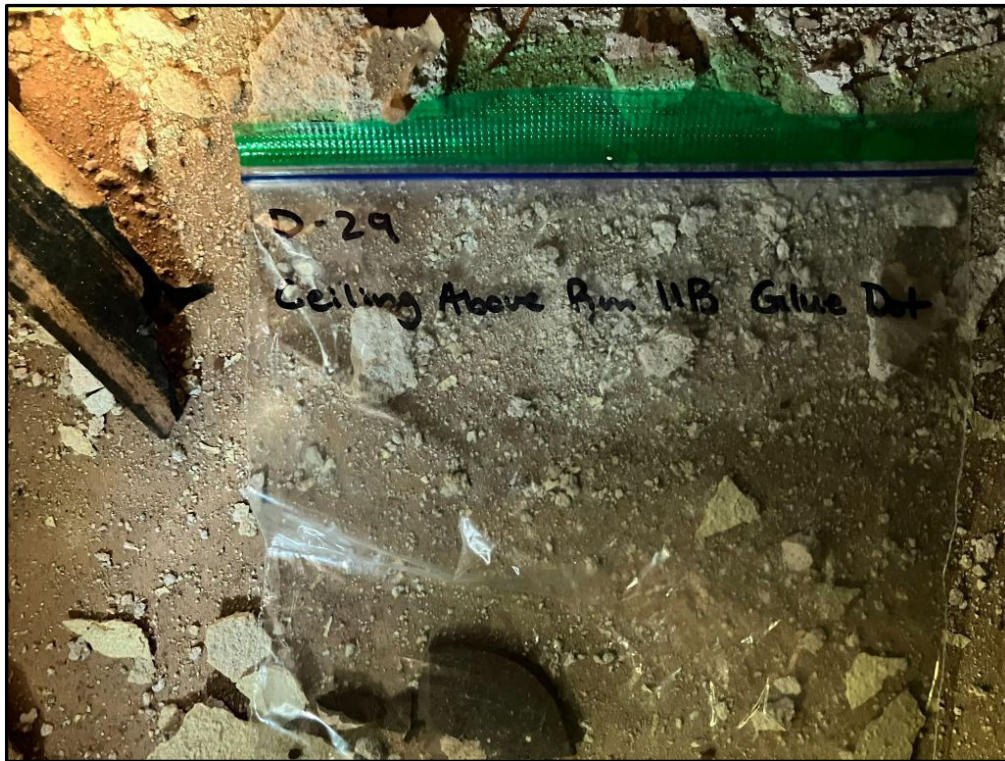
Sample ID.: D-29	Location: Attic above Classroom 11B – glue dot #2
Friable (Y/N): N/A	Approx. Qty. (Sq. Ft./Linear Ft.): N/A.
Description	Result
Brown glue	ND
White paper	ND
Brown paper	ND

Sample D-29: above Classroom 11B – glue dot #2

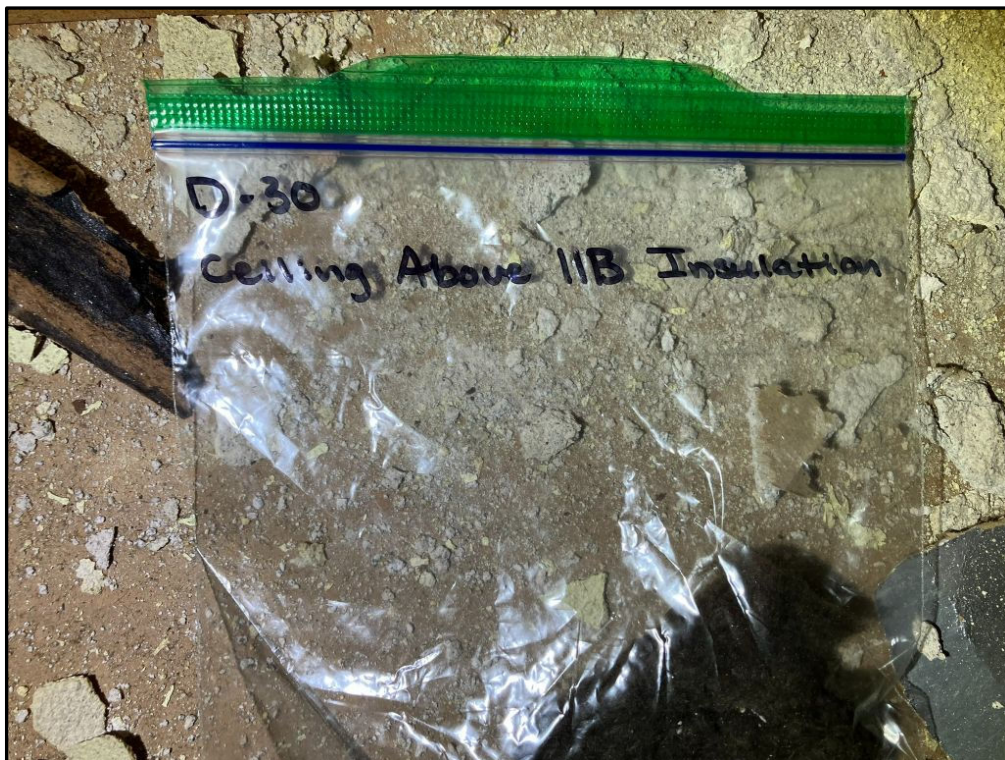
Sample ID.: D-30	Location: Attic above Classroom 11B – old insulation #3
Friable (Y/N): N/A	Approx. Qty. (Sq. Ft./Linear Ft.): N/A.
Description	Result
Black insulation	ND

Sample D-30: Attic above Classroom 11B – old insulation #3

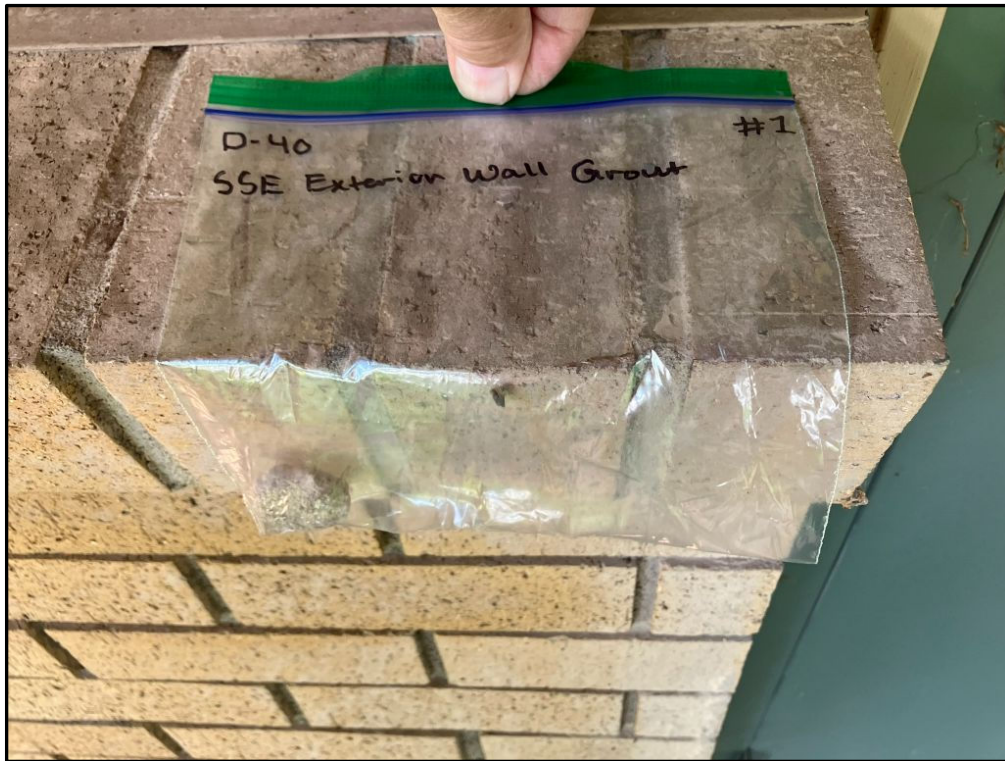
Sample ID.: D-40	Location: School SSE exterior brick wall – grout #1
Friable (Y/N): N/A	Approx. Qty. (Sq. Ft./Linear Ft.): N/A.
Description	Result
Gray grout	ND

Sample D-40: School SSE exterior brick wall – grout #1
