Notice of Intent to Remove Asbestos

Limited Lead and Asbestos Survey Report

**Discovery High School
2742 Harding Street
Longview, Washington**

Report Date: June 6, 2023

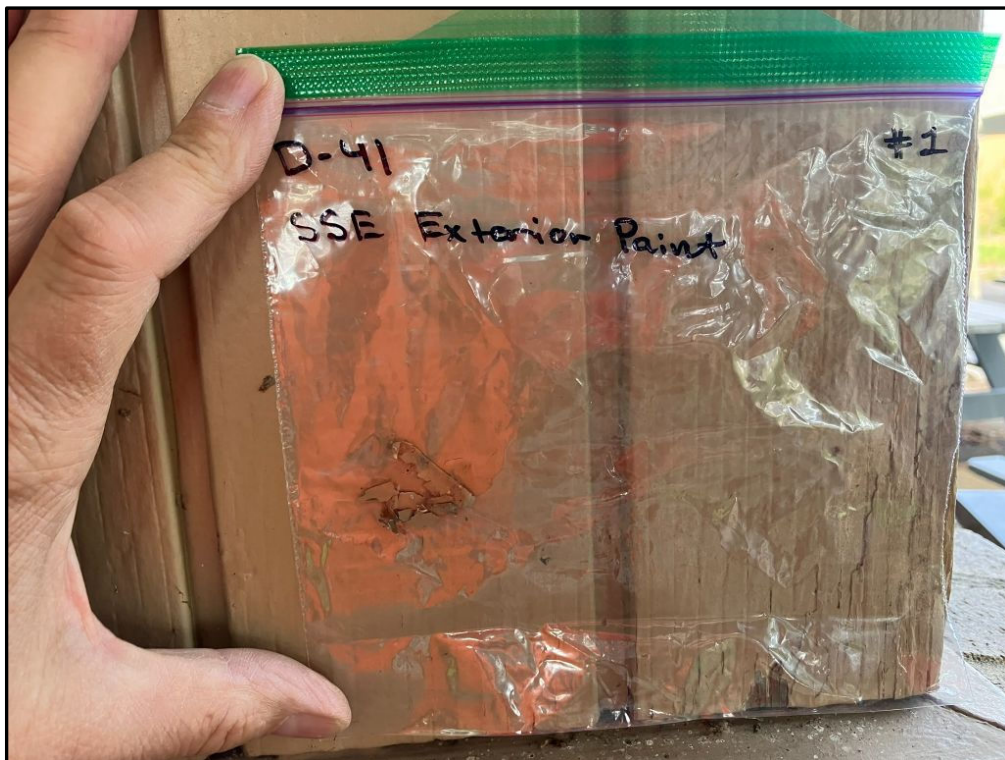
Sample D-41: School SSE exterior wall paint #1

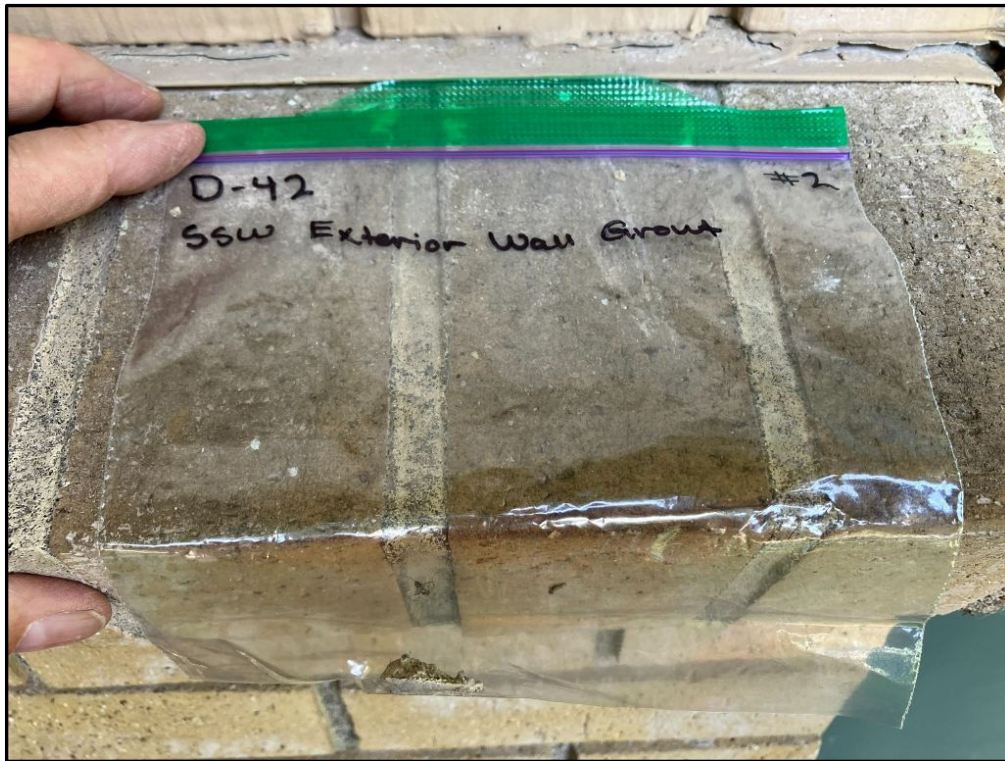
Sample ID.: D-42	Location: School SSW exterior brick wall – grout #2
Friable (Y/N): N/A	Approx. Qty. (Sq. Ft./Linear Ft.): N/A.
Description	Result
Gray grout	ND

Sample D-42: School SSW exterior brick wall – grout #2

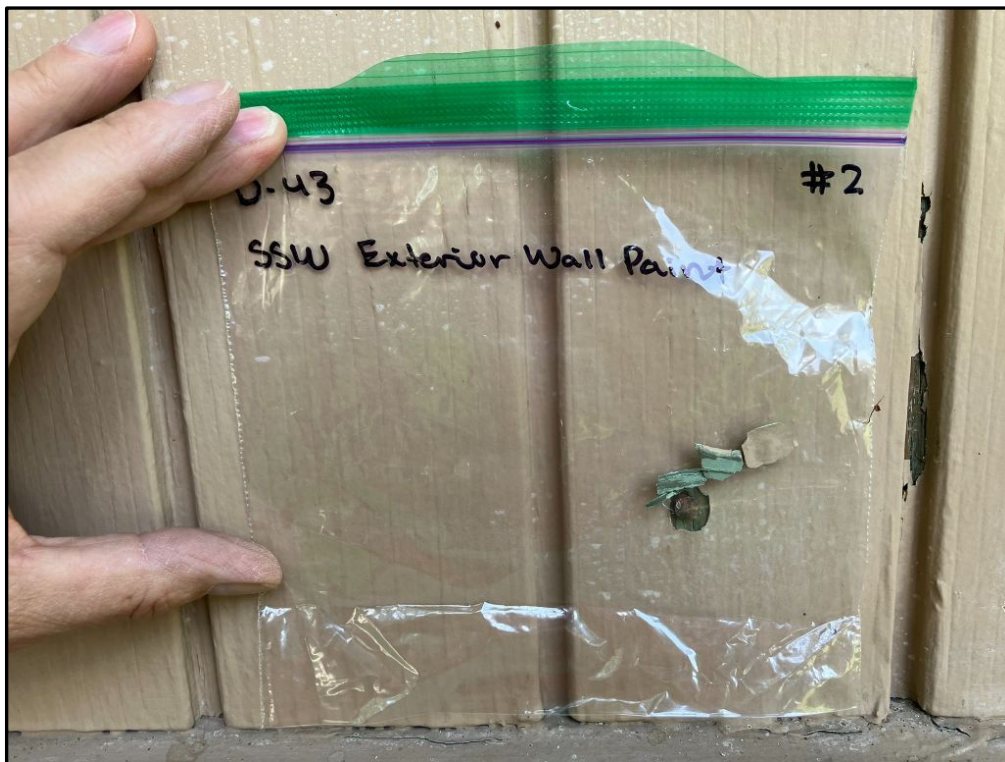
Sample D-43: School SSW exterior wall paint #2t

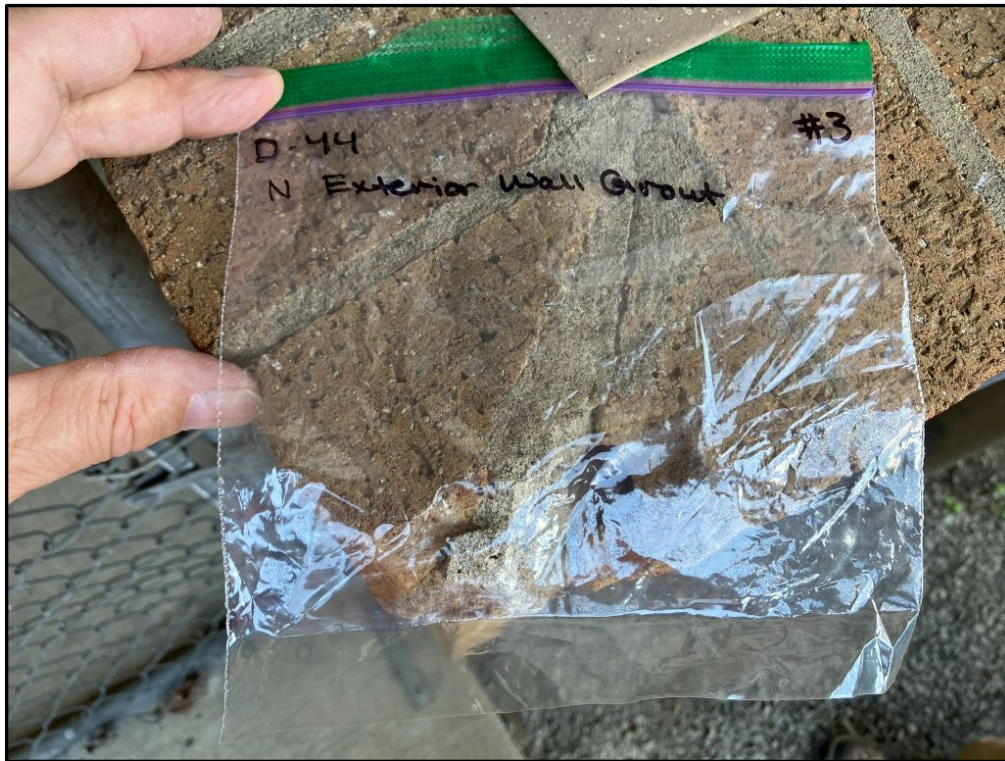
Sample ID.: D-44	Location: School N exterior brick wall – grout #3
Friable (Y/N): N/A	Approx. Qty. (Sq. Ft./Linear Ft.): N/A.
Description	Result
Gray grout	ND

Sample D-44: School N exterior brick wall – grout #3

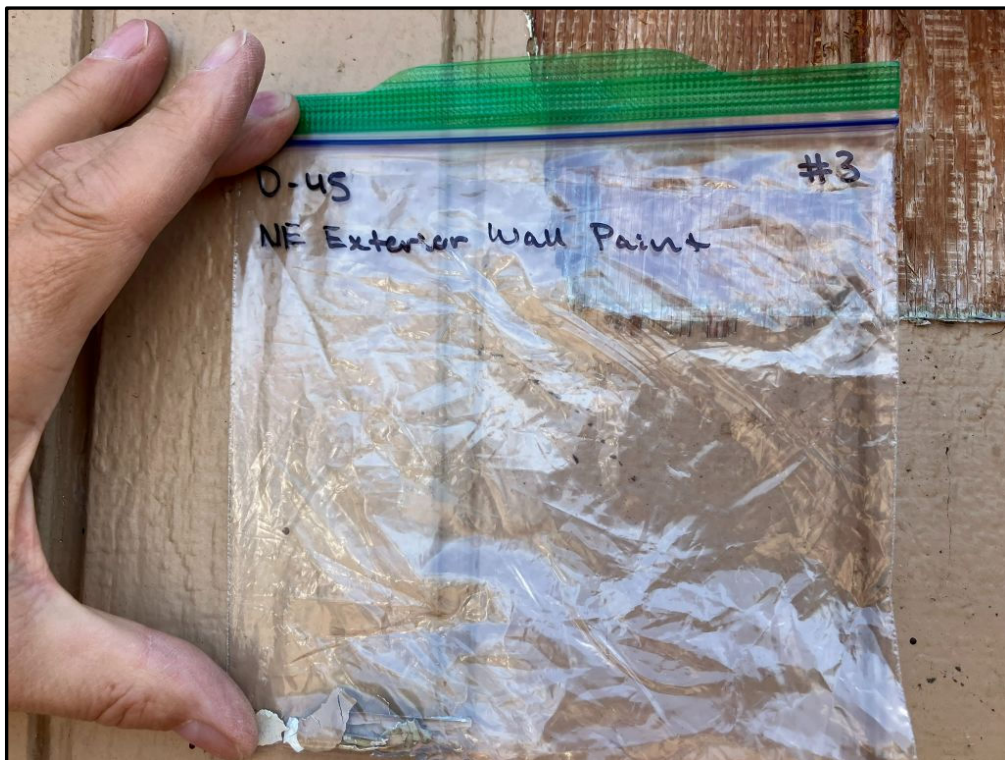
Sample D-45: School NE exterior wall paint #3
