Notification of Demolition

Case #: 24-180

Commercial Name or Description: New Mountian View Timberland Library

This letter report presents the results of the asbestos survey performed by Sandrini Restoration LLC and Loren Voie AHERA Building Inspector of the hotel building at 10111 US Highway 12 Randle, WA 98377, parcel #031753005001.

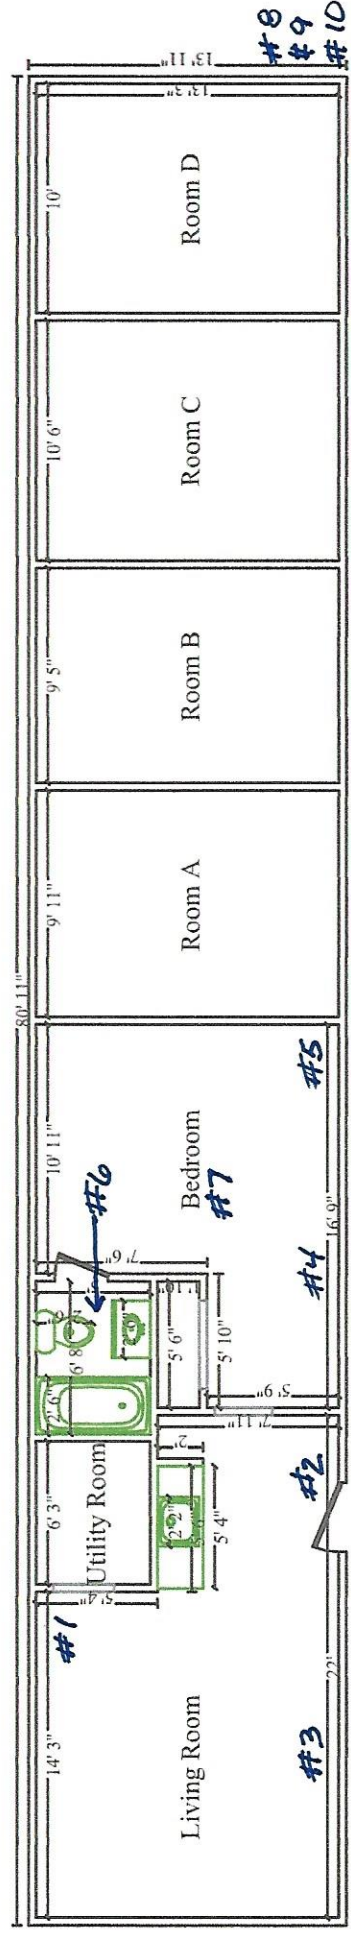
10111 US Hwy 12
Randle, wa 98377

- #1 white - joint compound
- #2 brown + white - flooring material
- #3 white - wallboard 1st layer
- #4 white - plaster wall material
- #5 red, black + brown - floor tile material
- #6 tan - floor tile material
- #7 white - ceiling joint compound
- #8 green + black - roofing material
- #9 black + brown - insulation board material
- #10 multi colored - roofing material - 1st layer

Note: There is no suspect material in rooms A, B, C + D
