Notice of Intent to Remove Asbestos

Case #: 24-181

Site Name: Timberland Regional Library

This letter report presents the results of the asbestos survey performed by Sandrini Restoration LLC and Loren Voie AHERA Building Inspector of the hotel building at 10111 US Highway 12 Randle, WA 98377, parcel #031753005001.

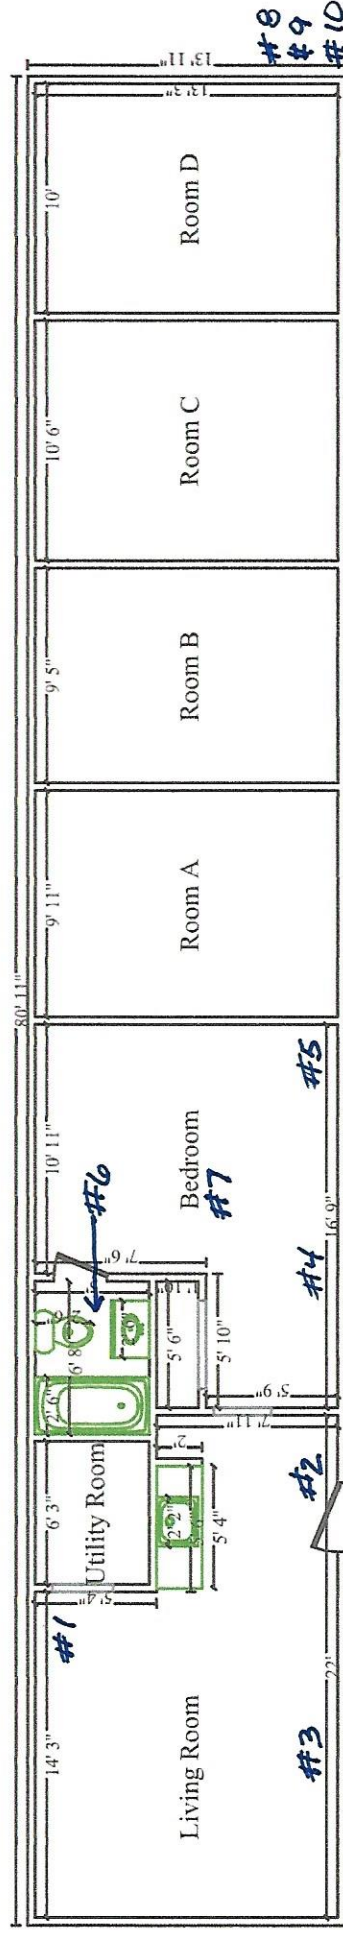
10111 US Hwy 12
Randle, wa 98377

- #1 white - joint compound
- 2 brown + white - flooring material
- 3 white - wallboard 1st layer
- 4 white - plaster wall material
- 5 red, black + brown - floor tile material
- 6 tan - floor tile material
- 7 white - ceiling joint compound
- 8 green + black - roofing material
- 9 black + brown - insulation board material
- 10 multi colored - roofing material - 1st layer

Note: There is no suspect material in rooms A, B, C + D
