Notice of Intent to Remove Asbestos

Asbestos Containing Materials Inspection

Good Faith Inspection

Project: 100 SE Leadbetter Road

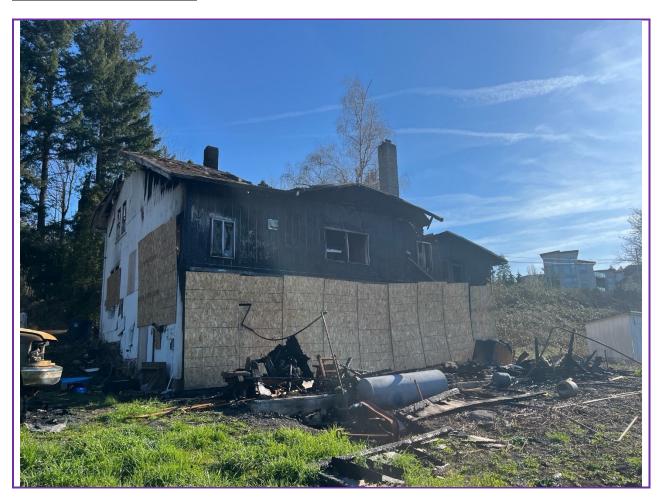
FRONT OF STRUCTURE

The structure was a wood framed single family residence. The home was on a raised foundation and sustained substantial fire damage.
