Notification of Demolition

3 Kings Environmental, Inc.

Asbestos Containing Materials Inspection

Project: 506 NE 59th St.
Vancouver, WA 98665

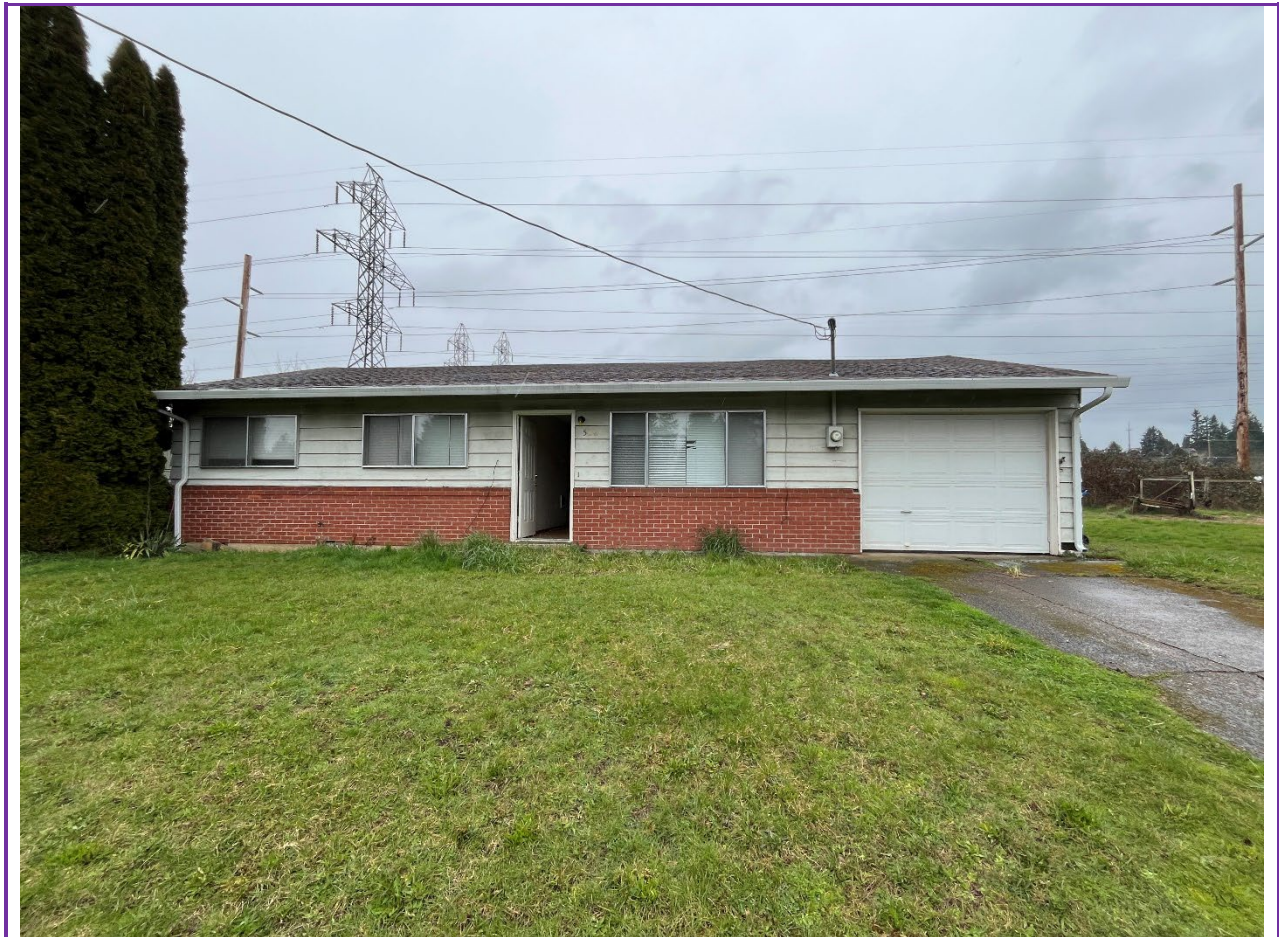
FRONT OF STRUCTURE

The structure was a wood framed one story single family residence on a concrete foundation with attached garage. The structure was built in 1963 with estimated square footage of 936 SF in the residence and 312 SF in the attached garage.
