Notice of Intent to Remove Asbestos

Case #: 24-214

Asbestos Survey Report

Survey Location: 1416 SE 97th Ave, Vancouver, WA 98664

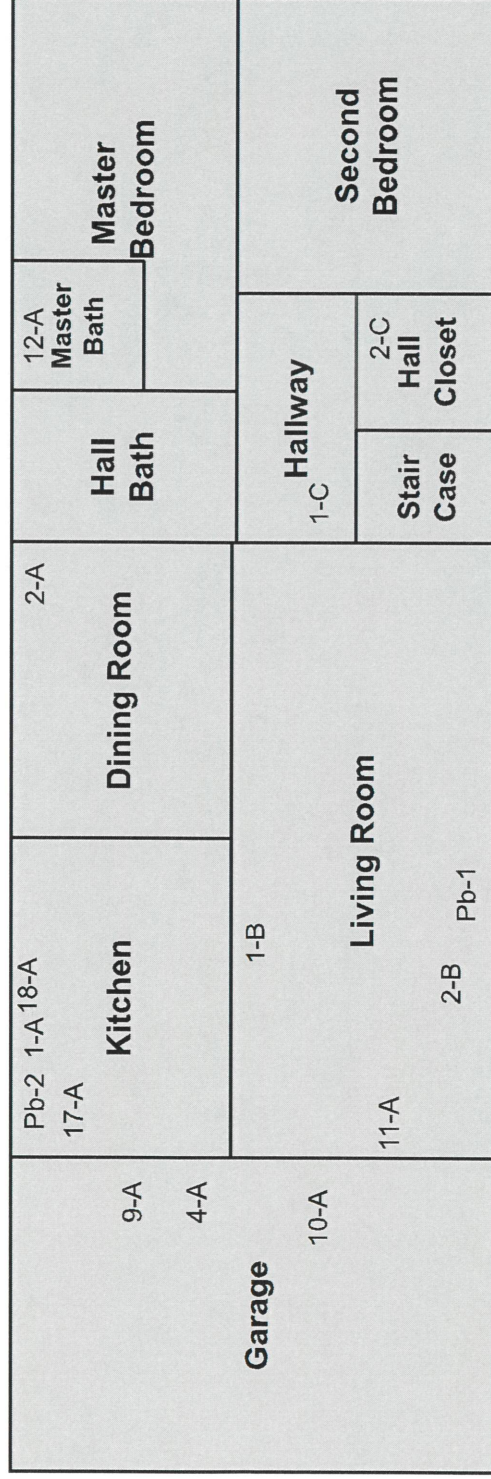
1416 SE 97th Ave, Vancouver, WA 98664 - Main Floor

Suspect Asbestos Containing Sample Locations

Closet	3-A Hallway/ Stairs	15-A Master Bathroom/Closet 13-A 14-A	16-A Flat Roof
First Bedroom	1-E	3-C Pb-5 Master Bedroom 1-D Pb-4	Flat Roof

5-A 5-B Pb-3 5-C	Crawlspace	Bathroom 7-A
Stair Case 3-B	8-A Hallway	
6-A	Living Room
