Notice of Intent to Remove Asbestos

Asbestos Survey Report

Project Name: 4110 Short Plat

Survey Location: 4110 NE 143rd Ave, Vancouver, WA 98682 - Garage, Barn, and Shed

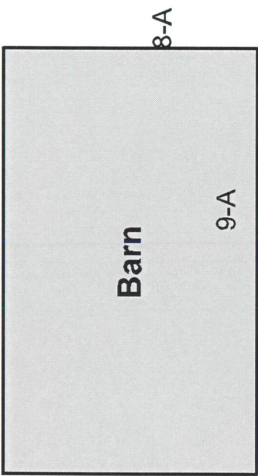
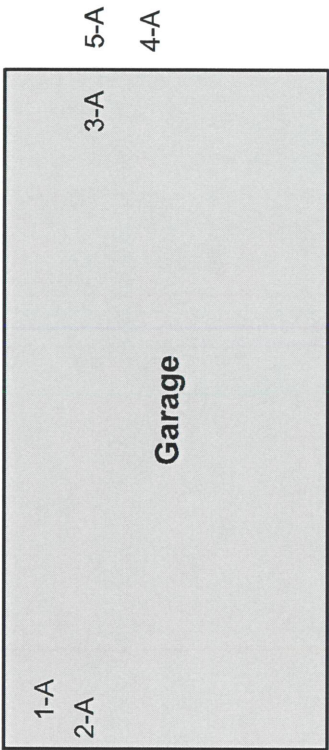
Suspect Asbestos Containing Sample Locations

4110 NE 143rd Ave, Vancouver, WA 98682 - Garage, Barn, and Shed
