## Notice of Intent to Remove Asbestos

# Asbestos Containing Materials Inspection

Good Faith Inspection

Project: 215 Ledbetter Survey  
215 SE Ledbetter Road  
Camas, WA 98607

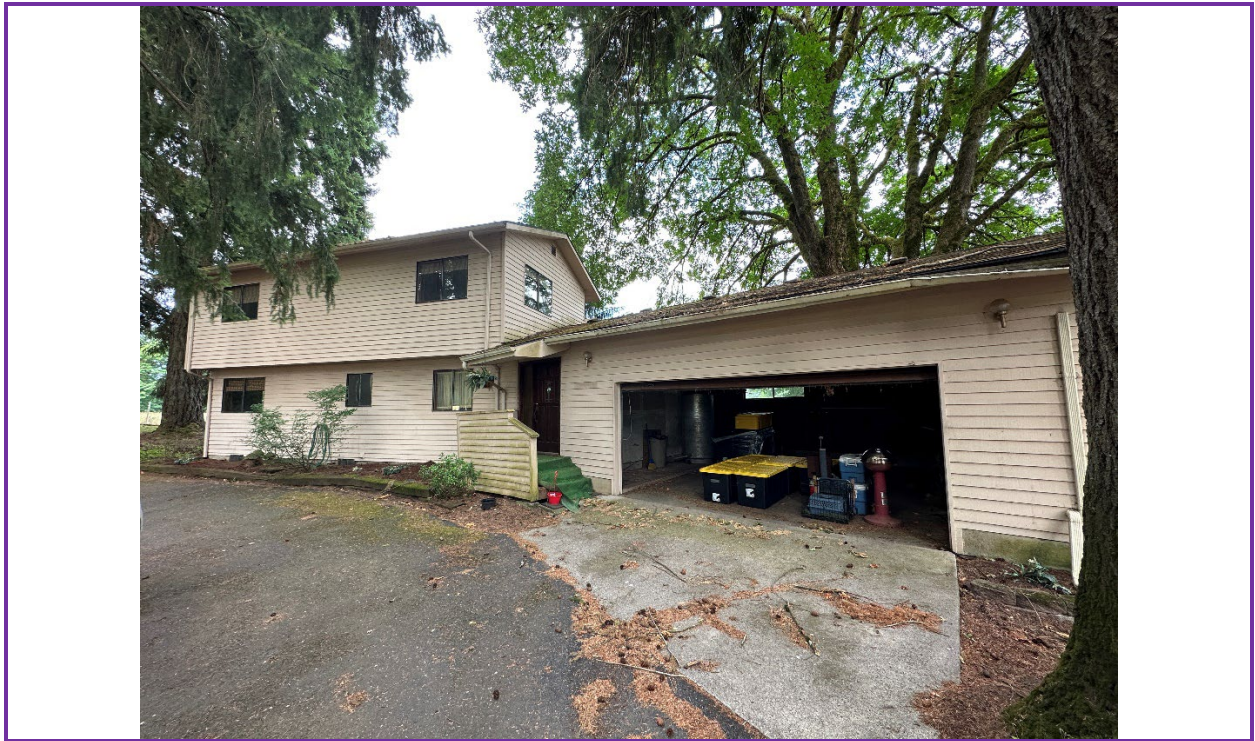
**FRONT OF STRUCTURE**

The structure was a 1,584 SF single family residence with a 1,008 SF basement and 475 SF attached garage.

The interior of the home was primarily drywall. Ceilings were drywall with popcorn texture. The floors were sheet vinyl.

The exterior of the home consisted of aluminum windows, wood lap siding, and a composition roof.
