Notice of Intent to Remove Asbestos

Asbestos Survey Report

Project Name: Timothy Gaston Job Number: 6190

Survey Location: 11208 NE 10th Ave, Vancouver, WA 98685

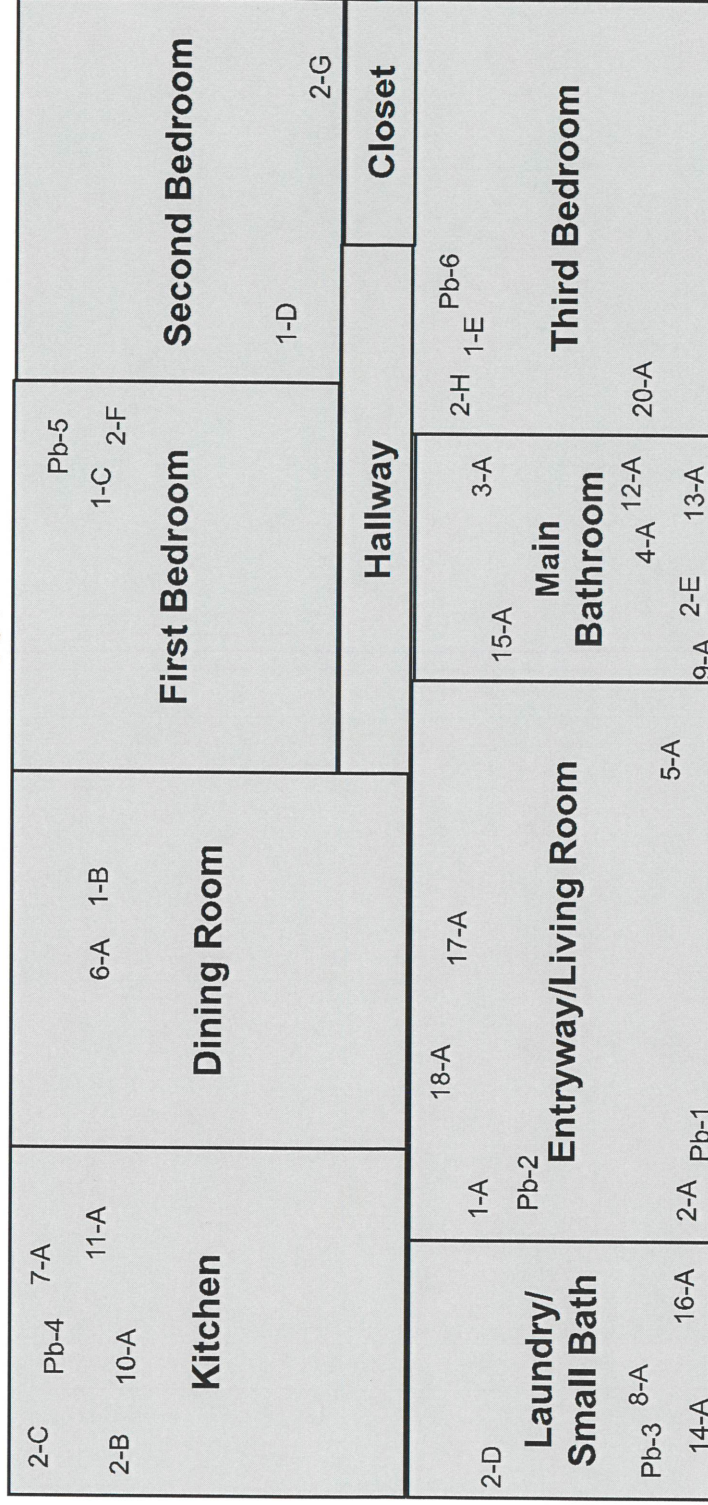
Suspect Asbestos Containing Sample Locations

11208 NE 10th Ave, Vancouver, WA 98685 - Main House
