Notice of Intent to Remove Asbestos

Case #: 24-482

ASBESTOS FULL SURVEY REPORT

1015 NE 78th Street, Vancouver, Washington 98665.

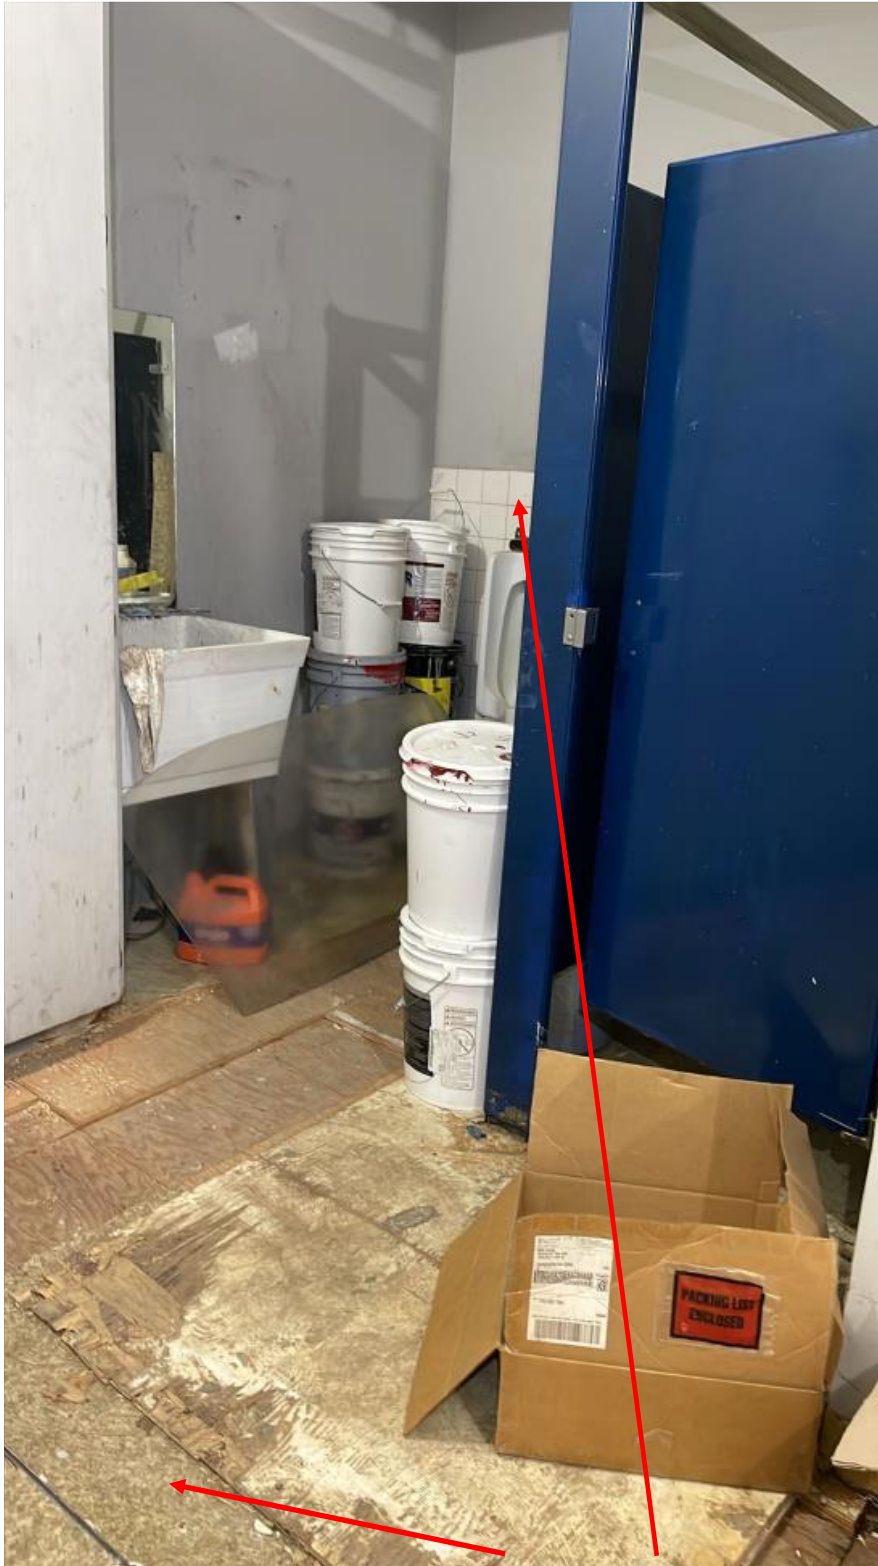
Mezzanine restroom (back) ACM vinyl and pipe fitting insulation (hard).

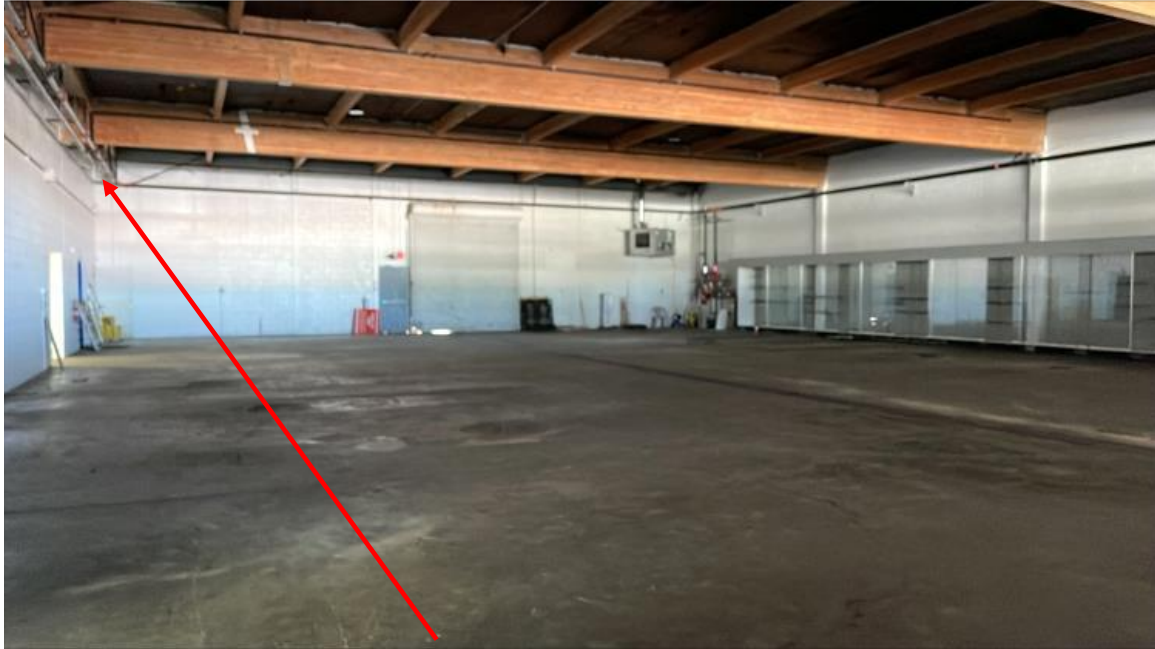
Shop area ACM pipe fitting insulation (hard)

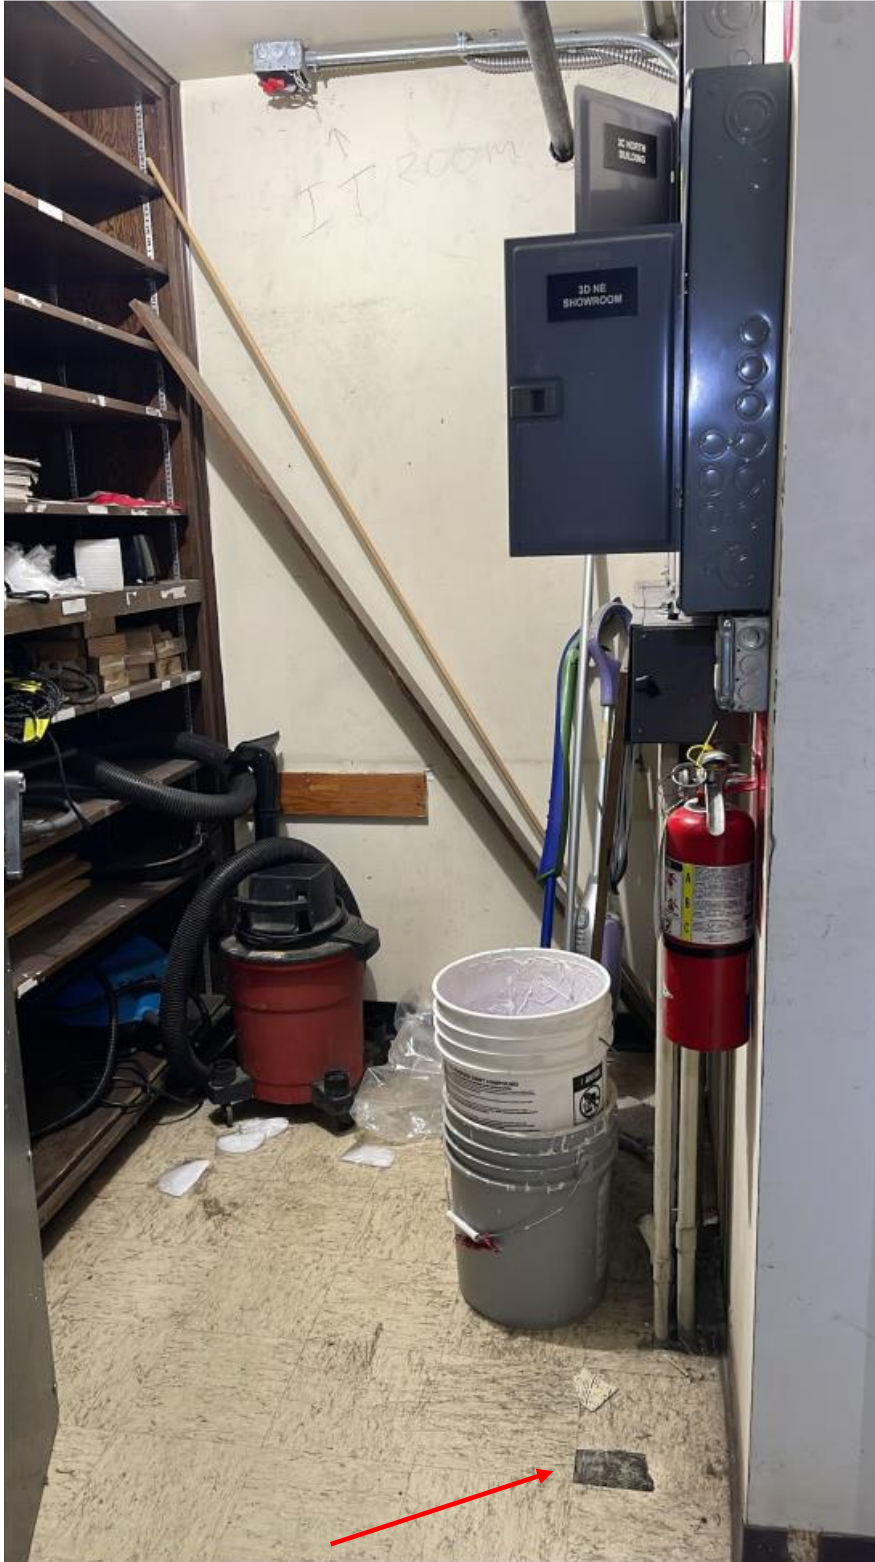
The analytical results indicate that asbestos was found above the guideline limit of 1% in the Storage Closet - Flooring (A1) sampling sections; these materials are considered homogeneous, therefore it is presumed that asbestos is present in other areas surveyed with the same Flexible Tile.

Storage closet ACM floor tiles & mastic.
