Notice of Intent to Remove Asbestos

Case #: 24-539

Limited in scope/Asbestos Survey Report

Project #: 462

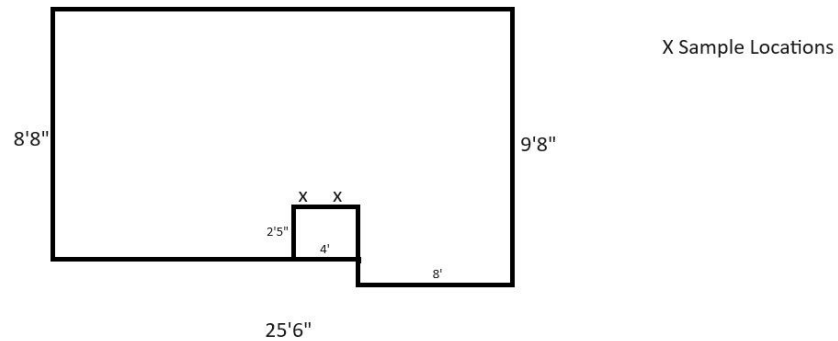
Kitchen/Dining

APPENDIX A: SITE MAP; location(s) where survey was performed
