Notice of Intent to Remove Asbestos

Case #: 24-540

Asbestos Survey Report

Survey Location: 20719 NE 83rd St, Vancouver, WA 98682

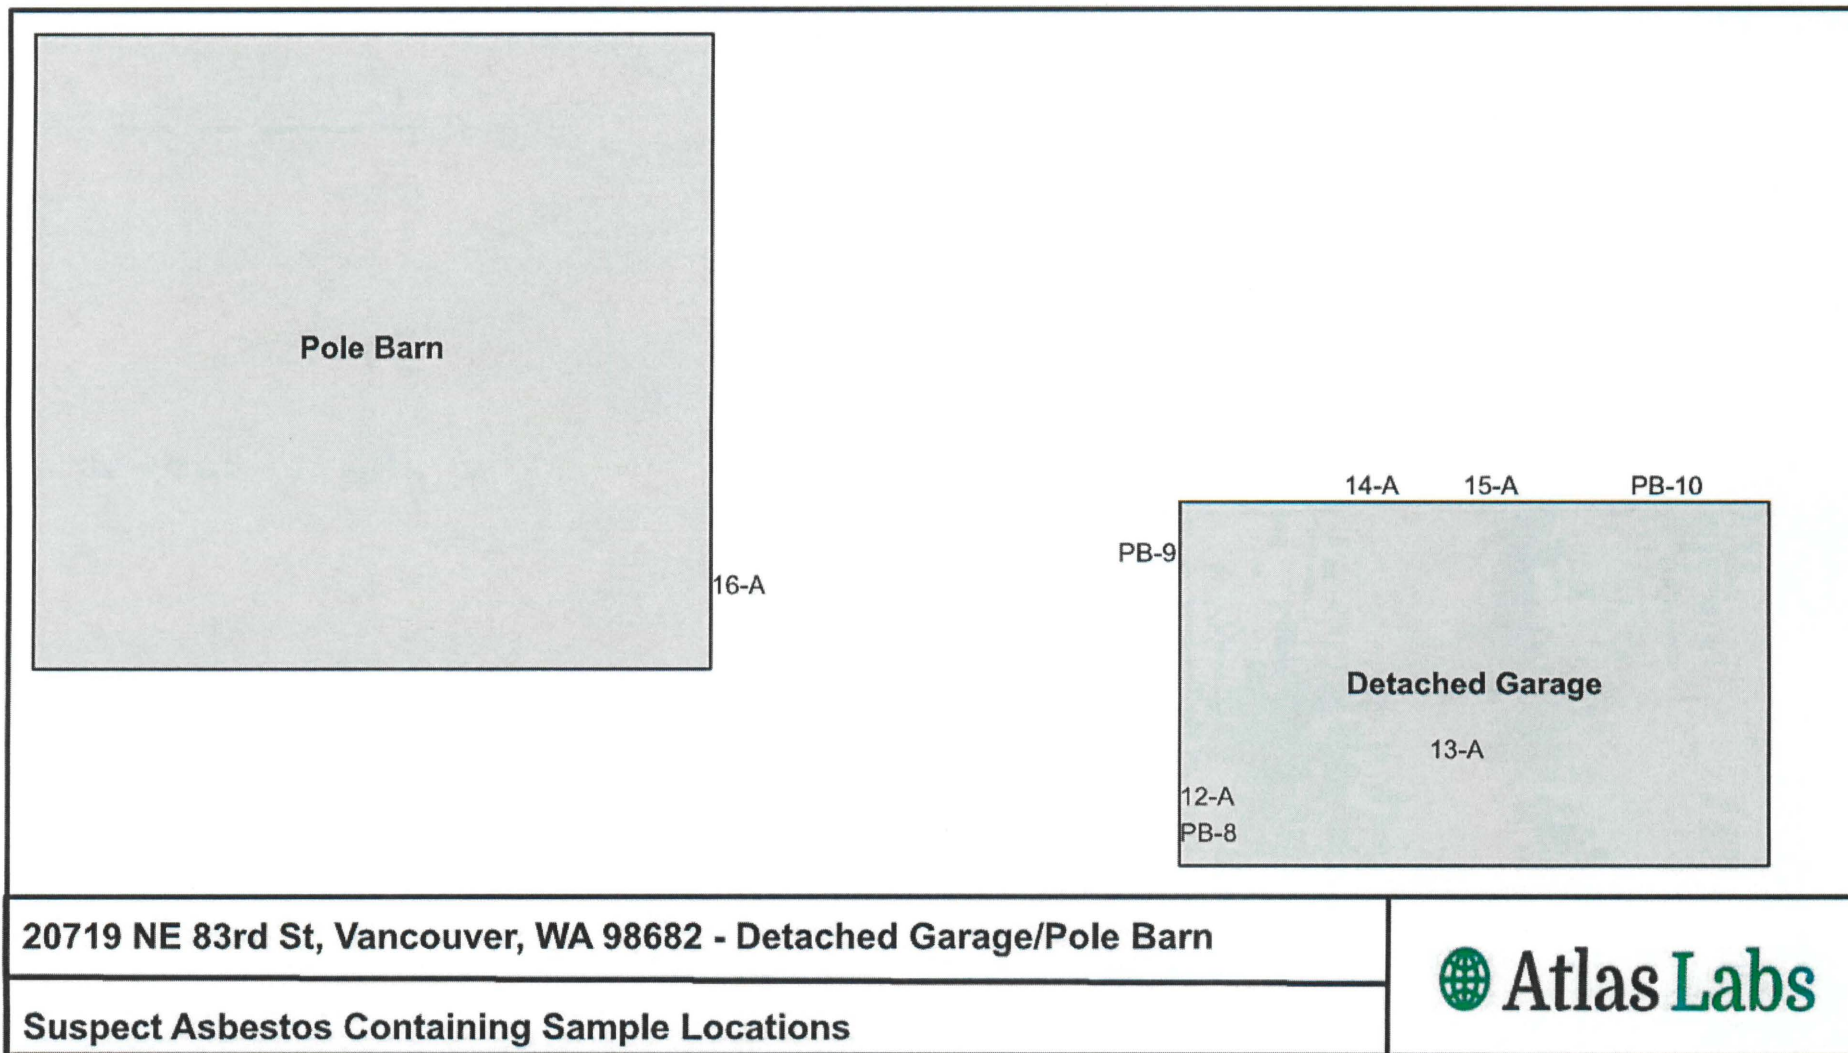
APPENDIX B - Suspect Asbestos Containing Material Sample Locations/Drawings
