PRE-RENOVATION ASBESTOS SURVEY REPORT

CENTRALIA MANOR

303 West Pine Street
Centralia, Washington 98513

Partner Project No. 23-411290.9

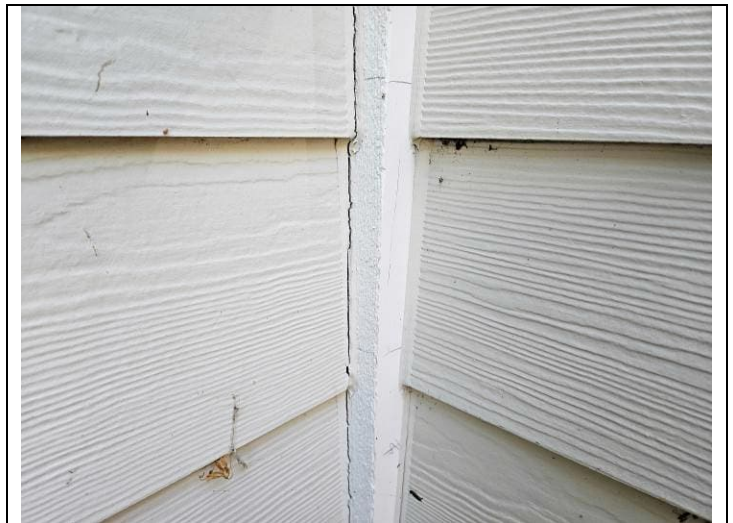
4. Exterior: caulk

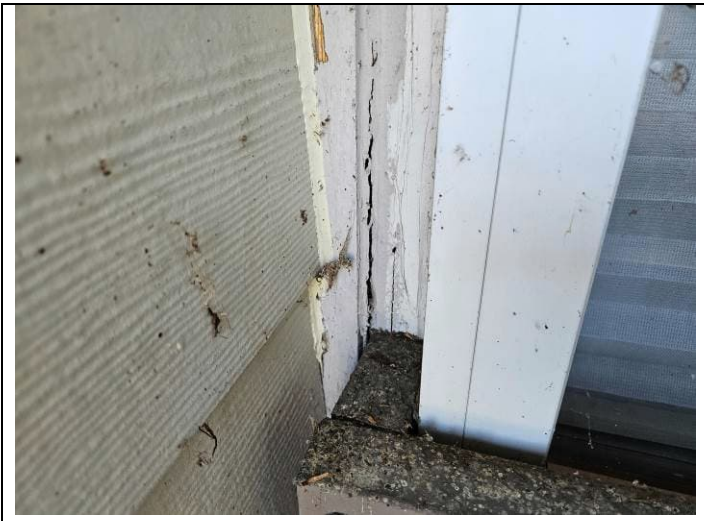
5. Exterior: caulk

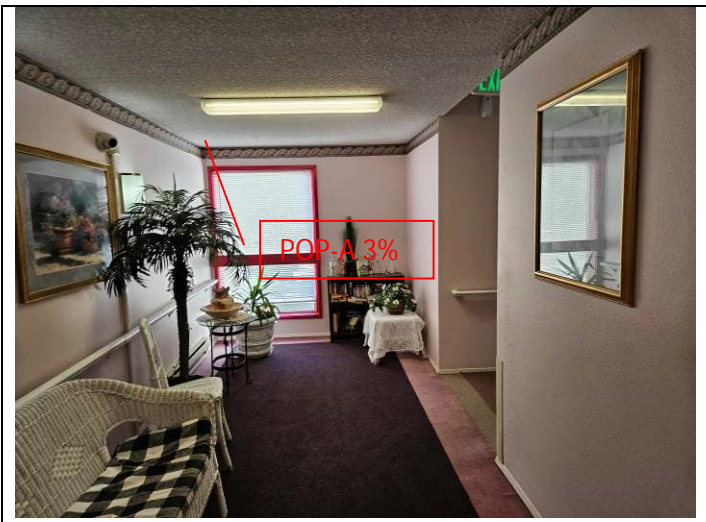
29. Interior: Floor 3, Corridor

Table 1: Identified ACM					
HA	Locations	Description	Condition	Asbestos Content	Quantity
POP-A-06	Interior-Bldg. 1, Floor 3, Corridor, Ceiling, Side A	Popcorn Ceiling Texture (white)	Friable / Good	3% Chrysotile	800 SF
POP-A-07	Interior-Bldg. 1, Floor 3, Corridor, Ceiling, Side D	Popcorn Ceiling Texture (white)	Friable / Good	3% Chrysotile	800 SF
POP-B-01	Interior-Bldg. 1, Floor 1, Unit 106, Bedroom, Ceiling, Side B	Popcorn Ceiling Texture (white)	Friable / Good	3% Chrysotile	600 SF
POP-B-02	Interior-Bldg. 1, Floor 1, Unit 106, Closet, Side A	Popcorn Ceiling Texture (white)	Friable / Good	3% Chrysotile	600 SF
POP-B-03	Interior-Bldg. 1, Floor 1, Unit 107, Closet, Side B	Popcorn Ceiling Texture (white)	Friable / Good	3% Chrysotile	600 SF
POP-B-04	Interior-Bldg. 1, Floor 2, Unit 201, Living Room, Ceiling, Side A	Popcorn Ceiling Texture (white)	Friable / Good	3% Chrysotile	600 SF
POP-B-05	Interior-Bldg. 1, Floor 2, Unit 201, Bedroom, Ceiling, Side D	Popcorn Ceiling Texture (white)	Friable / Good	3% Chrysotile	600 SF

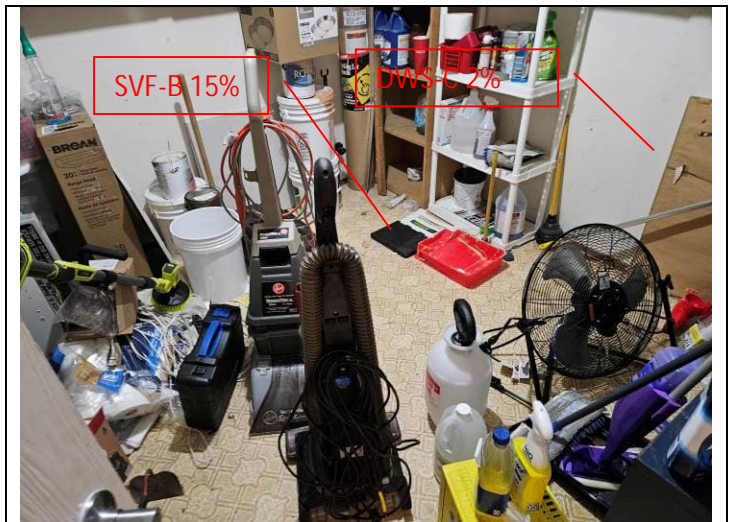
42. Interior: Floor 1, Storage/Maintenance

Table 1: Identified ACM					
HA	Locations	Description	Condition	Asbestos Content	Quantity
SVF-B-01	Interior-Bldg. 1, Floor 1, Community Storage/Maintenance Room, Side B	Sheet Vinyl Flooring (brown/tan)	Non-Friable / Good	SVF: 15% Chrysotile Mastic: ND*	350 SF
SVF-B-02	Interior-Bldg. 1, Floor 1, Community Storage/Maintenance Room, Side C	Sheet Vinyl Flooring (brown/tan)	Non-Friable / Good	SVF: 15% Chrysotile Mastic: ND*	350 SF
SVF-B-03	Interior-Bldg. 1, Floor 1, Community Storage/Maintenance Room, Side D	Sheet Vinyl Flooring (brown/tan)	Non-Friable / Good	SVF: 15% Chrysotile Mastic: ND*	350 SF
SVF-D-01	Interior-Bldg. 1, Floor 2, Unit 201, Kitchen Floor, Side D	Sheet Vinyl Flooring (tan sheet)	Non-Friable / Good	SVF 1: ND* Mastic 1: ND* SVF 2: 15% Chrysotile Mastic 2: ND*	400 SF
SVF-D-02	Interior-Bldg. 1, Floor 2, Unit 201, Bathroom Floor, Side A	Sheet Vinyl Flooring (tan sheet)	Non-Friable / Good	SVF 1: ND* Mastic 1: ND* SVF 2: 15% Chrysotile Mastic 2: ND*	400 SF
