# Notice of Intent to Remove Asbestos

## **“Good Faith” Asbestos Survey Report**

**Located at:  
150 Annonen Rd.  
Winlock, WA 98596**

**September 23, 2024**

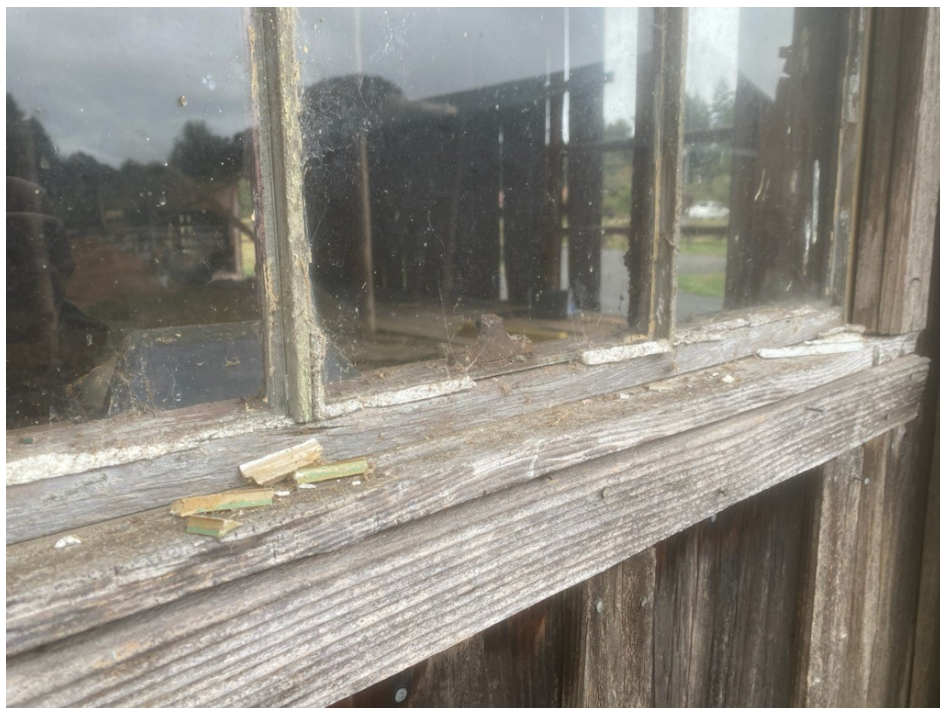
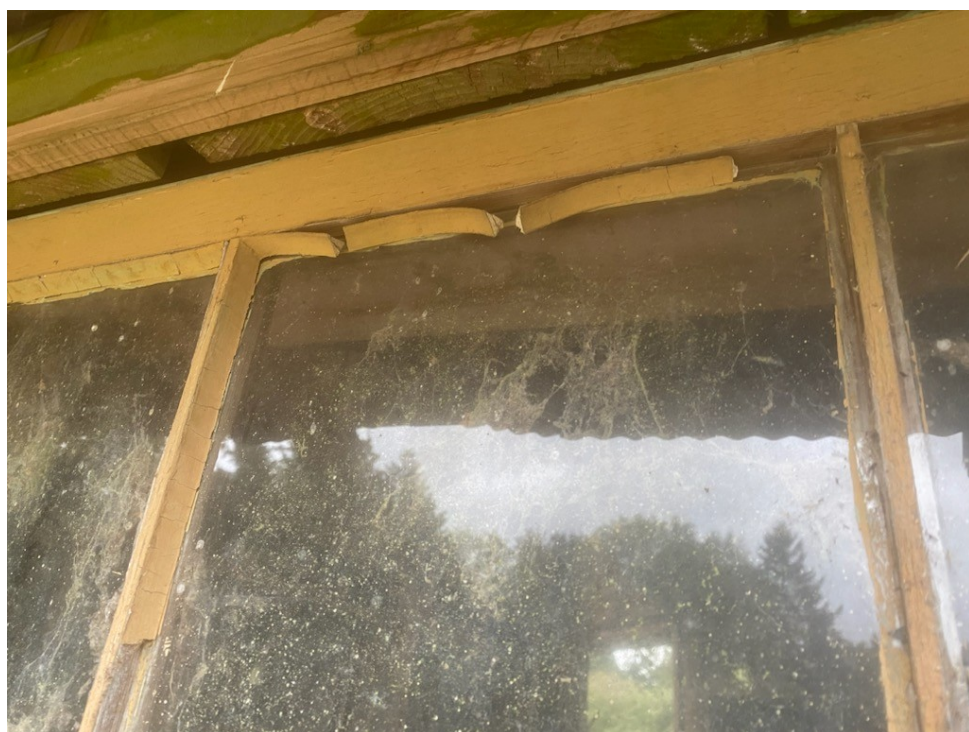
Sample Number	Material	Location of Samples	Condition	Friable Yes/No	Asbestos Content %
W-1	Window Glaze	Exterior Window Frame Systems	Good	No	2% Chrysotile
W-2	Window Glaze	Exterior Window Frame Systems	Good	N/A	Not Detected
W-3	Window Glaze	Exterior Window Frame Systems	Good	N/A	Not Detected

Sample Numbers	Material	Location of Material	Approximate Quantity
W-1	Window Glaze	Exterior Window Frame Systems	10 Windows

**W-1 Window Glaze Exterior Window Frame System**

Regulated ACM are required to be handled in accordance with Washington State Regulations prior to any demolition, renovation, or remodeling that would disturb these materials. Washington State Department of Labor and Industries require that the abatement be performed using Certified Asbestos Workers under the direct on site supervision of an Asbestos Supervisor. The only exemption of this is for residential owners performing removal of asbestos materials other than furnace interiors, or direct applied mudded asbestos insulation. The requirements for handling, packaging, and disposing of asbestos-containing materials can be found in WAC Chapter 296-62, Volume I, Part I-1.
