## Notice of Intent to Remove Asbestos

## **Asbestos Survey Report**

**Survey Location: 1818 54th St, Washougal, WA 98671**

**Inspection Date: November 1st, 2024**

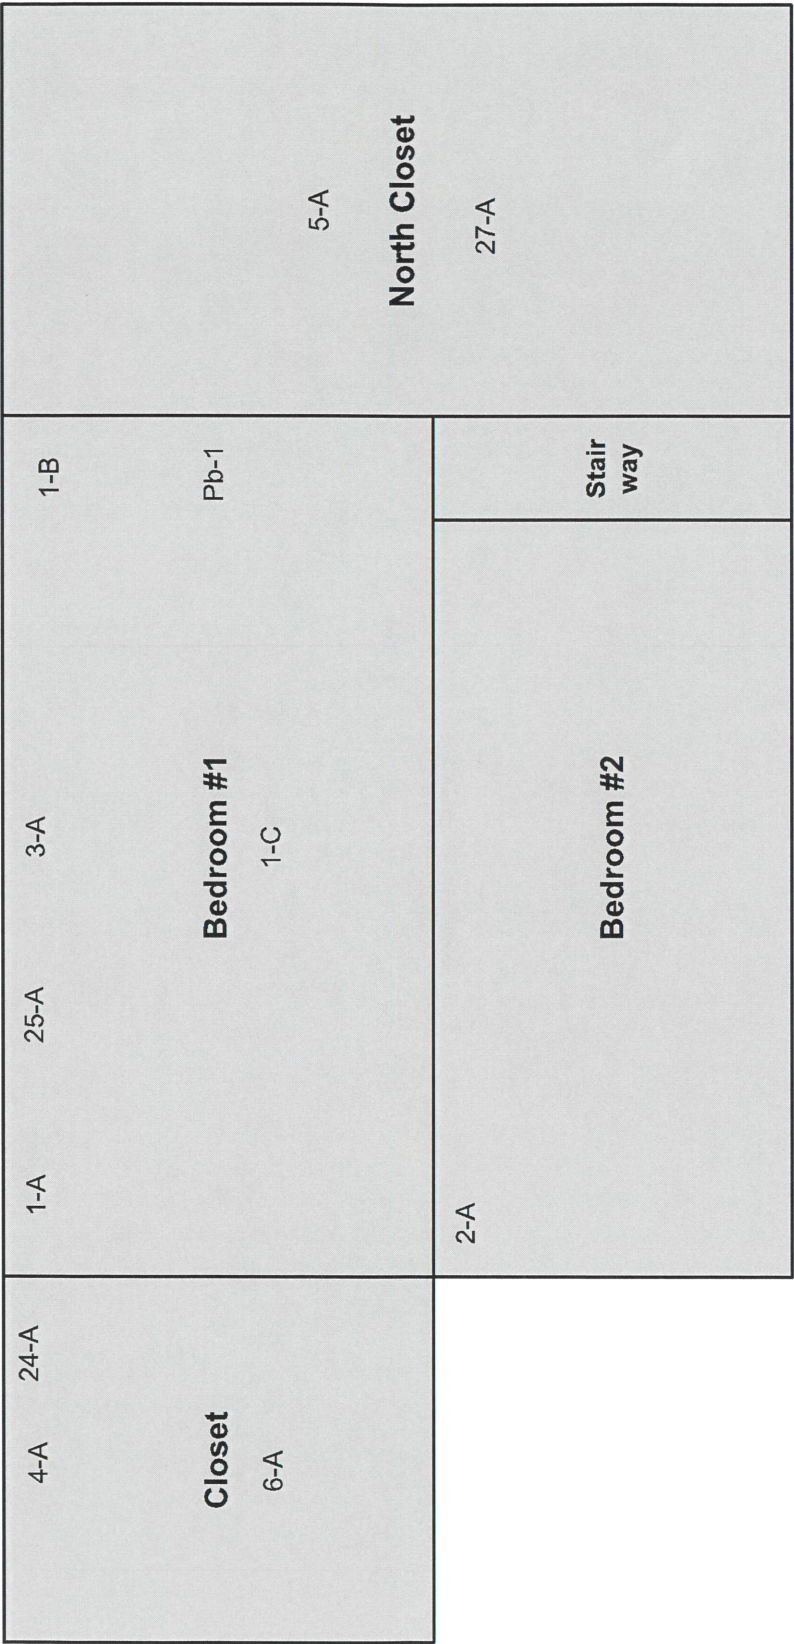
1818 54th St, Washougal, WA 98671 - Main Floor

Suspect Asbestos Containing Sample Locations
